**US Army Corps of Engineers
Omaha District
API 653 Out-of-Service
Inspection Report**

**Andrews Air Force Base, Morningside, Maryland
Facility 5025
Tank 25**

**US Army Corps of Engineers Center of Expertise for Petroleum, Oils and Lubricants
USACE POL-MCX**

16 January 2018

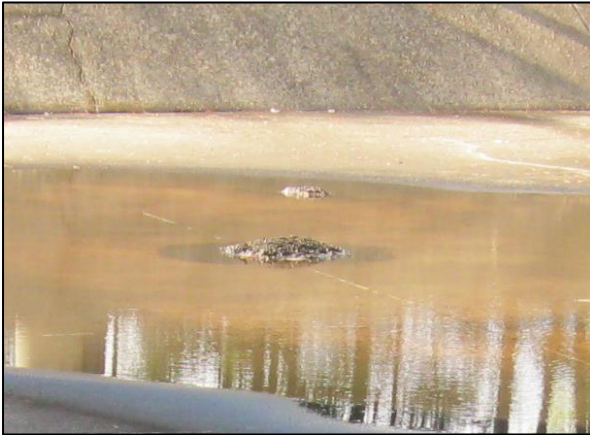
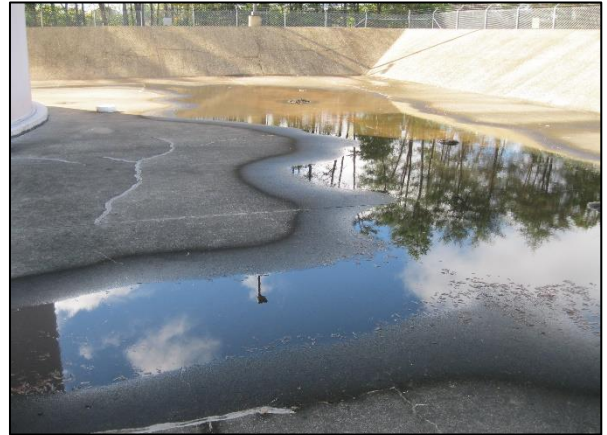
Reference: Guidance for maintenance of fuel storage facilities provided in UFC 3-460-03 paragraph 8-10.3.1 includes inspection of dike areas for cleanliness and removal of debris and vegetation. NFPA 30 paragraph 22.11.2.8 prohibits storing combustible material in the dike area.

RECOMMENDATION: Continue to remove the algae from the dike area.

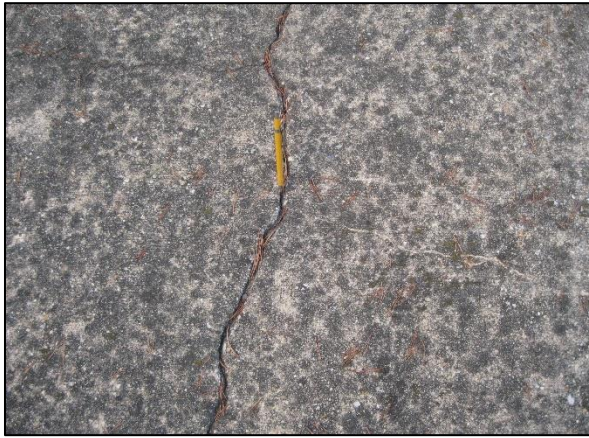
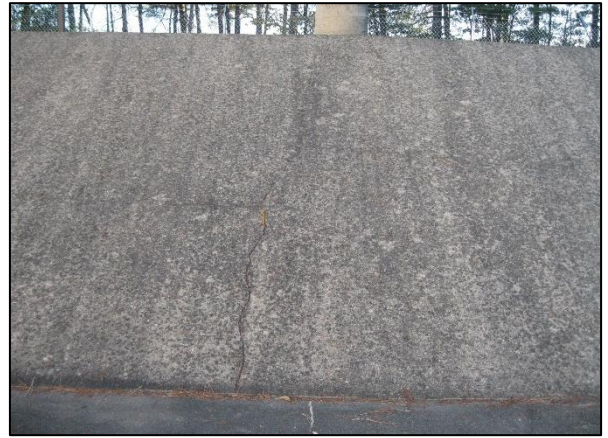
OBSERVATION: There are approximately 800 linear feet of cracks in the concrete covering the dike basin and 400 linear feet of cracks in the concrete covering the dike berms. The design drawings indicate a liner under the concrete ballast. Although the integrity of the line could not be visually verified, the liner seemed to be intact, based on the operators observations of retained rain water.

REFERENCE: Guidance for operation and maintenance of fuel facilities provided in UFC 3-460-03 paragraph 8-10.2 includes inspection of dike areas, removal of vegetation, and sealing of cracks.

RECOMMENDATION: As there is a liner under the concrete, sealing the cracks is not required. However, to inhibit growth of vegetation and further deterioration, and to simplify evaluation of the dike for environmental regulators, seal all of the cracks in the concrete covering the dike liner. Some of the cracks that should be repaired are shown in a sketch in our subconsultants report.

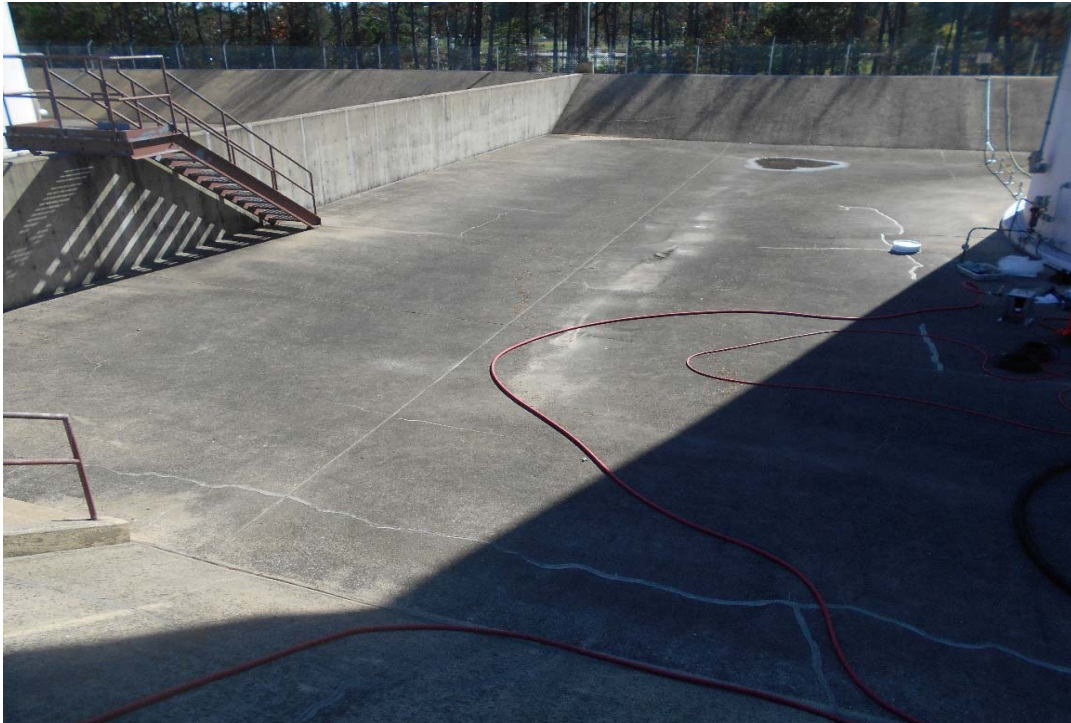
4.1.1 Secondary Containment: The secondary containment area consists of a concrete floor with sloped concrete walls. An informal evaluation of the secondary containment area was conducted. Field assessment indicates the secondary containment is of sufficient size to contain a total tank loss and thus satisfies the requirements of API Standard 653. The secondary containment drain is in satisfactory condition. The integrity of the secondary containment to contain product is questionable due to numerous cracks in the secondary containment floor and walls. The secondary containment floor has approximately 800 LF of exposed cracks. The secondary containment sloped walls have approximately 400 LF of exposed cracks. The design drawings indicate a liner under the concrete, the liner could not be visually evaluated. The secondary containment area does not appear to be properly graded to drain water away from the tank in accordance with NFPA 30. The secondary containment has a low-lying area collecting water on the West side of the tank.

E3: General View of Secondary Containment

4.2.1 **Secondary Containment:** Repair all exposed cracks in the secondary containment floor and sloped walls by grinding in a V-shape pattern with at least ¼-inch width at the surface and a depth of at least ¼-inch and sealing with flexible urethane (e.g. Sikaflex 1c) or a similar approved sealant.

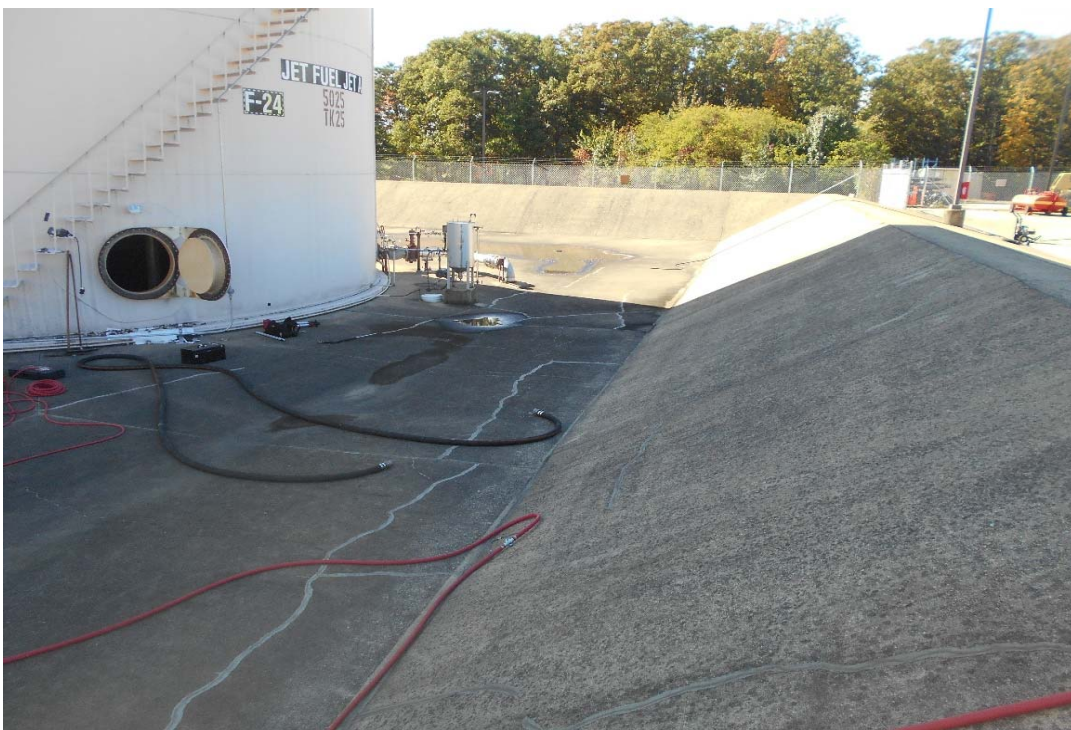
E4: General View of Secondary Containment

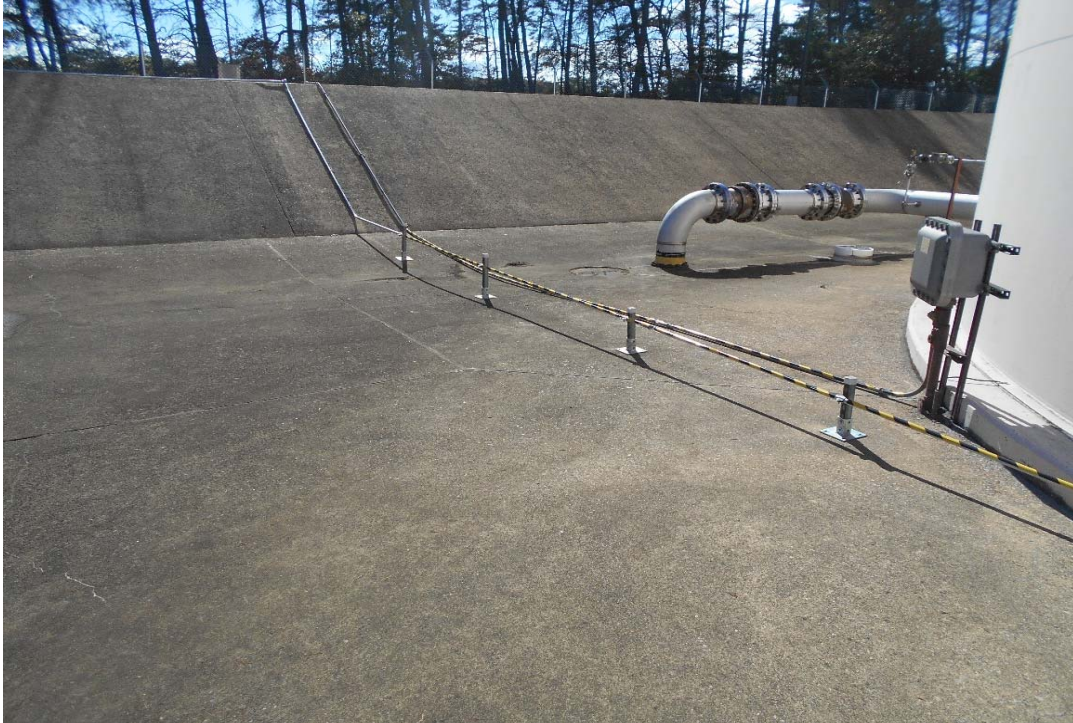
E5: General View of Secondary Containment

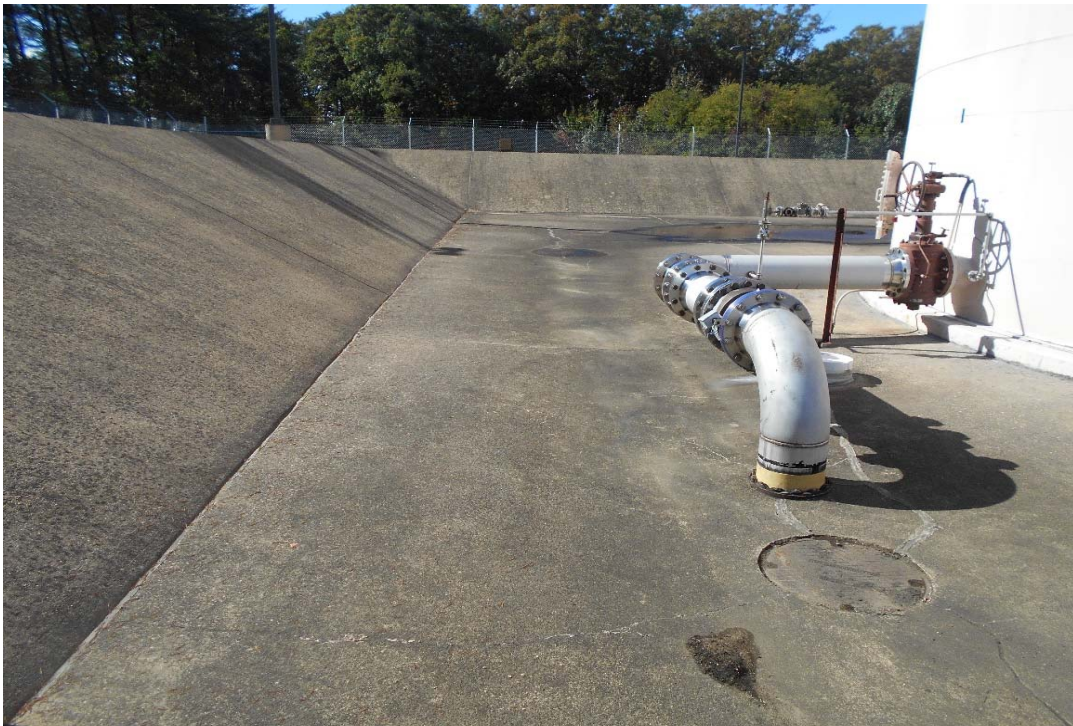
E6: General View of Secondary Containment

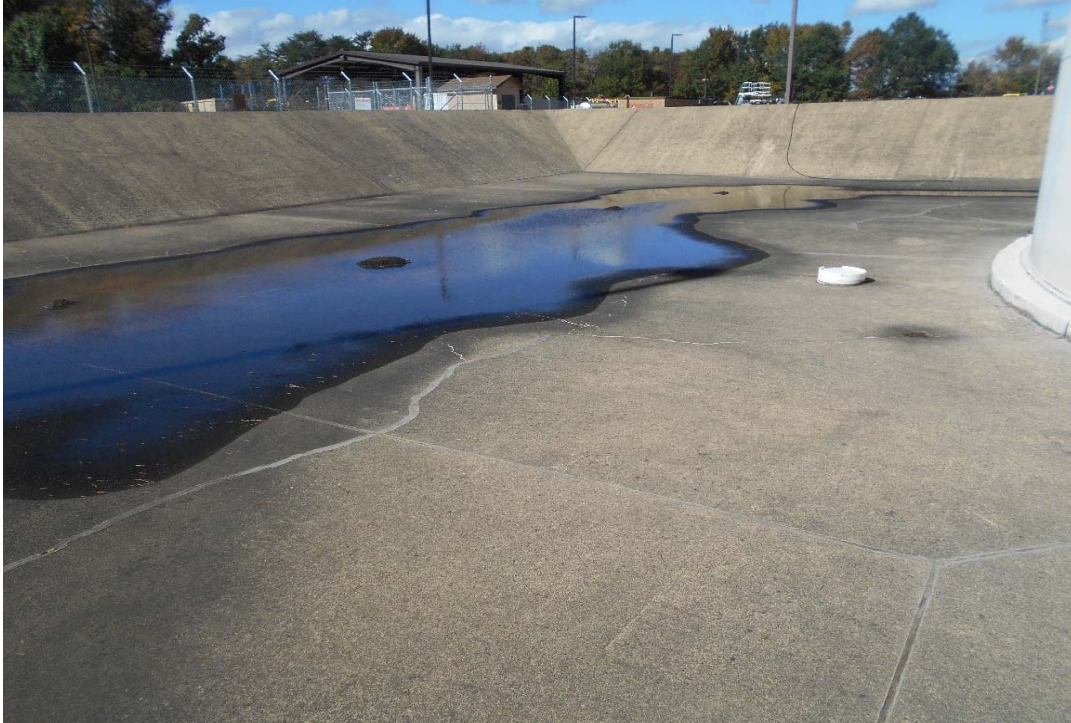
E7: General View of Secondary Containment

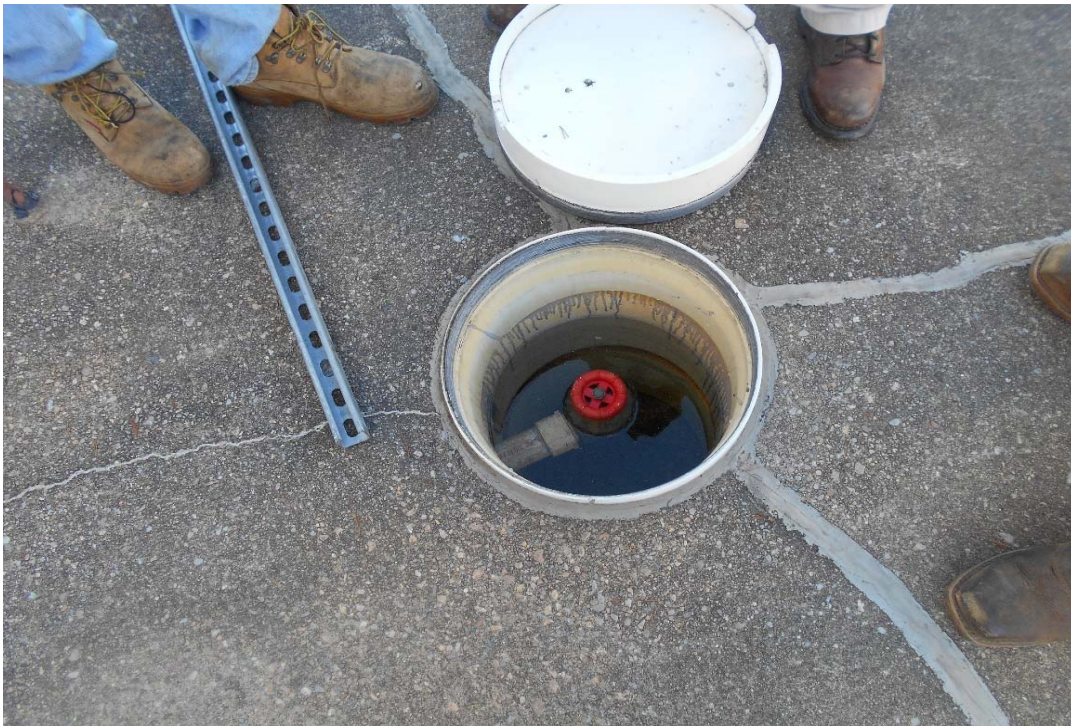
E8: Bottom Leak Detection Monitoring Well

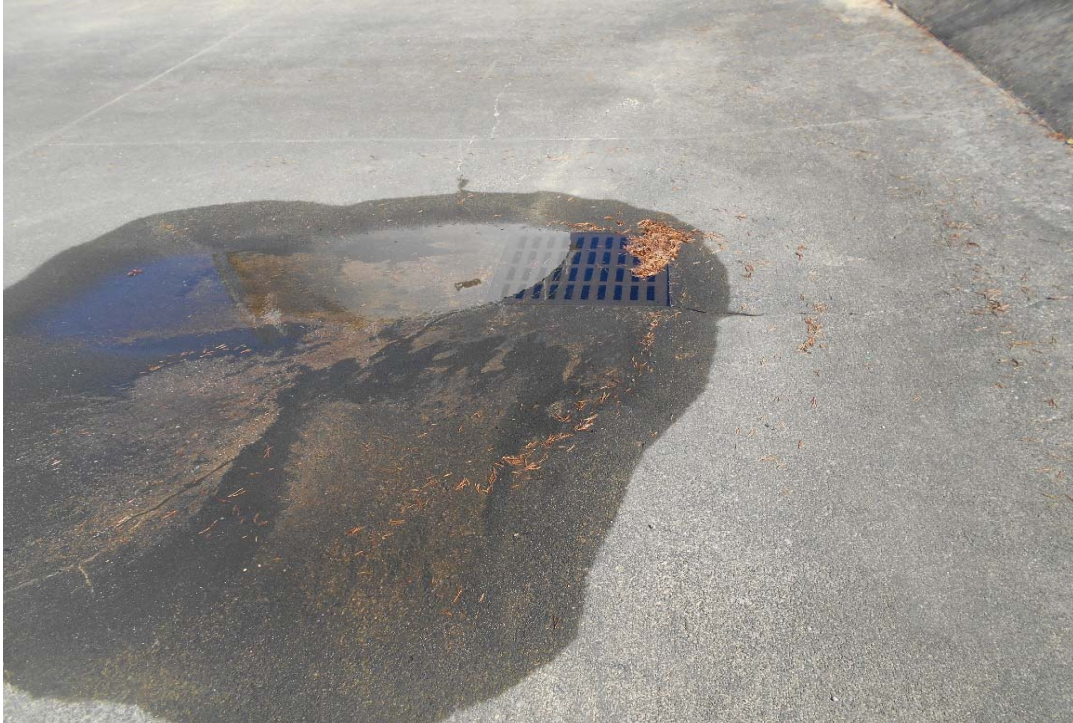
E13: Secondary Containment Drain

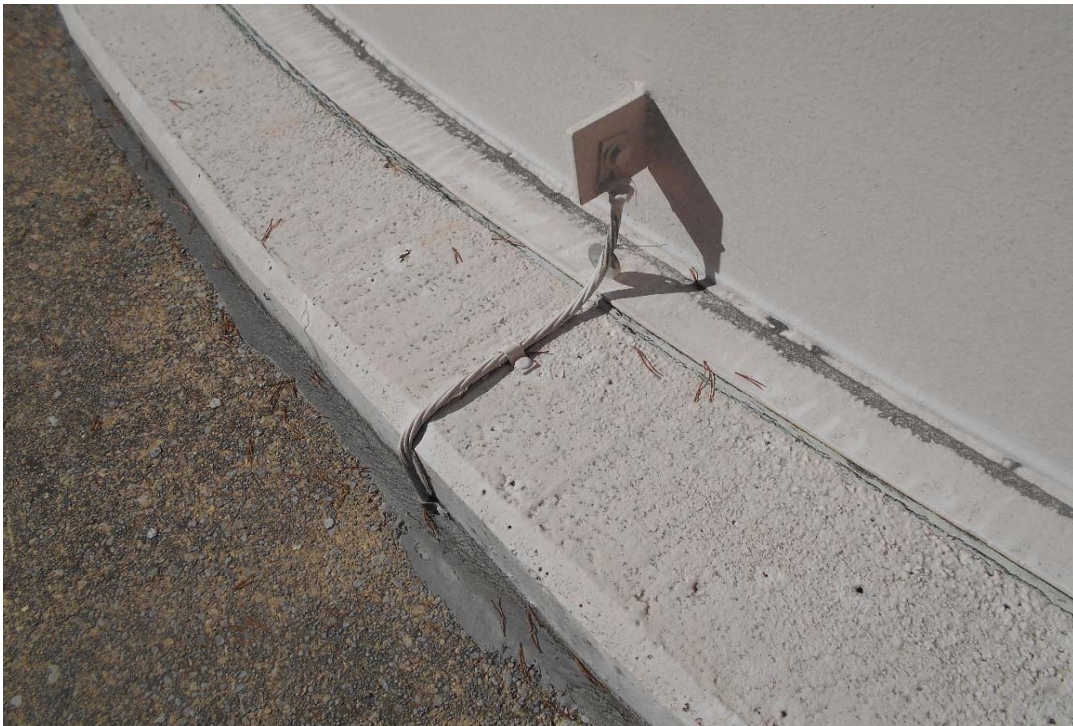
E14: General View of Concrete Ringwall

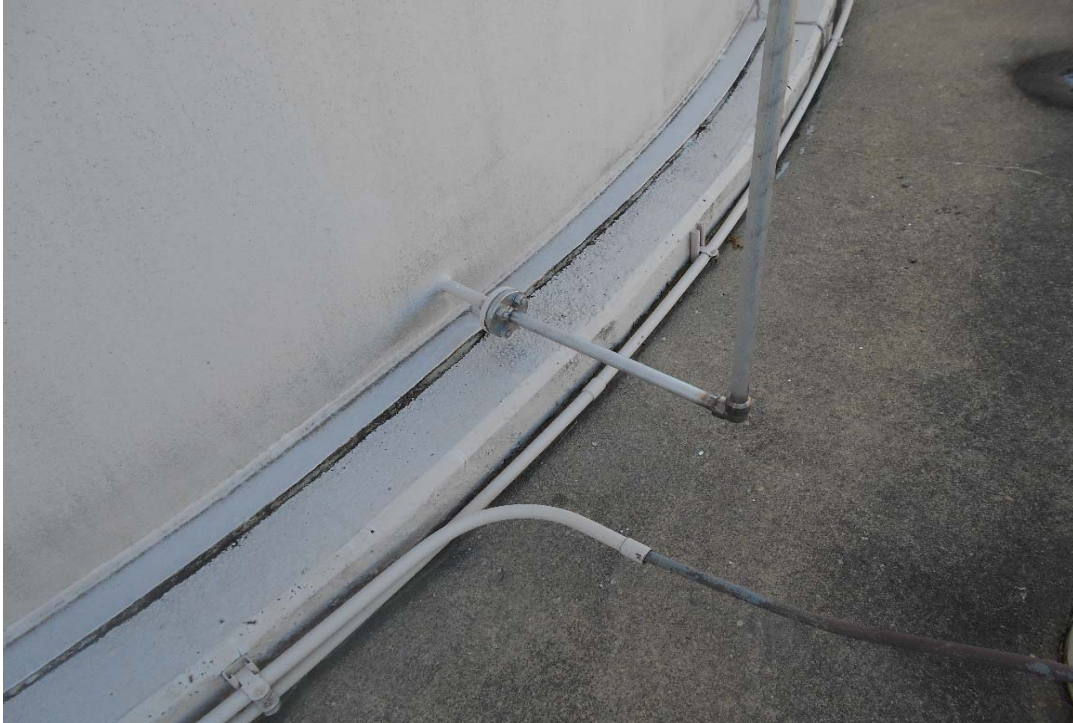
E15: General View of Concrete Ringwall

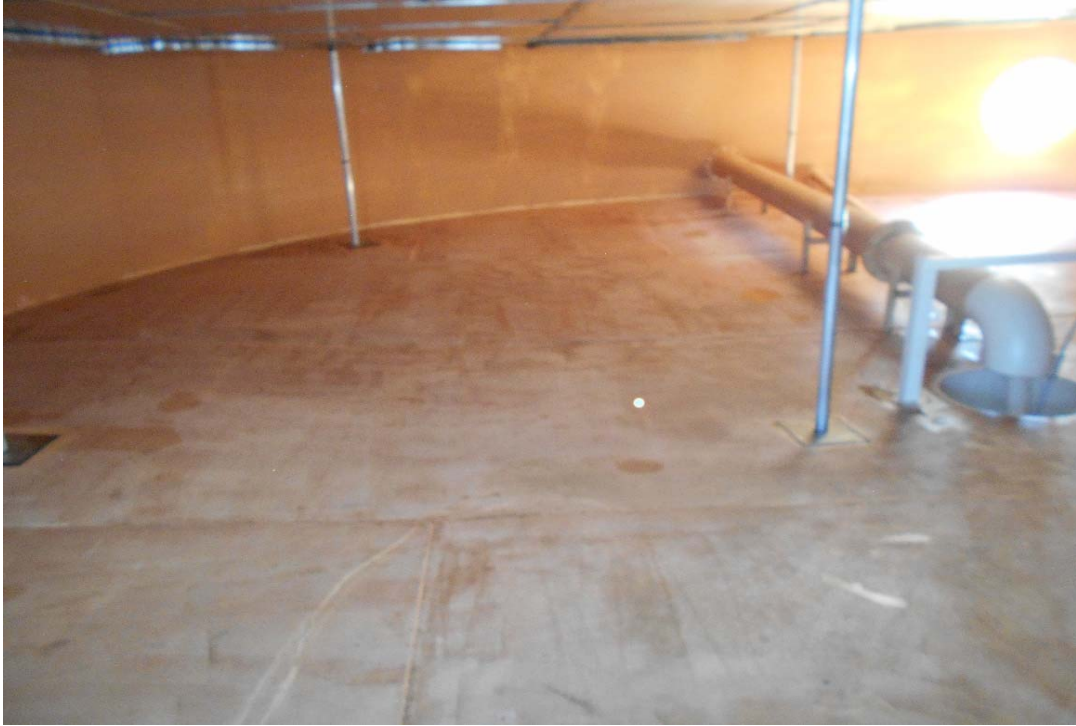
E17: General View of Bottom

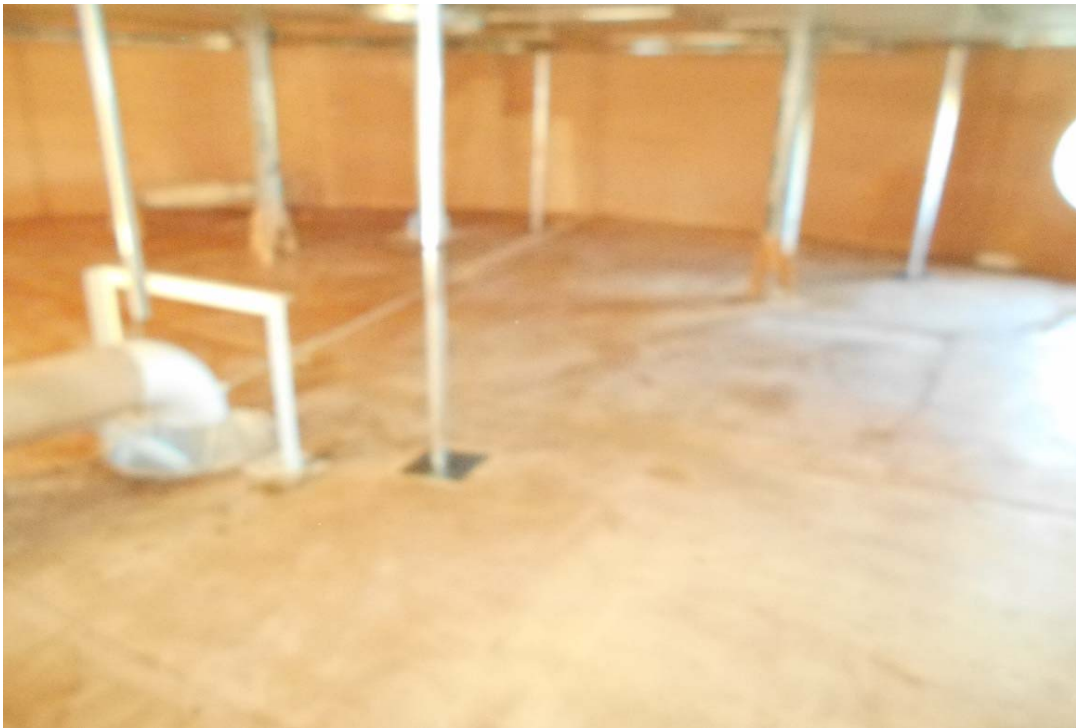
E18: General View of Bottom

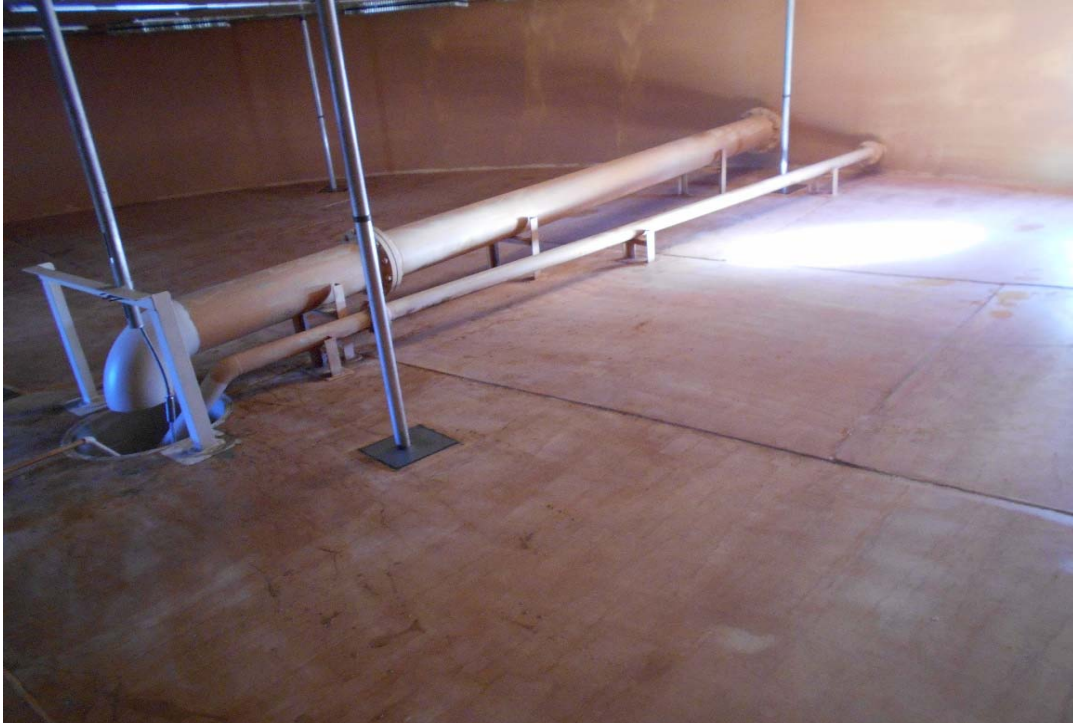
E19: General View of Issue Line and Drain Line

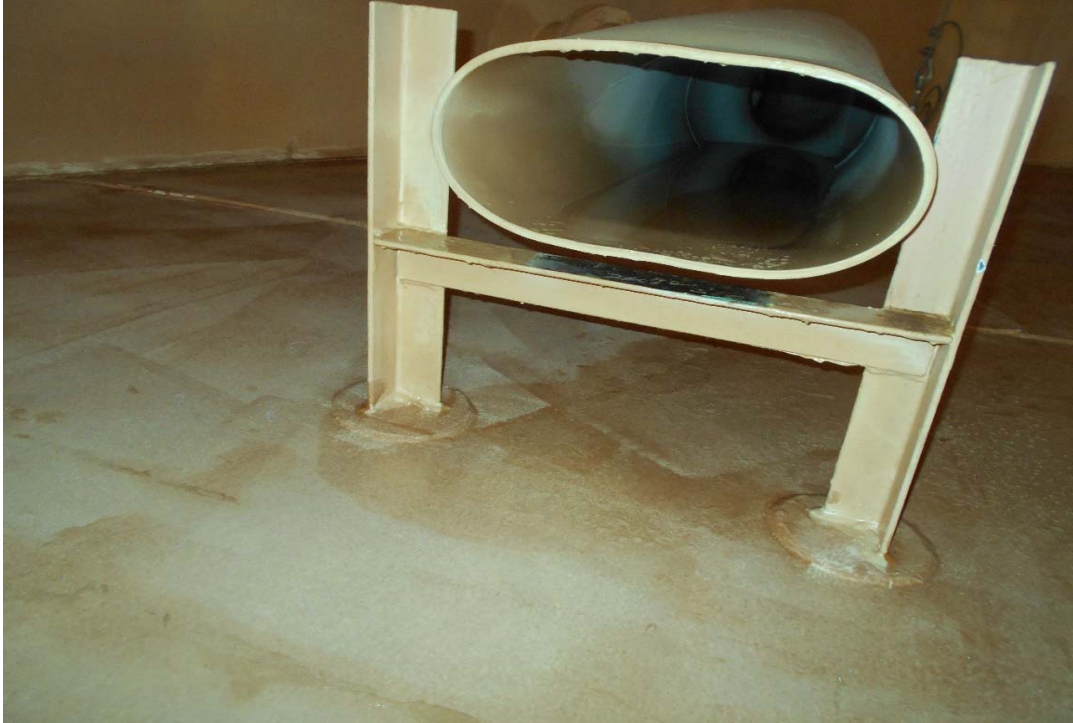
E21: Diffuser NOT Resting on Pipe Support

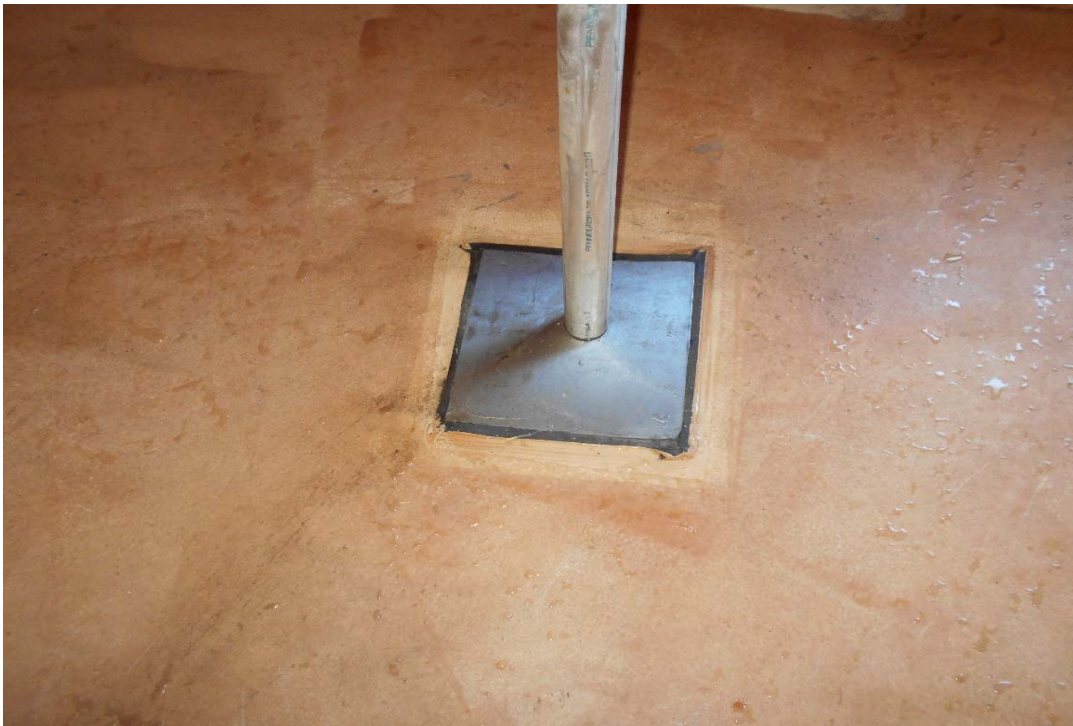
E22: General View of Floating Roof Striker Plate

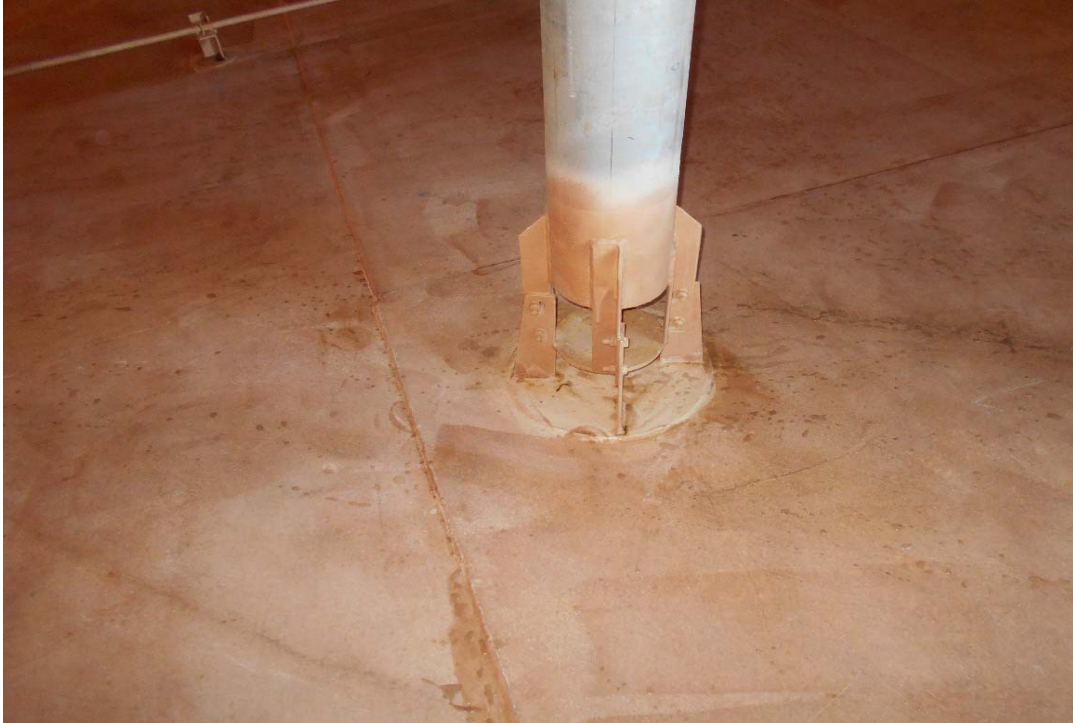
E23: Sample Stilling Well Hard Bolted to Bottom

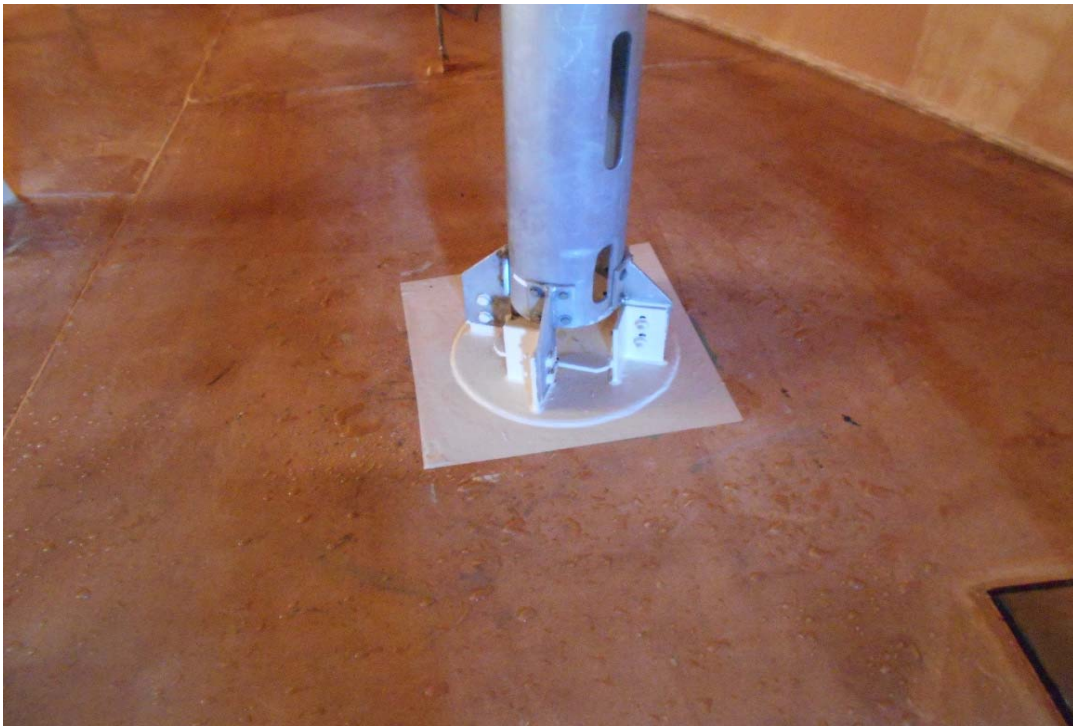
E24: ENRAF ATG Stilling Well Hard Bolted to Bottom

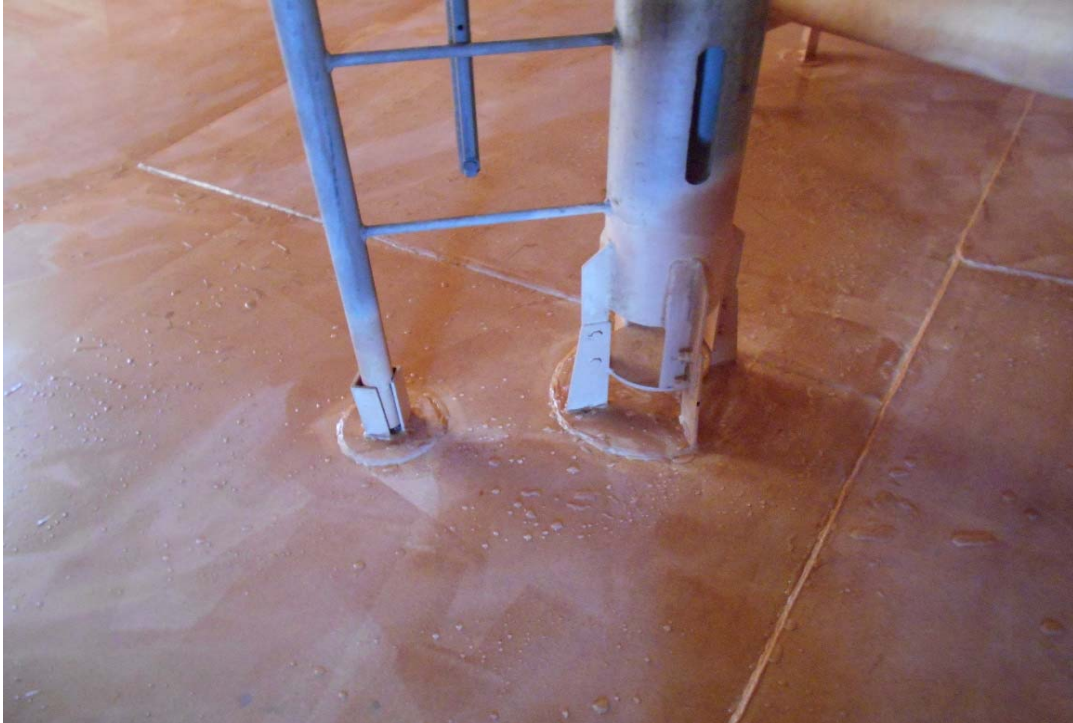
E25: Internal Ladder with Sample Stilling Well

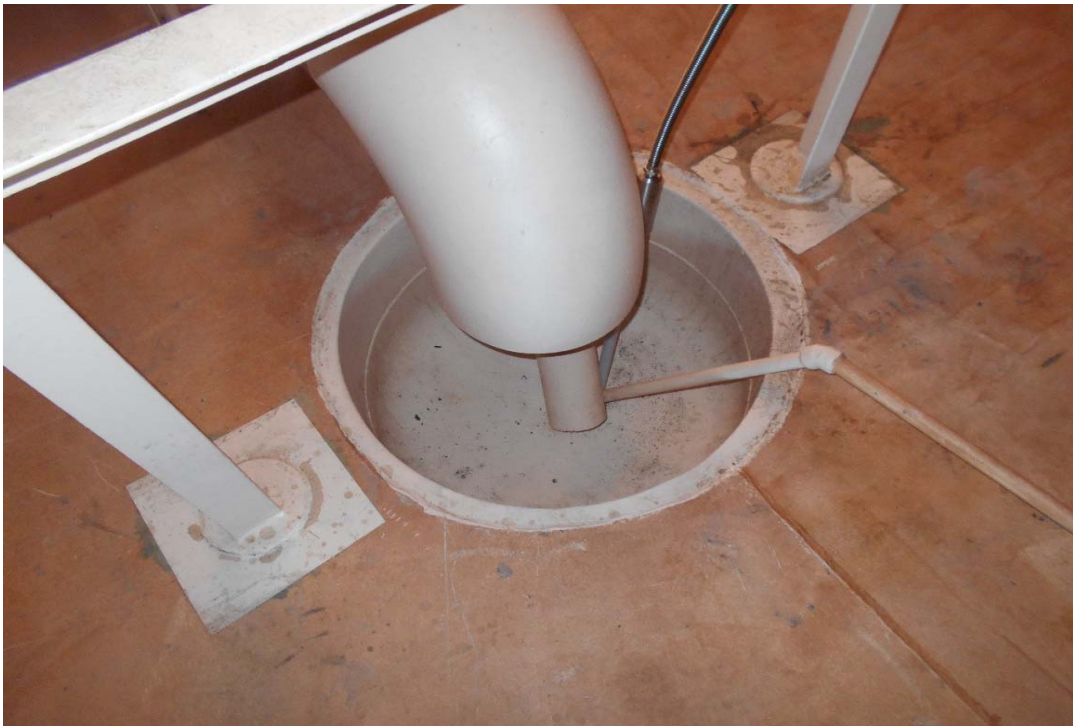
E26: Bottom Sump Area

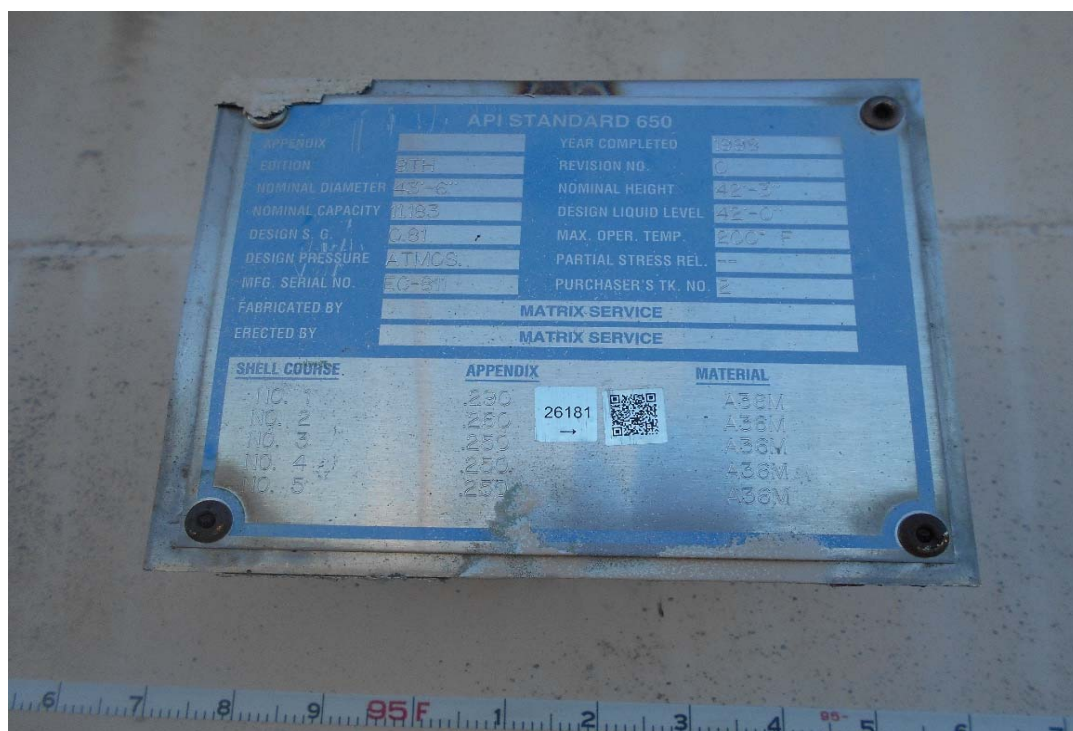
E34: General View of Tank Data Plate

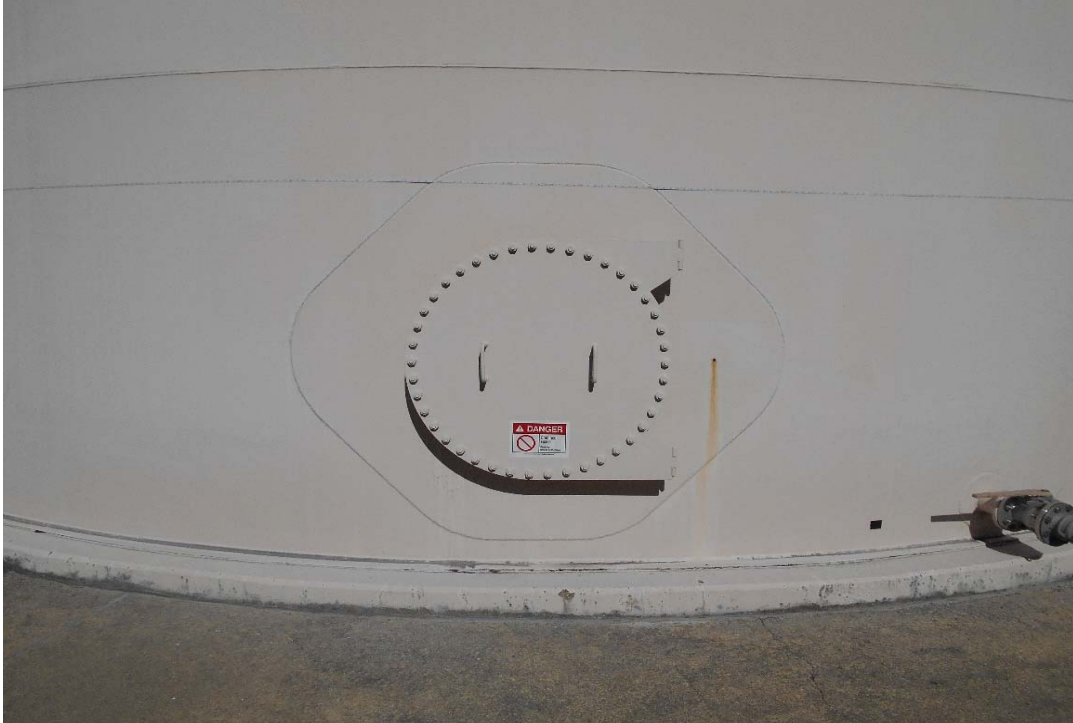
E35: General View of Manway

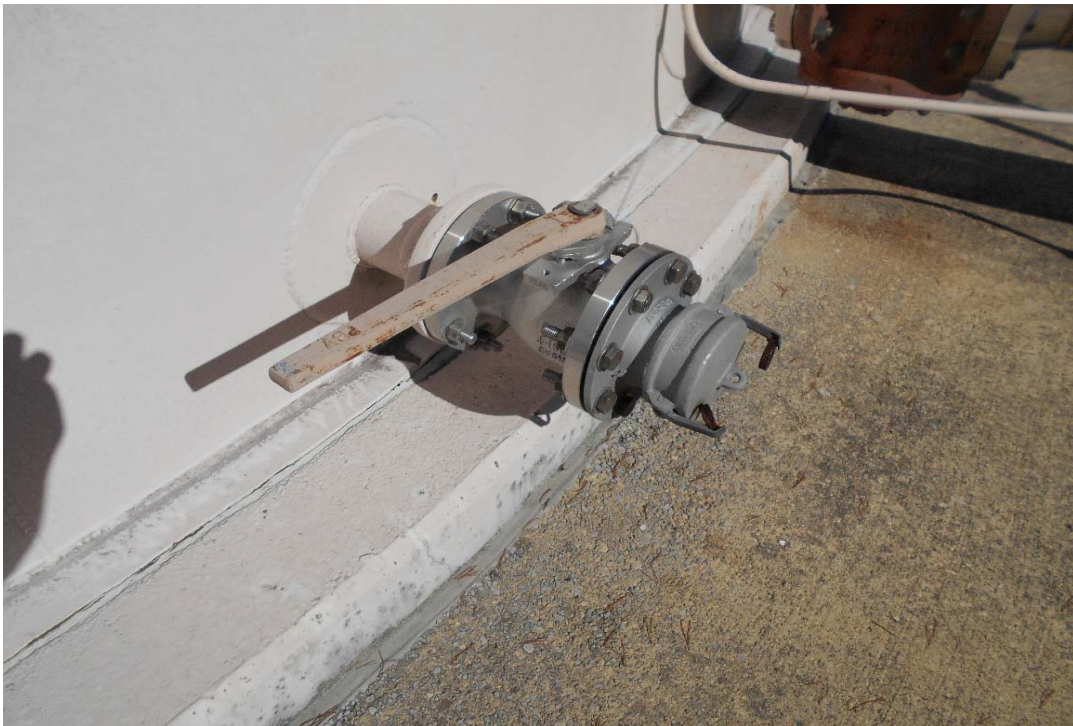
E36: General View of Drain Nozzle

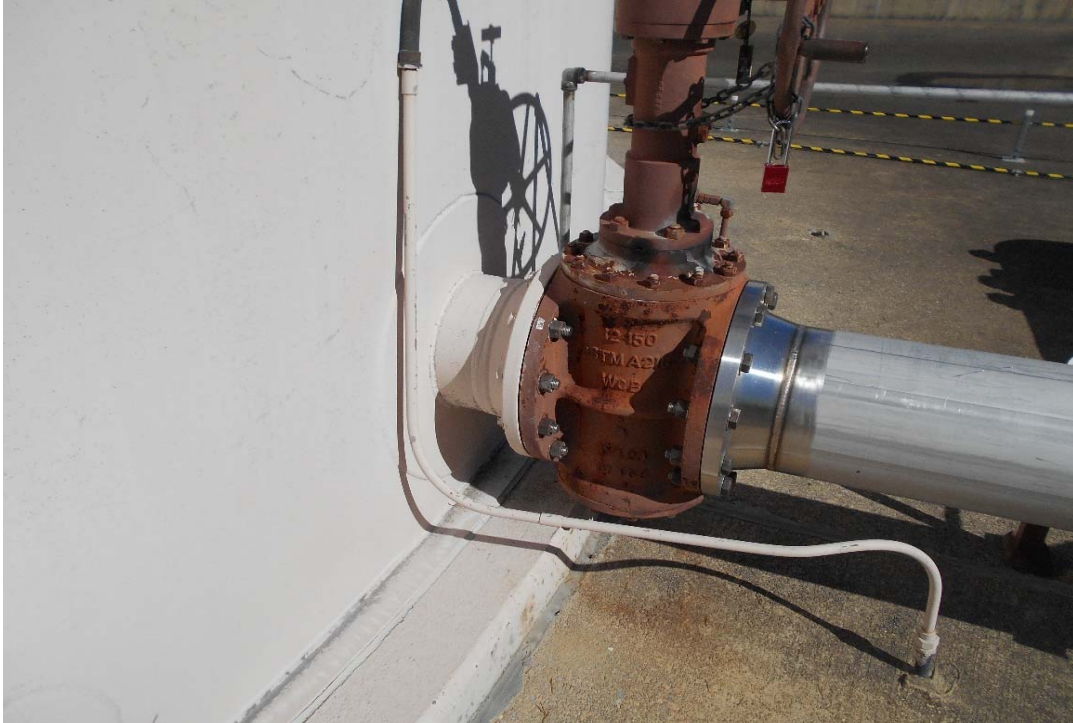
E37: General View of Issue Line Nozzle

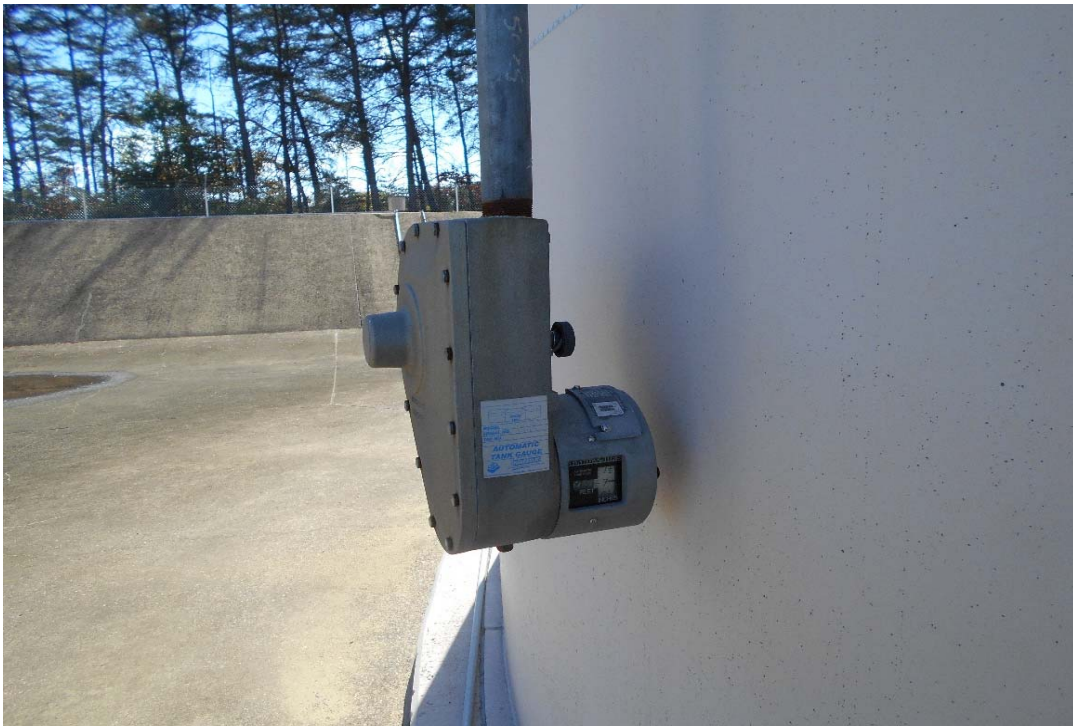
E38: SAHND&JURS Manual Tape Level Gauge

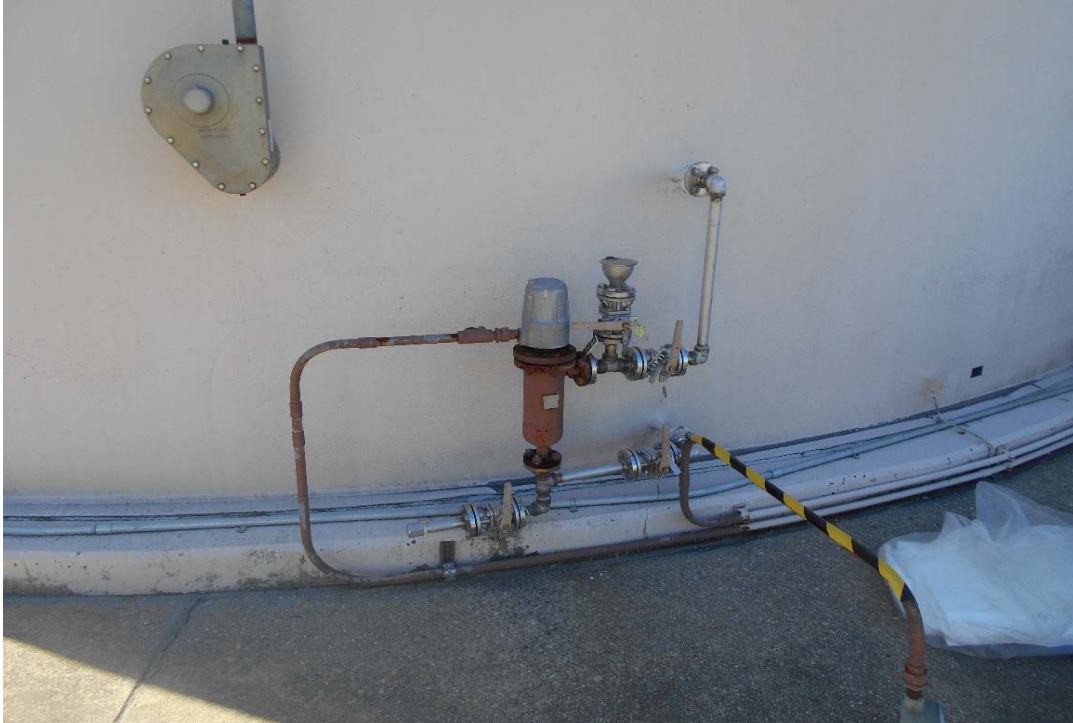
E39: General View of Low Level Alarm Assembly

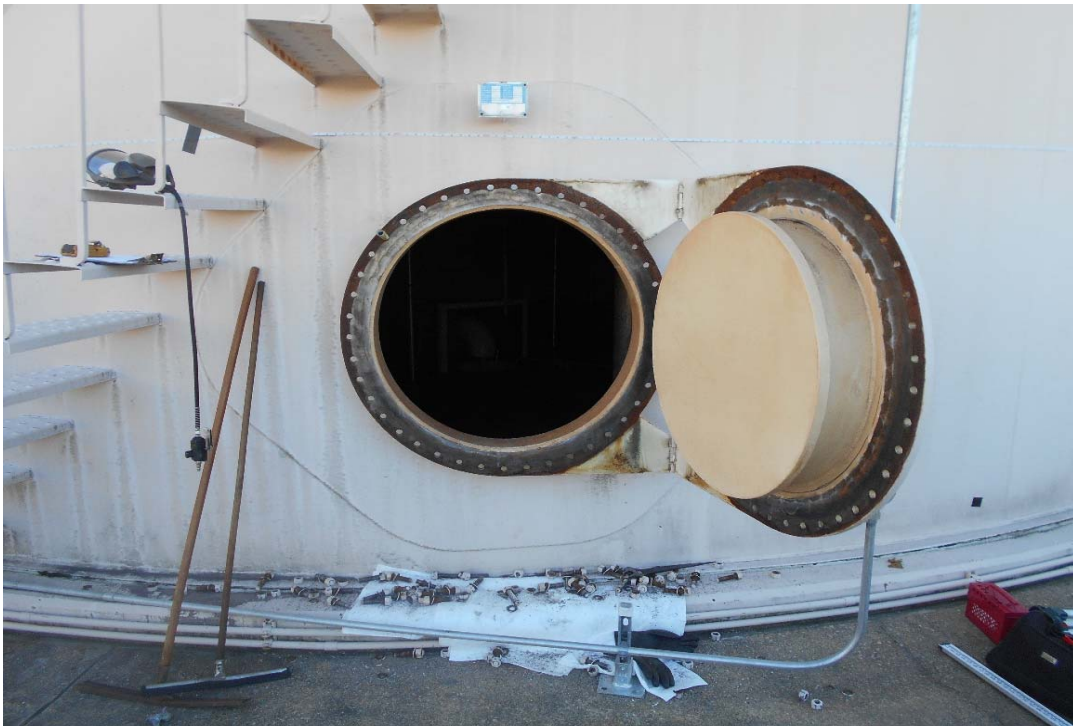
E40: General View of Manway

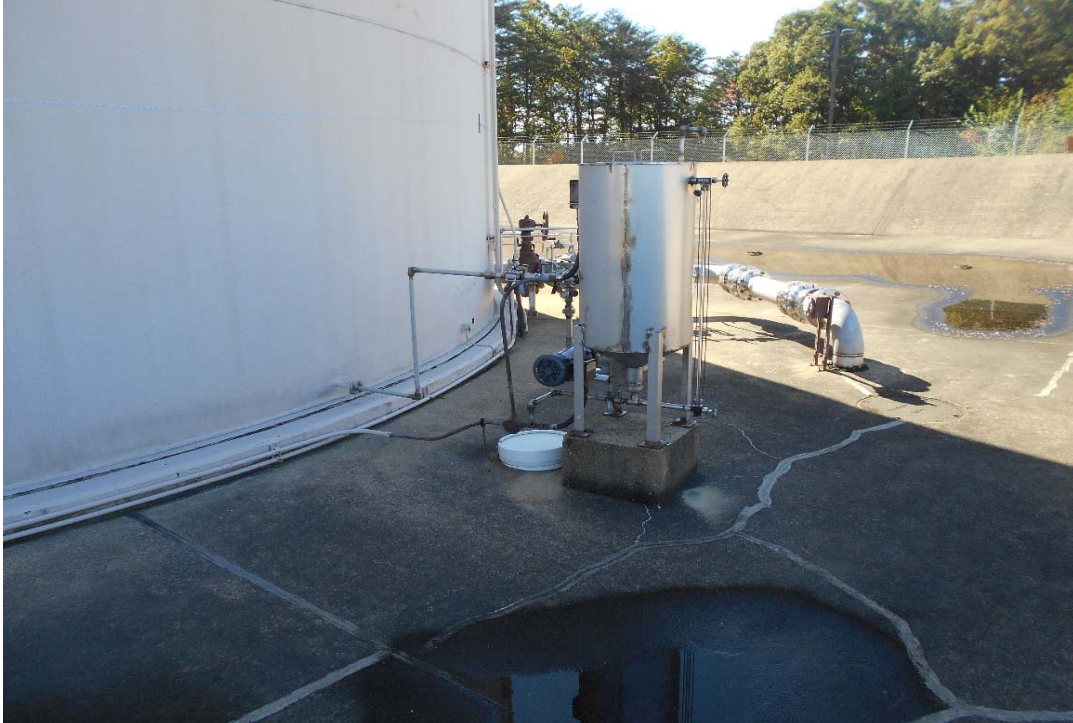
E41: General View of Product Saver Tank

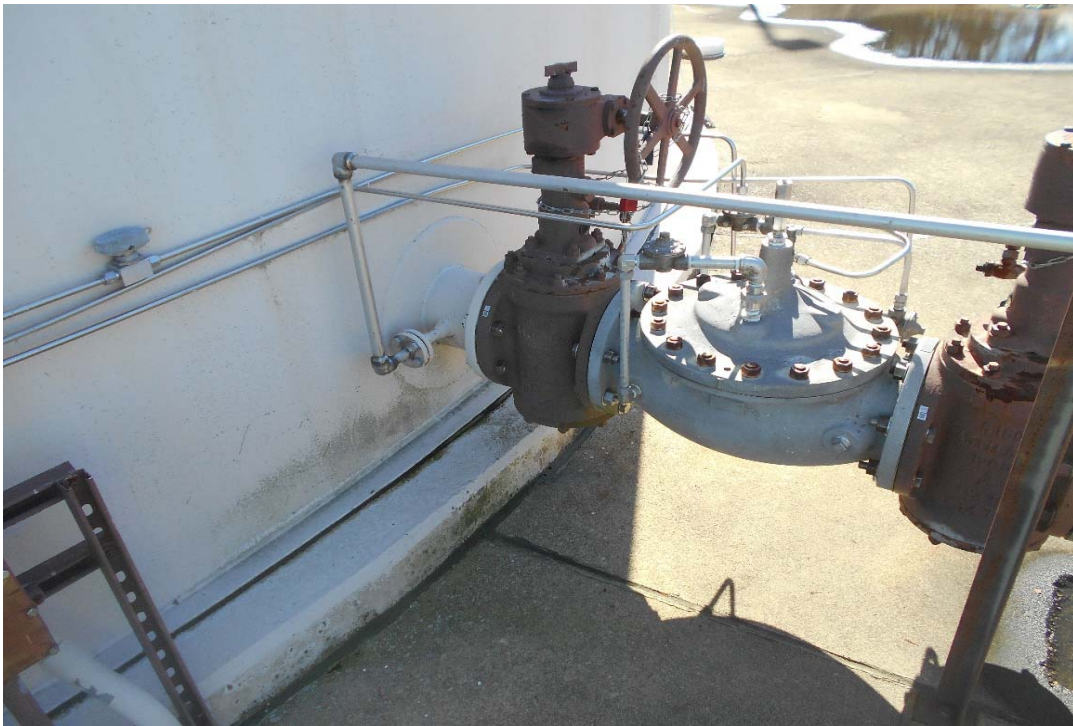
E42: General View of Receipt Line Nozzle
