**US Army Corps of Engineers
Omaha District
API 653 Out-of-Service
Inspection Report**

**Andrews Air Force Base, Morningside, Maryland
Facility 5025
Tank 25**

**US Army Corps of Engineers Center of Expertise for Petroleum, Oils and Lubricants
USACE POL-MCX**

16 January 2018

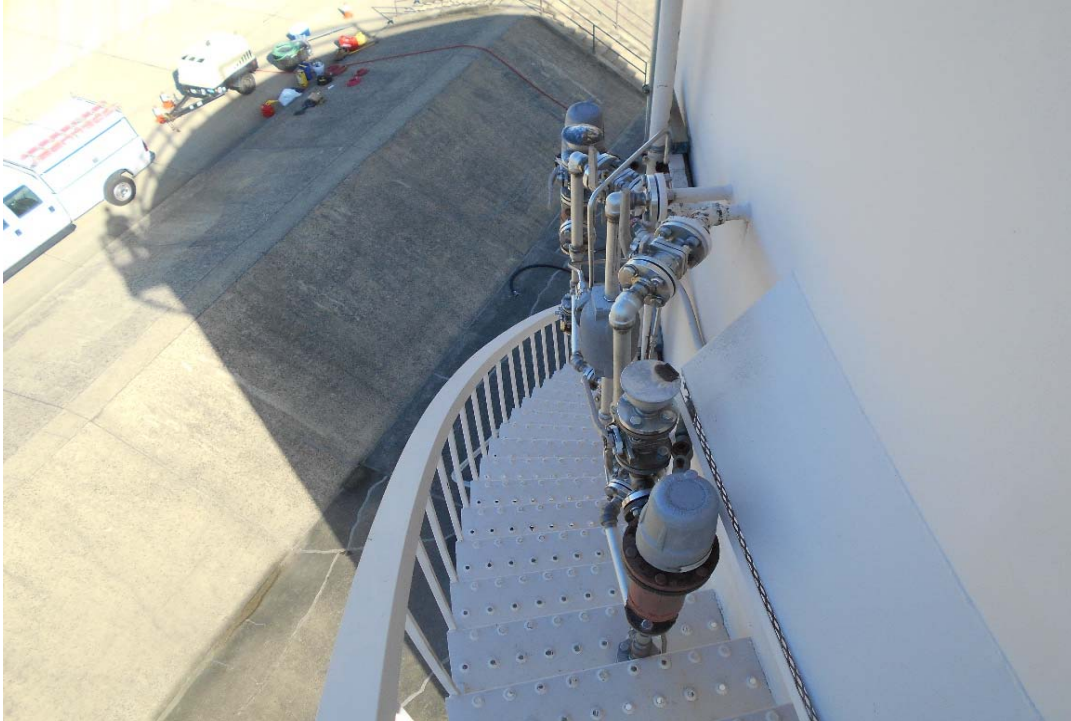
E43: General View of High Level Control Assemblies

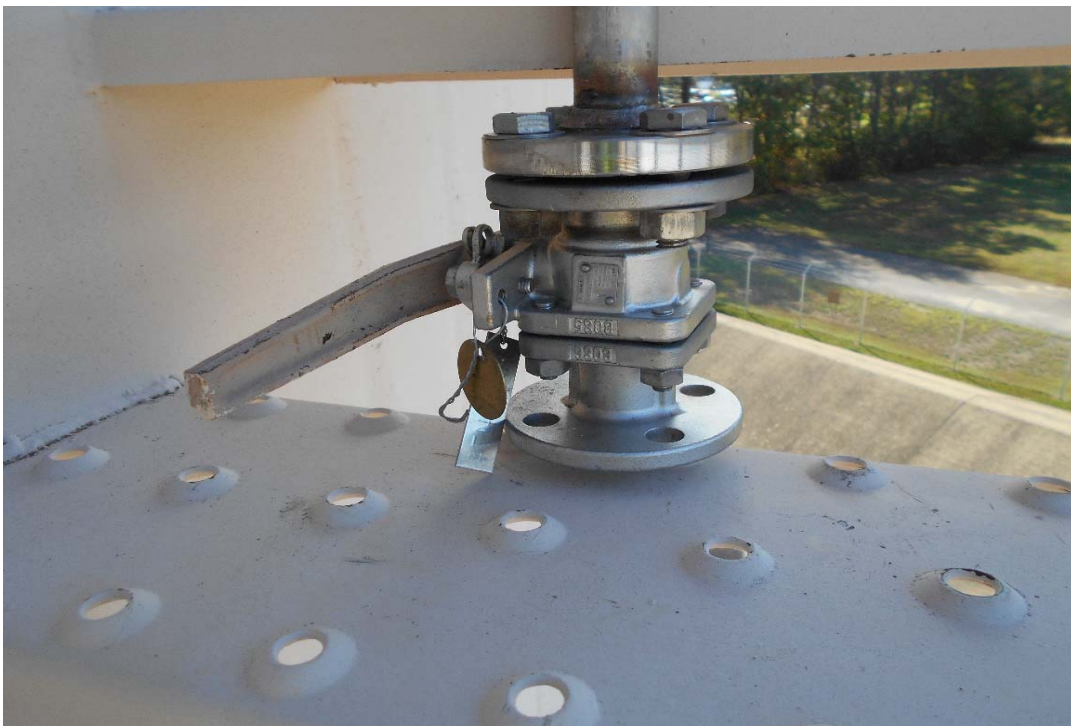
E44: High-High Level Alarm Assembly Drain without Blank on Flange

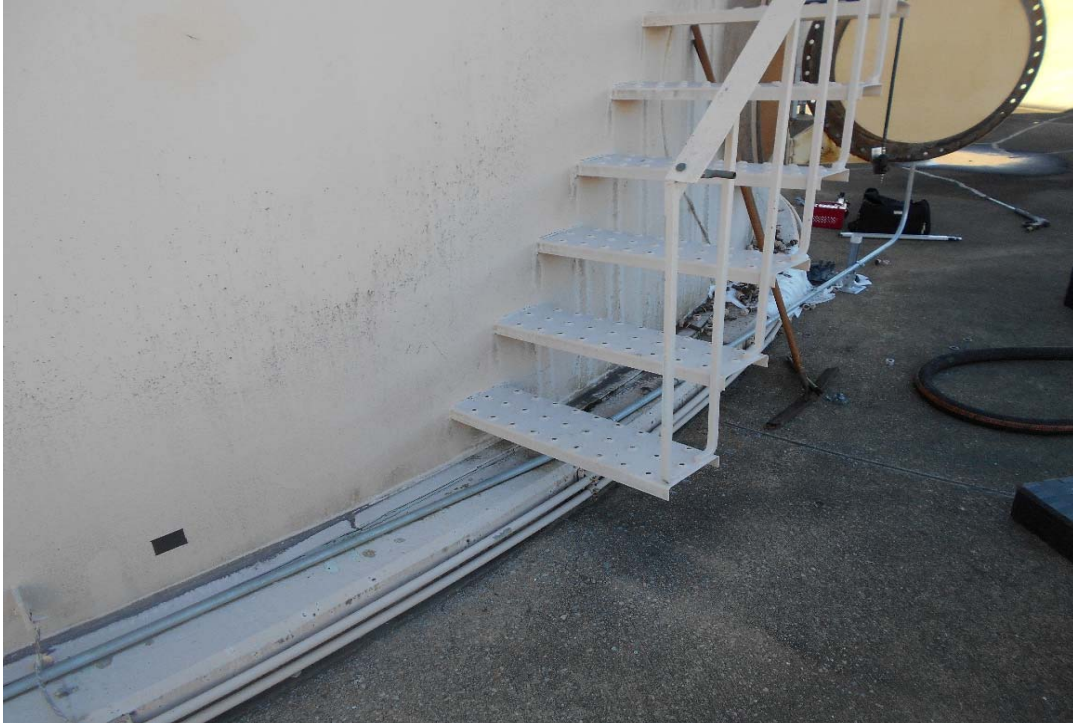
E45: General View of Circumferential Stairway Base

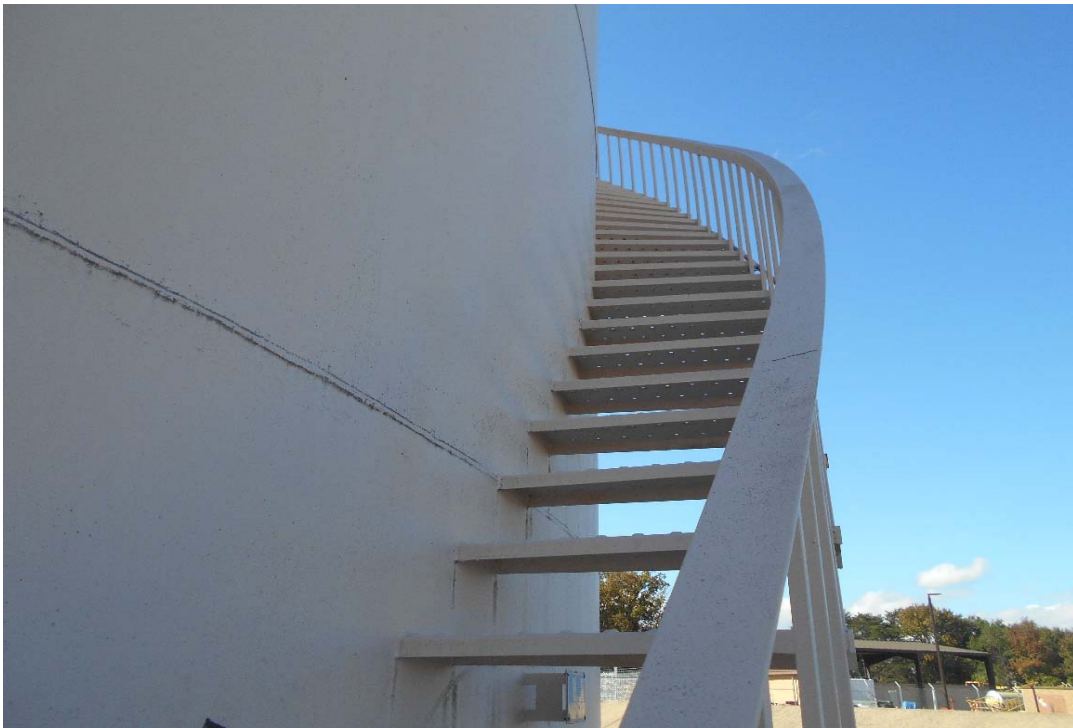
E46: General View of Circumferential Stairway

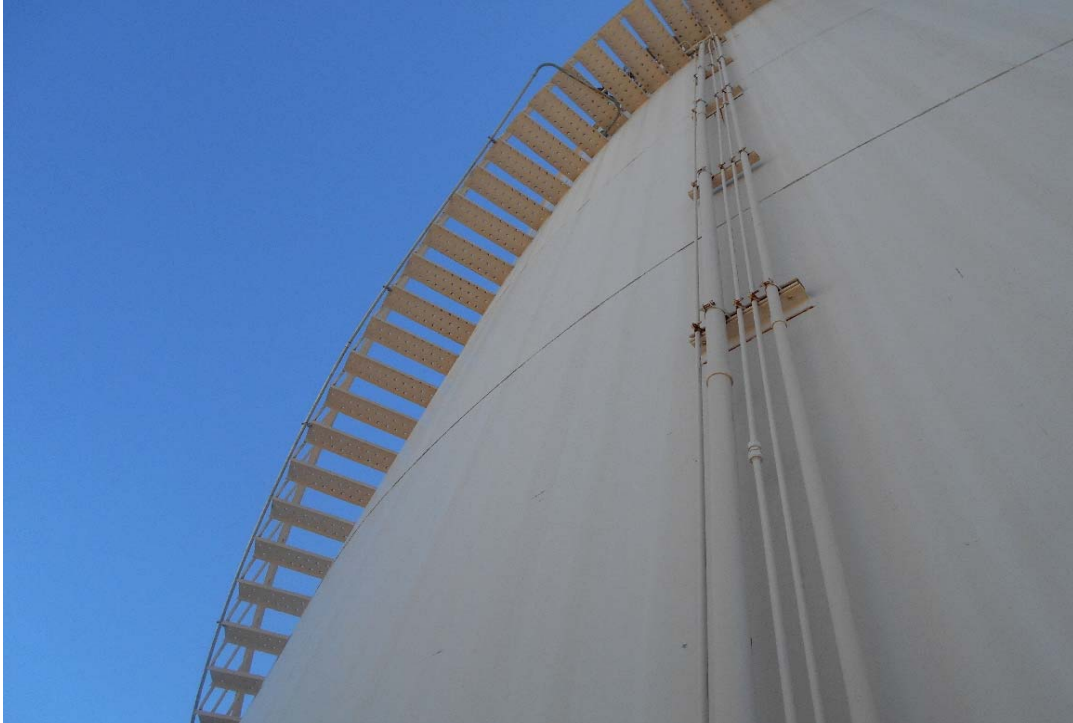
E47: General View of Underside of Circumferential Stairway

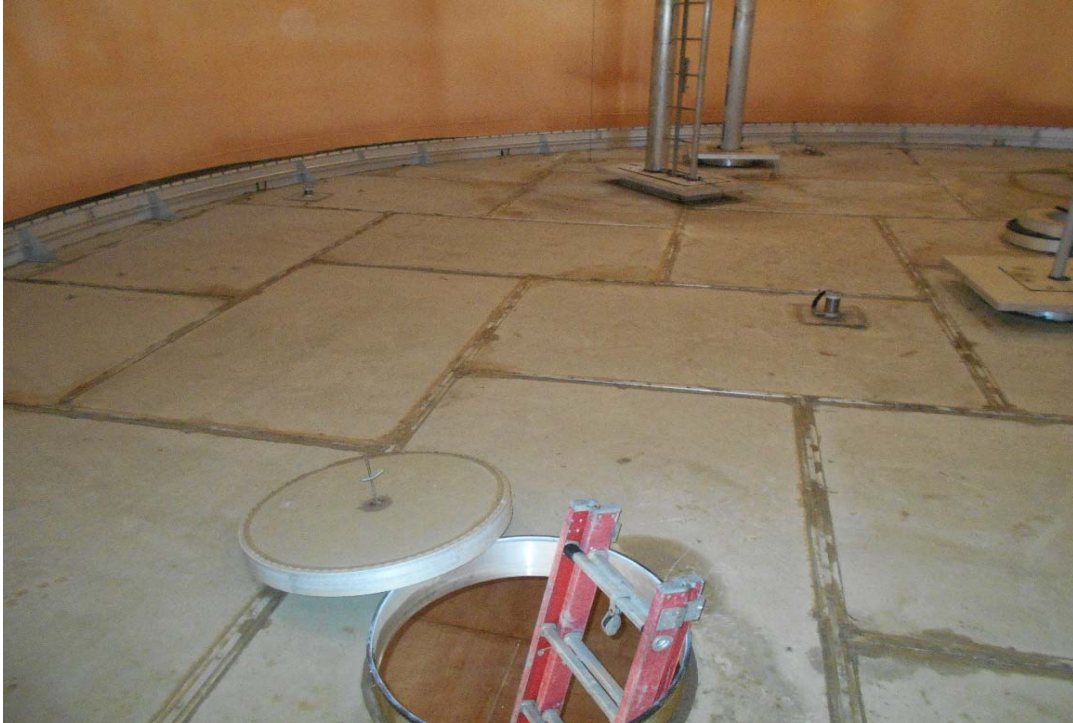
E53: General View of Floating Roof

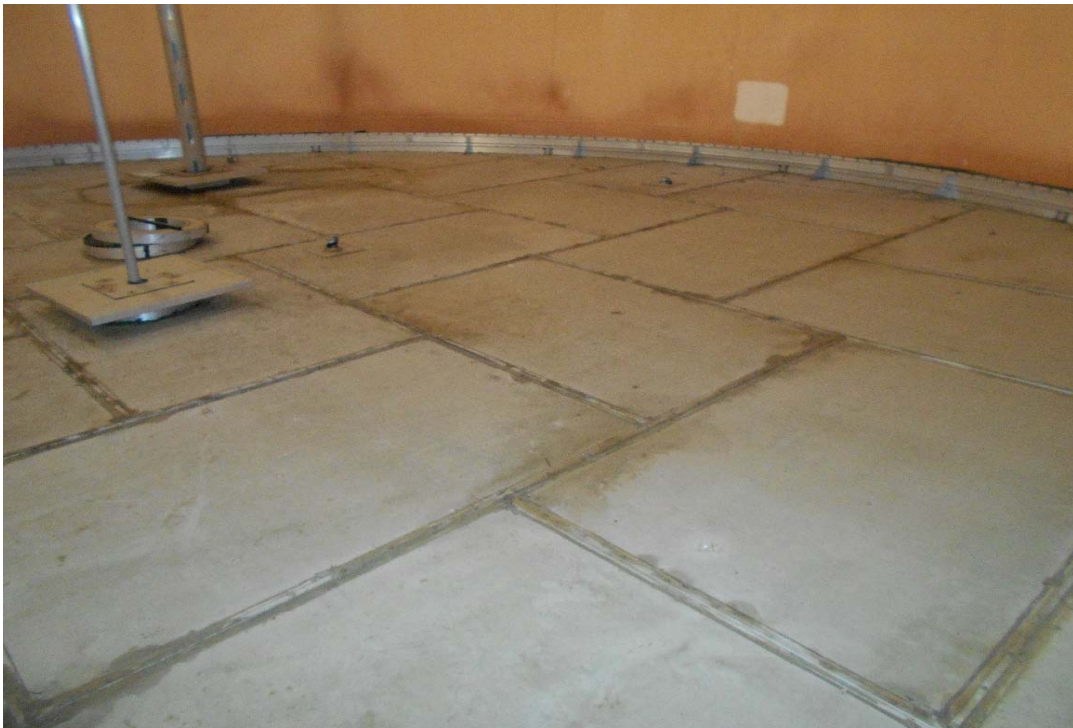
E54: General View of Floating Roof

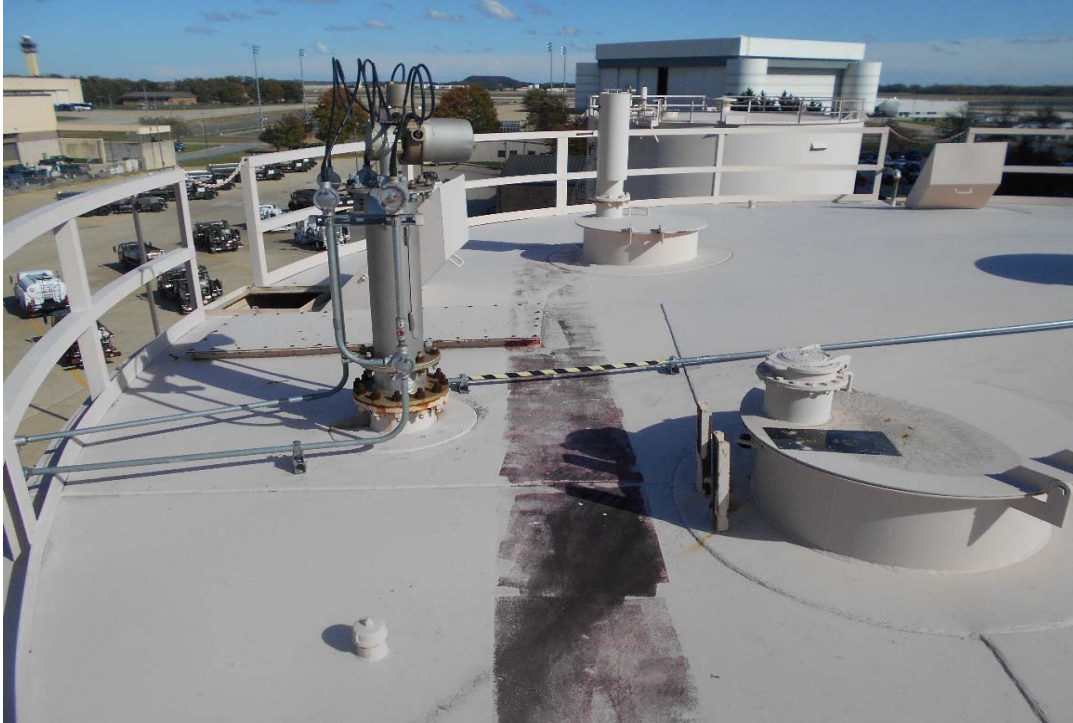
E57: General View of Fixed Roof

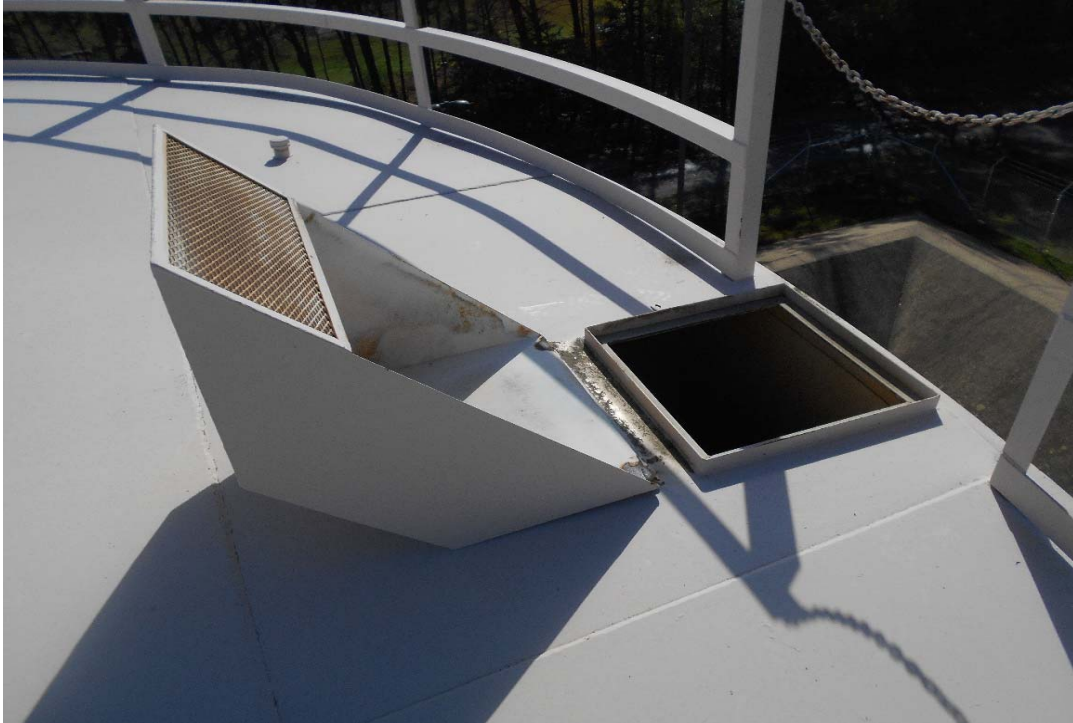
E59: General View of Shell Circulation Vent/Inspection Hatch

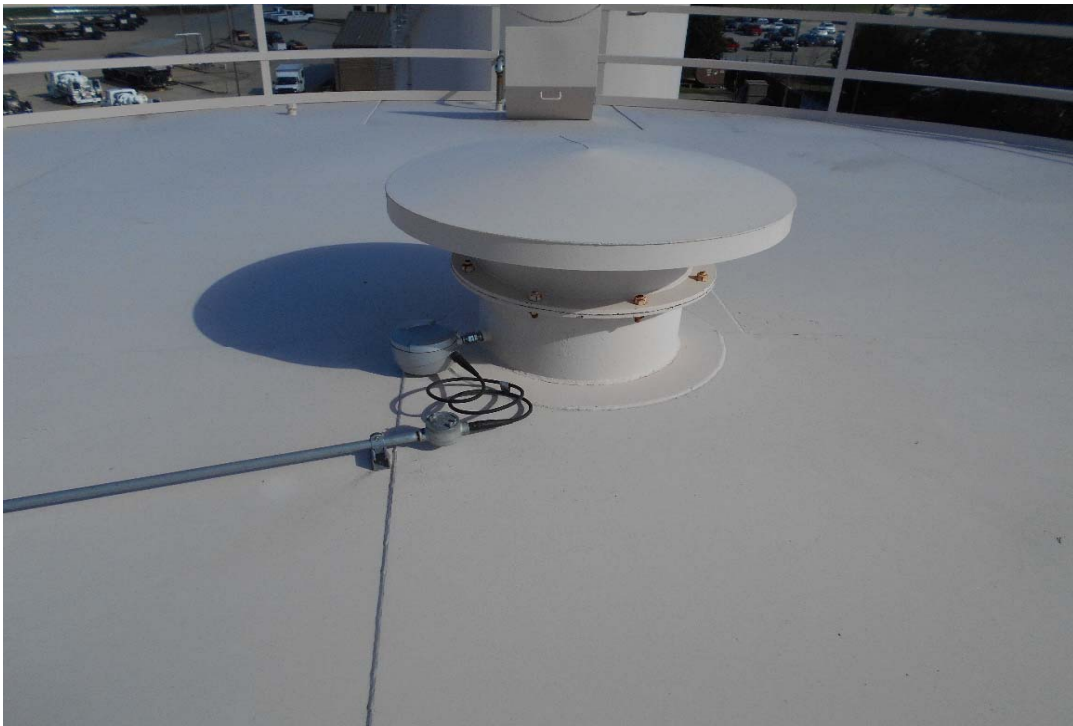
E60: General View of Center Circulation Vent with VITO Water Probe

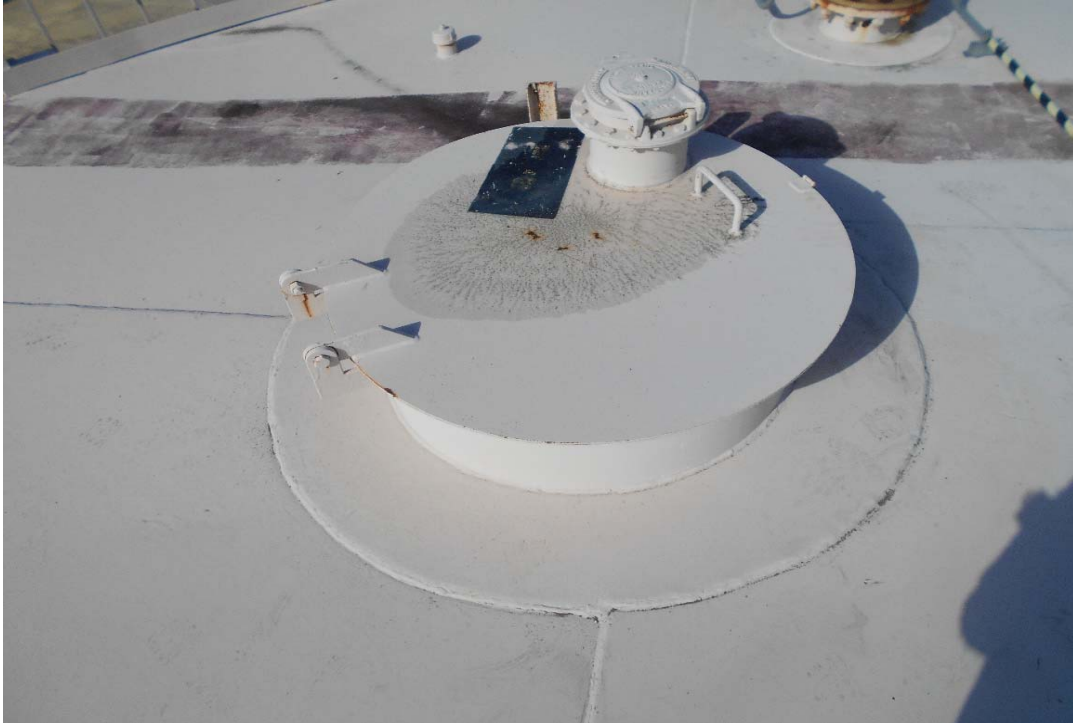
E61: General View of Access Hatch for Internal Ladder

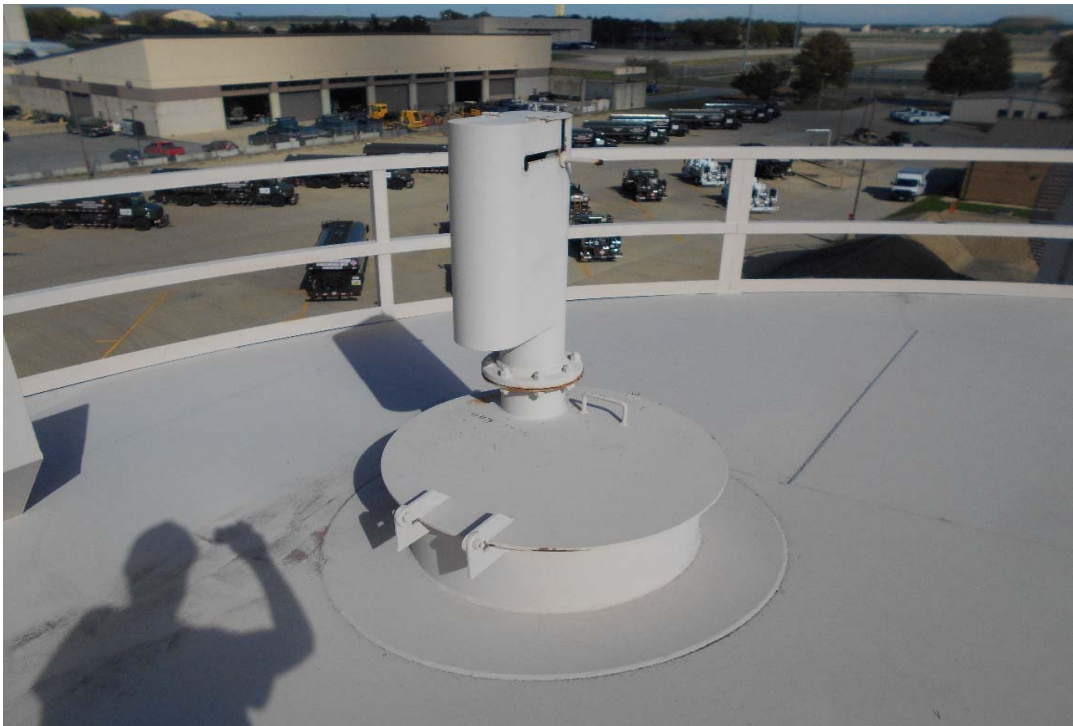
E62: General View of Sample

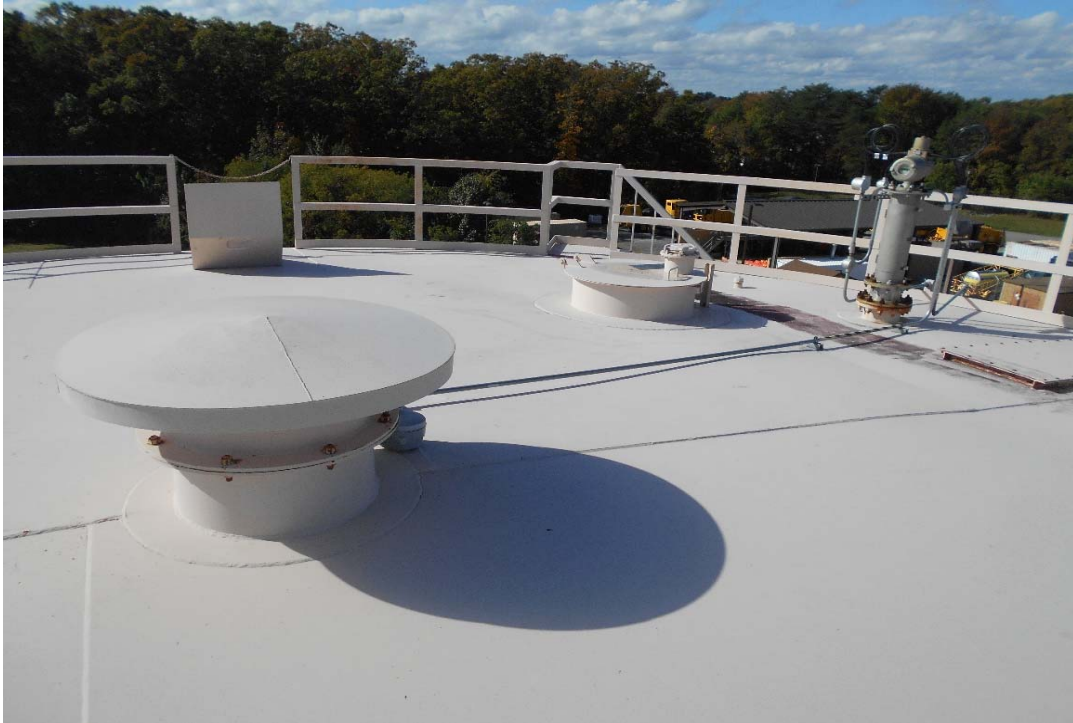
E63: General View of Fixed Roof

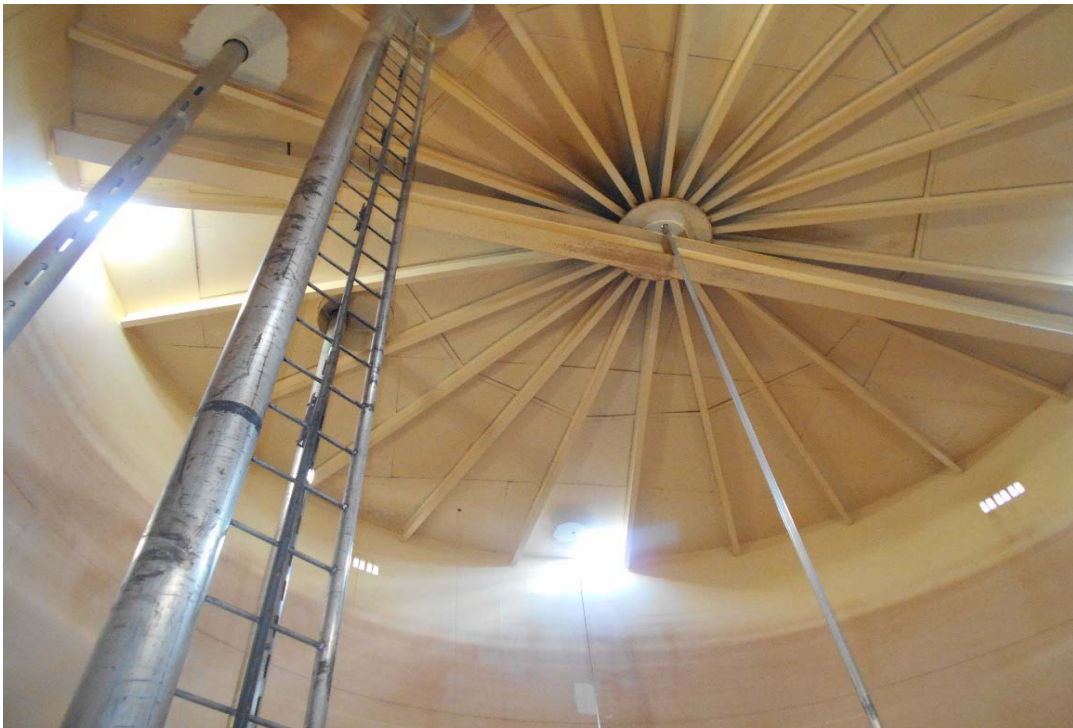
E64: General View of Underside of Fixed Roof

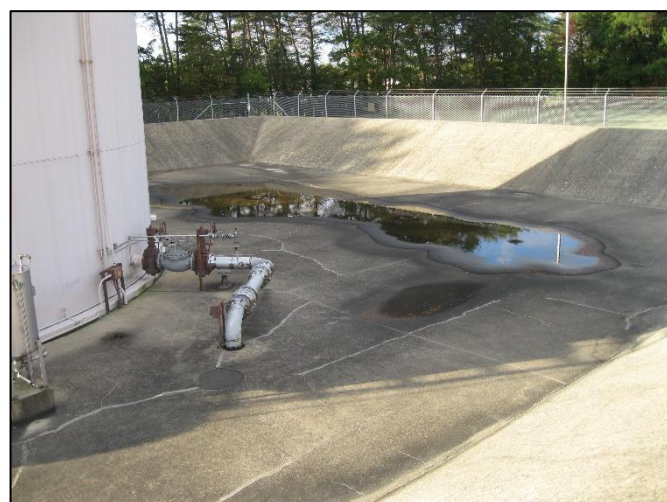
B.5: Receipt Piping and Undrainable Pool

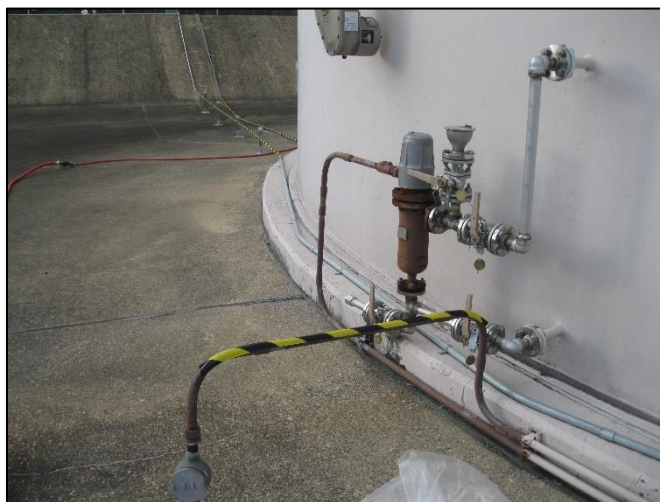
B.8: Sub Low Level Alarm

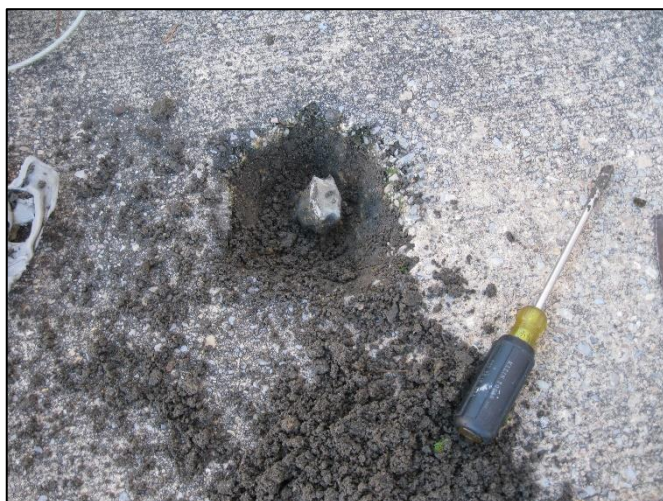
B.9: Ground Cable to Rod Connection in Cavity

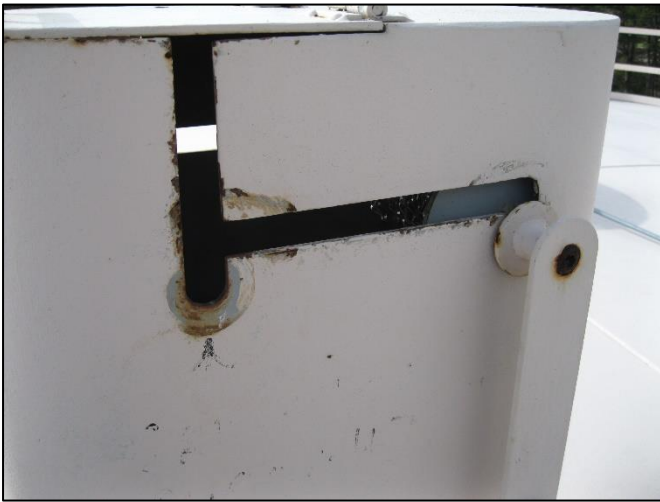
B.13: Floating Plug Retriever

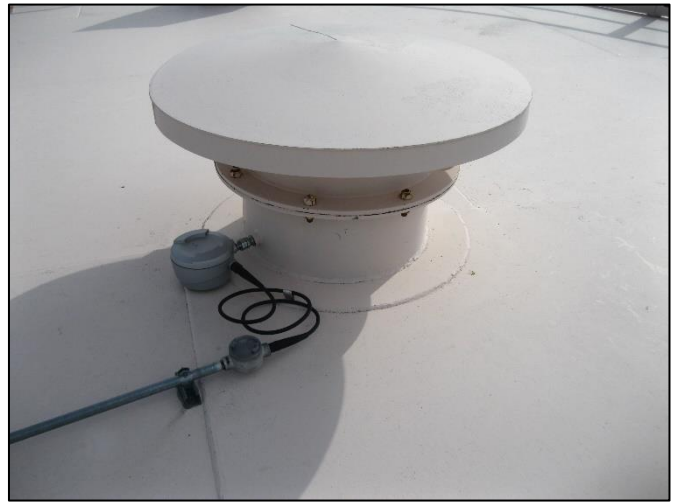
B.14: Roof Center Vent and Vito Probe Box

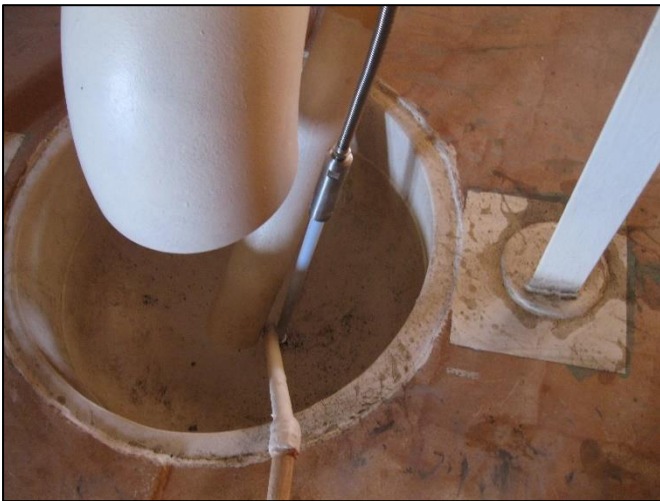
B.15: Bottom Sump, Piping, and Vito Probe

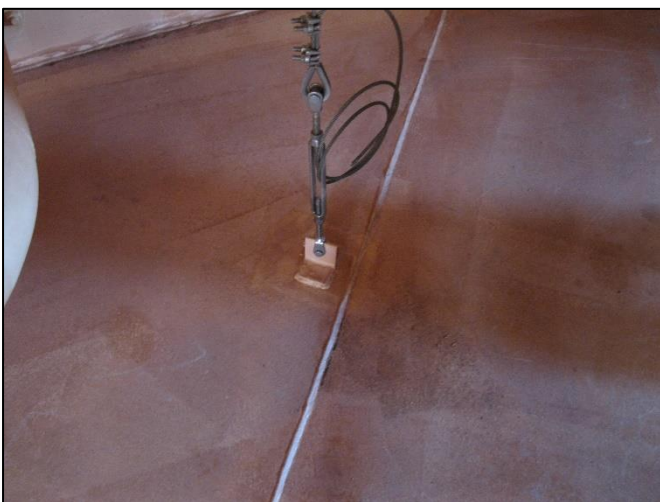
B.17: Anti-rotation Cable Connection to Tank Bottom

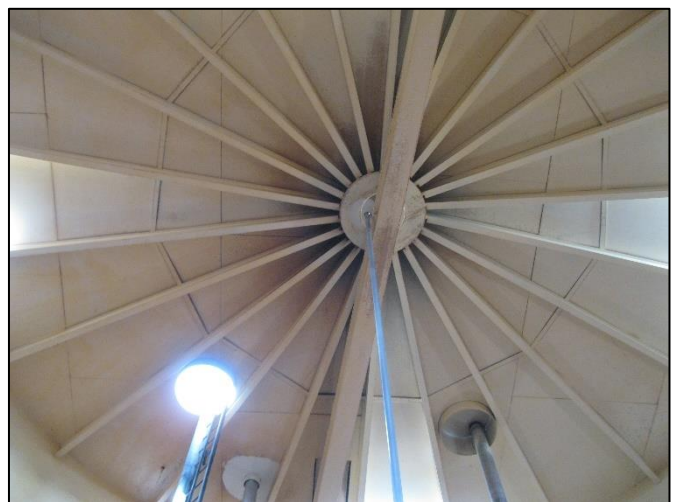
B.18: Underside of Tank Roof
