**US Army Corps of Engineers  
Omaha District  
API 653 Out-of-Service  
Inspection Report**

**Andrews AFB  
Facility 3474  
Tank 2**

**US Army Corps of Engineers Center of Expertise for Petroleum, Oils and Lubricants  
(USACE POL-MCX)  
2/5/2018**

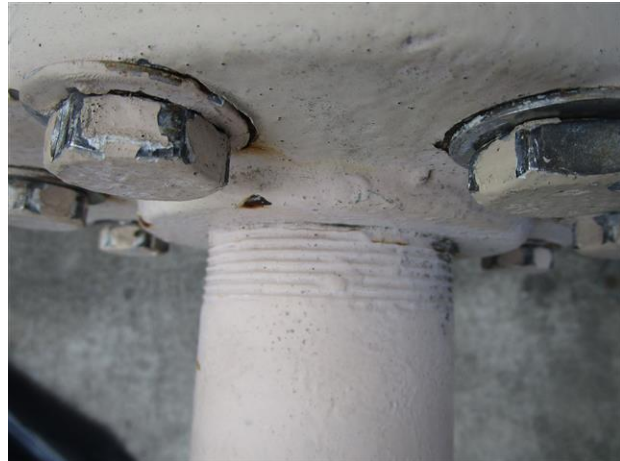
C10: Threaded Connection on Low Suction

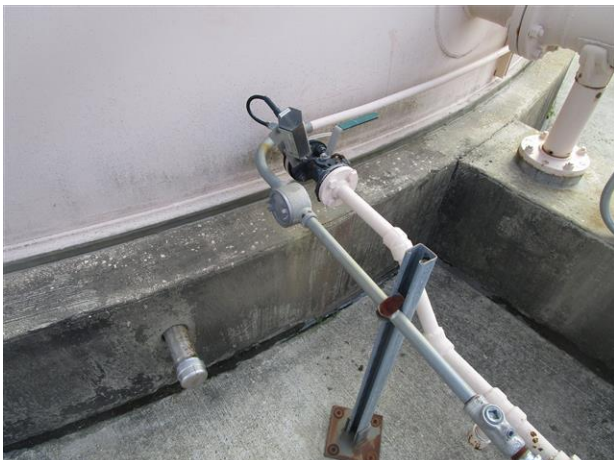
C11: Water Draw-Off with Ball Valve

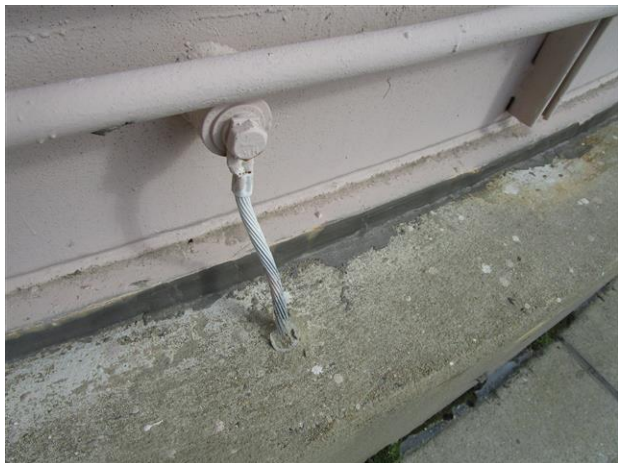
The tank is equipped with four (4) grounding lugs and cables that are in good overall condition with no signs of damage or detachment.

C13: Grounding Cable

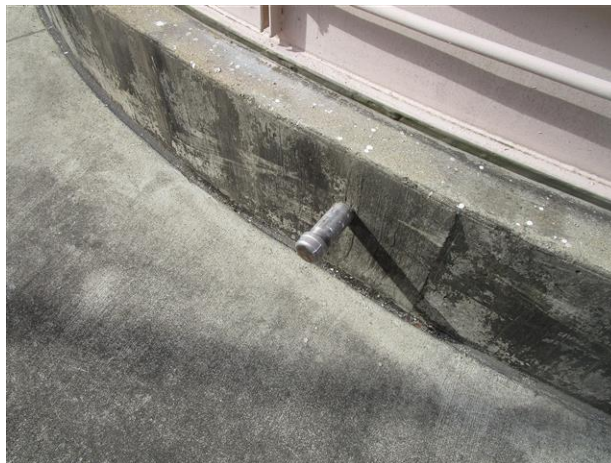
UTT readings were taken on each nozzle with a welded connection in each of four (4) quadrants (0°, 90°, 180°, and 270°). One (1) UTT reading was taken on each reinforcement pad. UTT readings indicated no significant metal loss. Tell-tale holes provided for reinforcement pads are open to the atmosphere. The main suction and receipt piping is not provided standard military labeling. Crossover piping provided for the receipt and main suction lines are provided with sight flow indicators. Sight flows are no longer used in this application as they present potential leak paths. Coating provided for the main suction and receipt crossover piping, HLA, HHLA, HLCV shutoff, and the LLA displays flaking, corrosion staining, and deterioration. The HLA, HHLA, HLCV, and LLA are provided with threaded connections. The low suction line is provided with a 4" threaded connection proceeding the cam lock connection. UFC limits the use of threaded connections as they may not provide an adequate seal. The water draw-off line is provided with a ball valve at the tank skin location. Double block and bleed (DB&B) valves should always be used at the skin location as a ball valve may not provide adequate isolation during maintenance and inspection activities.

C14: Tell-Tale Pipe

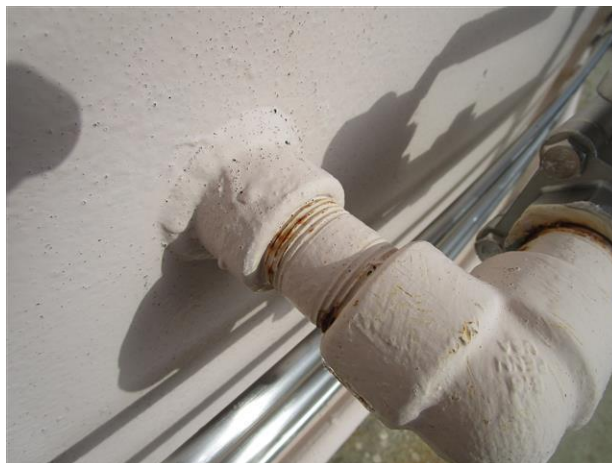
C16: LLA / LLLA w/ Threaded Connections

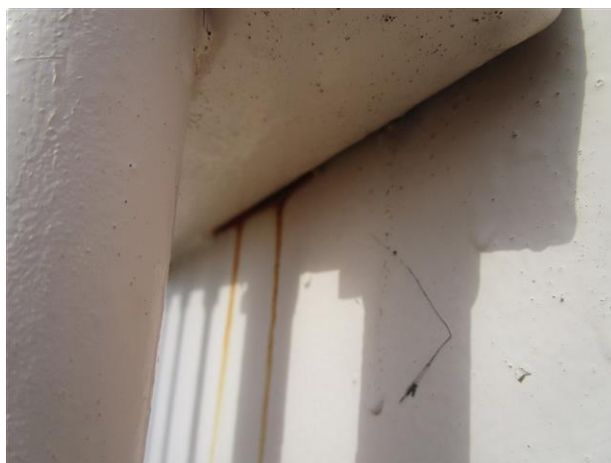
C18: Conduit Support w/ Crevice Corrosion

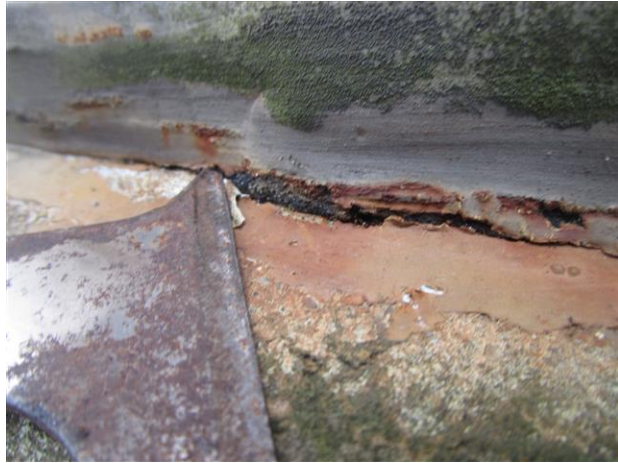
Tank 2 rests on a concrete ring wall foundation. The tank chime-to-ring wall interface is provided with sealant in good overall condition displaying only minor signs cracking and staining. Sealant provided at the tank ring wall-to-containment interface is in poor condition and exhibits signs of voids, cracking, disbondment, and vegetation growth. A settlement evaluation was performed during the inspection. No signs of settlement were noted. See Appendix A for settlements results.

C20: Tank Chime Sealant Failure

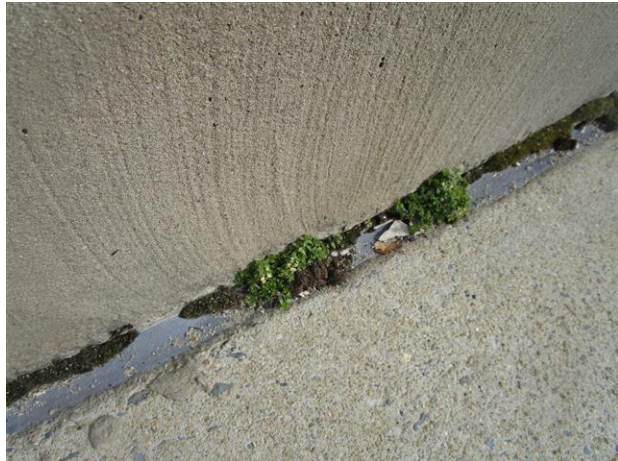
C22: Vegetation in Ring Wall Control Joint

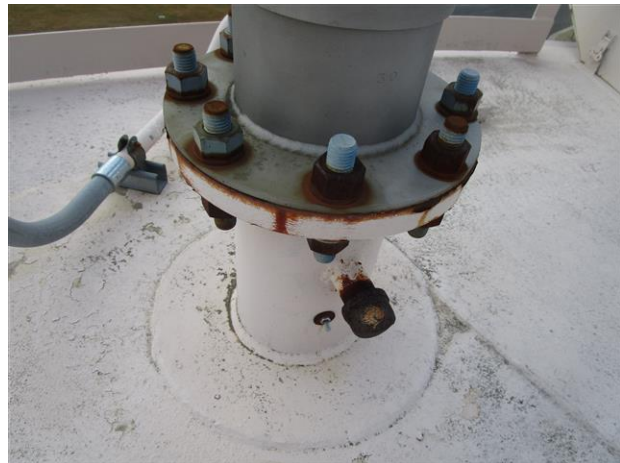
C28: Corroded Fasteners on Enraf ATG

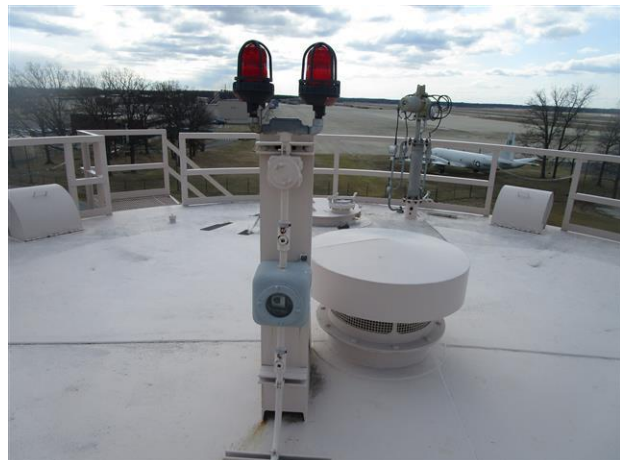
C30: Visible Alarms and Center Vent

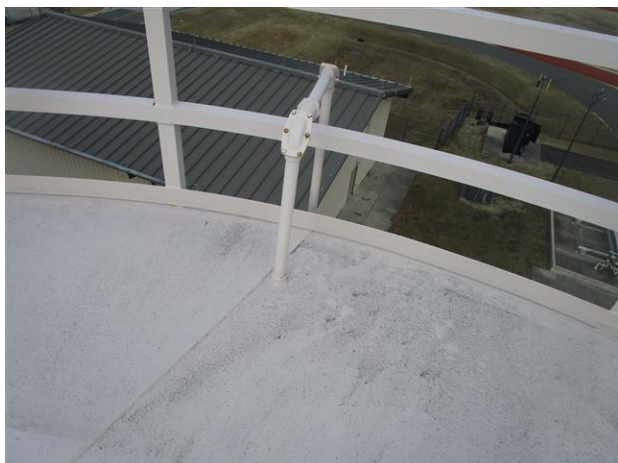
C31: Tape Level Gauge Penetration

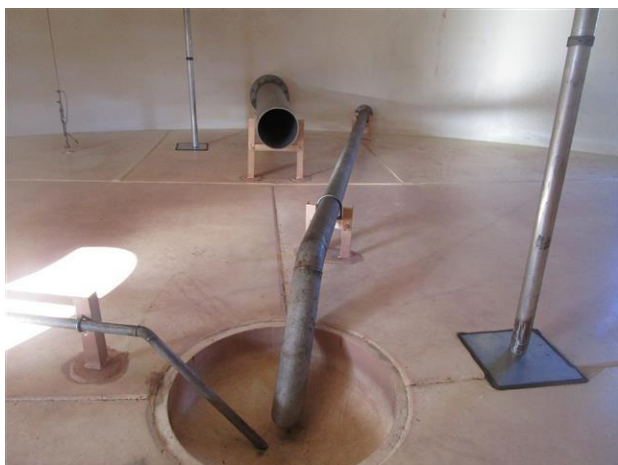
The tank bottom is of cone-down construction with lap-welded carbon steel plates. The tank bottom was examined using magnetic flux leakage (MFL), ultrasonic thickness testing (UTT), and visual testing (VT) methods. The MFL bottom scan revealed no indications of top-side or soil-side indications. Five (5) UTT measurements were taken on each bottom plate. One (1) UTT reading was taken every 2 feet around the tank perimeter within the tank bottom critical zone.

C33: Bottom Overview

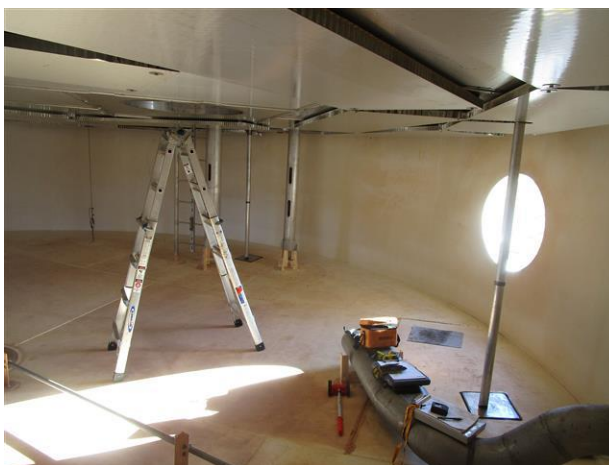
C34: Bottom Overview

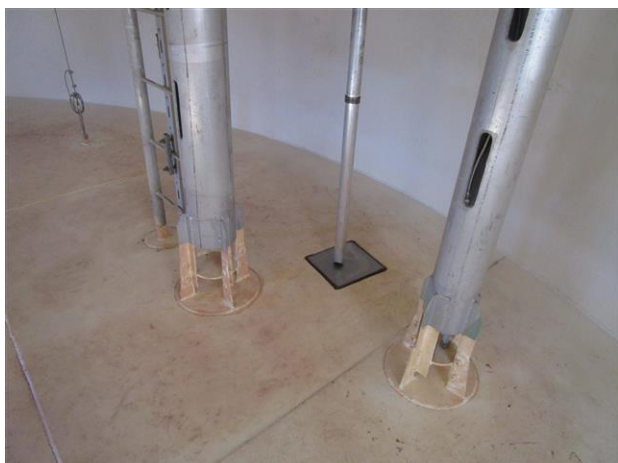
C35: Stilling Wells and Ladder Overview

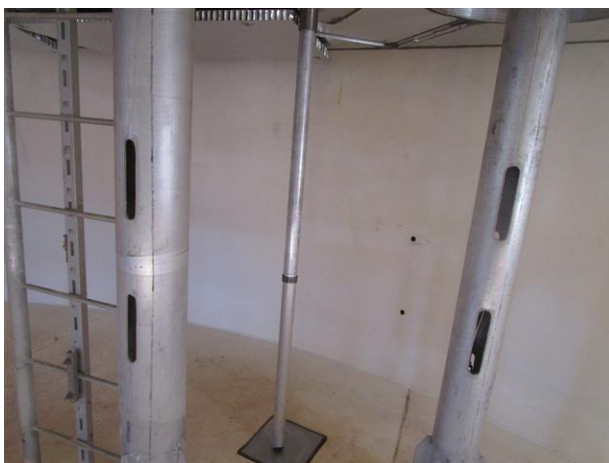
gauging is performed through the gauging hatch located on the fixed roof manway. Neither the Enraf ATG nor manual gauging hatch stilling wells are fully slotted. Stilling wells provided for the manual gauging hatch and Enraf ATG are attached directly to well guides at the tank bottom. If the tank begins to settle, this configuration may cause increased stress at the tank bottom. The tank is provided with a Shand and Jurs float gauge for gauging the tank volume from the ground level.

C36: Partially Slotted Stilling Wells

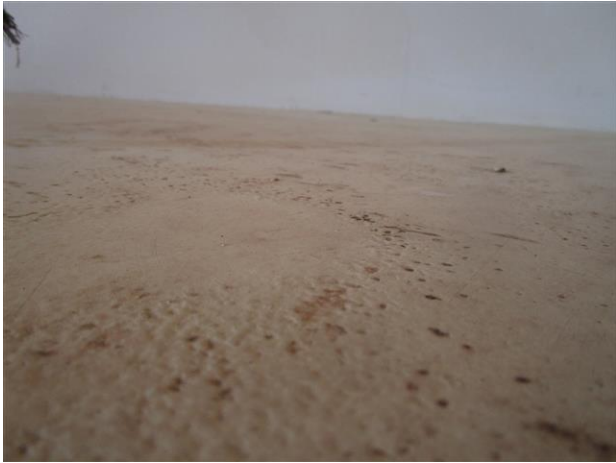
C37: Wide Spread Pitting along the Tank Bottom

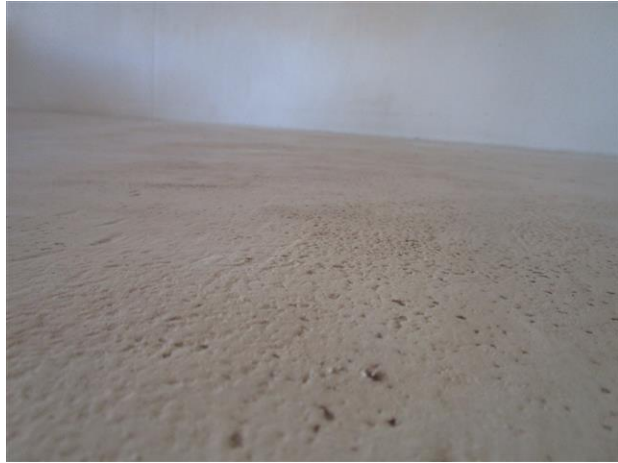
C38: Wide Spread Pitting along the Tank Bottom

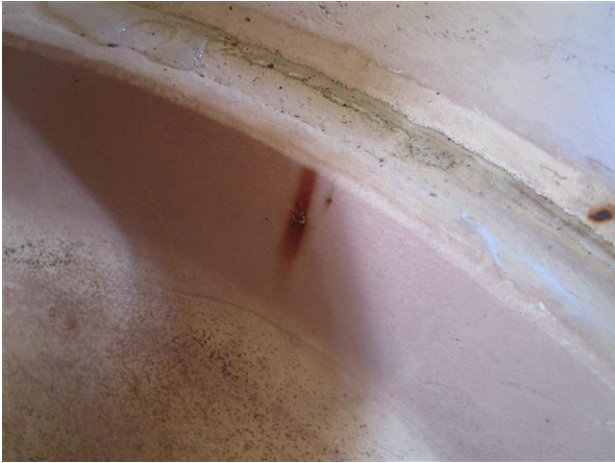
All exterior and internal surfaces of the tank are coated. Coating was in good overall condition with only minor signs of failure located primarily on nozzles, appurtenances, and in the center sump with the exception of the shell-to-bottom weld which displayed disbondment.

C43: Coating Failure at Center Sump
