**US Army Corps of Engineers  
Omaha District  
API 653 Out-of-Service  
Inspection Report**

**Andrews Air Force Base, Morningside, Maryland  
Facility 3473  
Tank 73**

**US Army Corps of Engineers Center of Expertise for Petroleum, Oils and Lubricants  
USACE POL-MCX**

**22 February 2017**

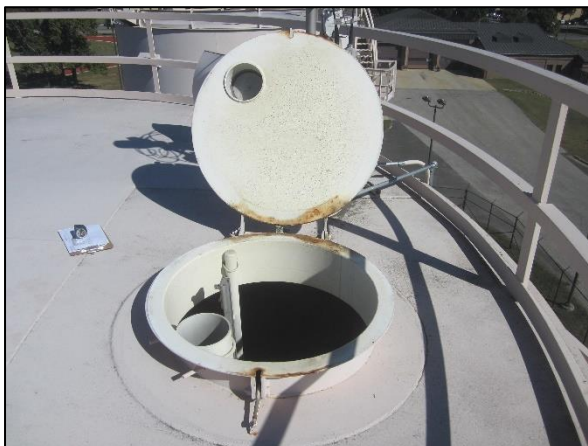
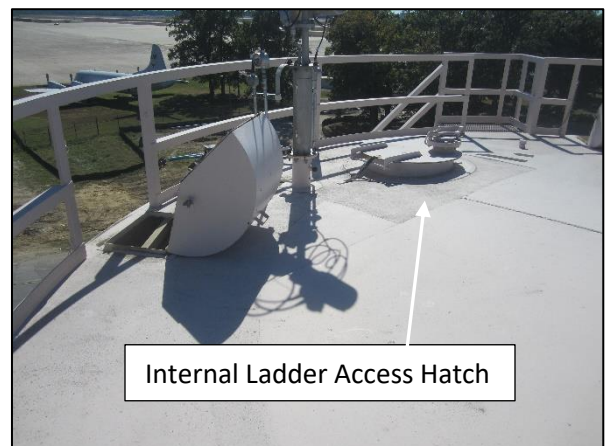
**c. Provide OSHA Compliant Ladder Access Hatch**

**OBSERVATION:** The internal ladder access round roof manhole provides less than 28 inches of clearance on the climbing side of the ladder, does not have a deflector plate, is not gasketed or bolted, does not have a rain lip, and allows rain water to enter the tank.

**REFERENCE:** OSHA regulation 29 CFR 1910.27 (c) requires 30 inches of clearance on the climbing side of a ladder, or a deflector plate on the underside of the opening, set at an angle of 60 degrees from horizontal. API 650 paragraph 5.8.4 requires round roof manholes to be gasketed and bolted. Guidance for new construction provided in DoD Standard Design AW 78-24-27 includes a rectangular ladder access hatch with hinges and a rain lip as allowed by API 650 Paragraph 5.8.6.

**RECOMMENDATION:** Provide an OSHA and API compliant internal ladder access hatch.

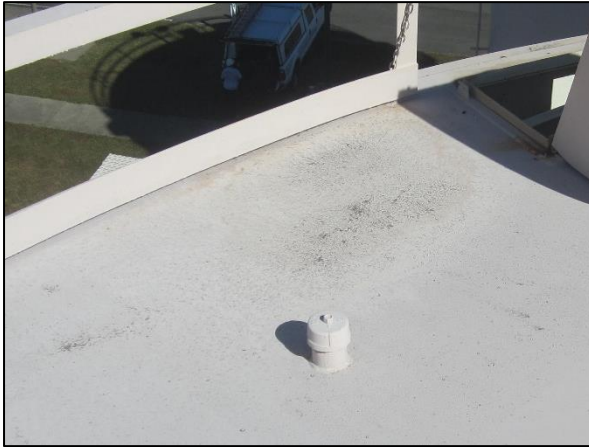
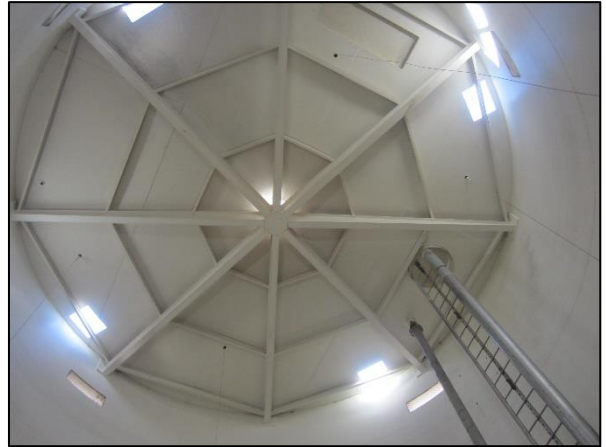
**REFERENCE:** As early as 1996, API 650 required rafter spacing at the perimeter of the tank roof to be no greater than 75 inches apart. Earlier API requirements may have been more stringent. Later editions of API 650, paragraph 5.10.4.4 increased the maximum allowable spacing to 84 inches.

**RECOMMENDATION:** Modify the roof support structure to eliminate the water ponding and bring the roof into compliance with API 650.

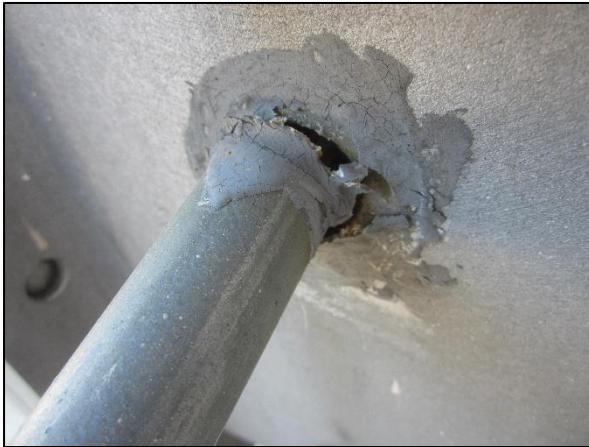
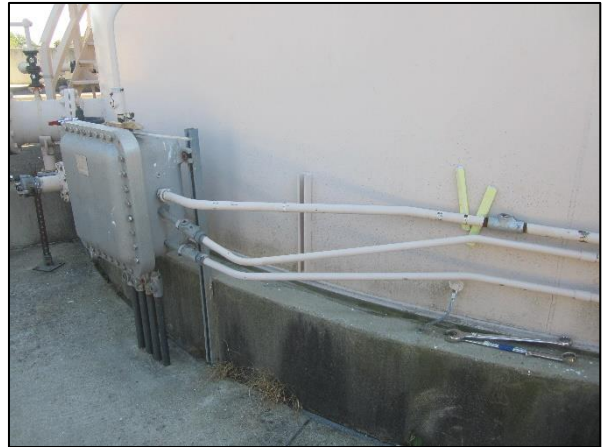
**g. Provide Conduit and Connector**

**OBSERVATION:** A conduit, with wiring connections inside an electrical junction box, is not properly connected to the junction box, but is only butted up against the box and caulked.

**REFERENCE:** NFPA 70 paragraph 500.5(B)(2)(1) and guidance for new construction provided in UFC 3-460-01 Paragraph 2-12.1.1 considers all outdoor locations within 5 feet of fuel storage tanks to be Class 1 Division 2. NFPA 70 paragraph 500.7 requires electrical equipment that is not intrinsically Safe and used in Class I Division 2 locations to be explosion proof.

**RECOMMENDATION:** Provide an explosion proof conduit connection to the electrical junction box.

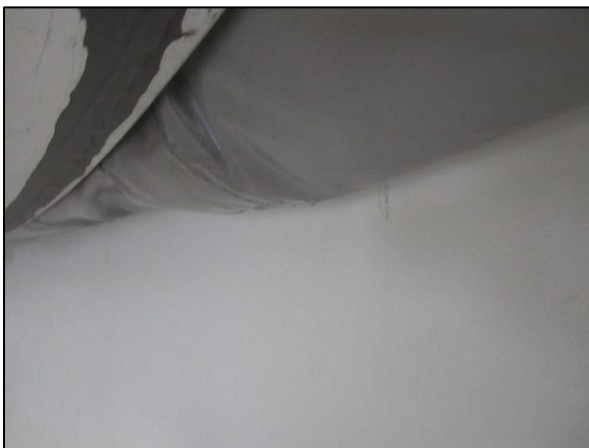
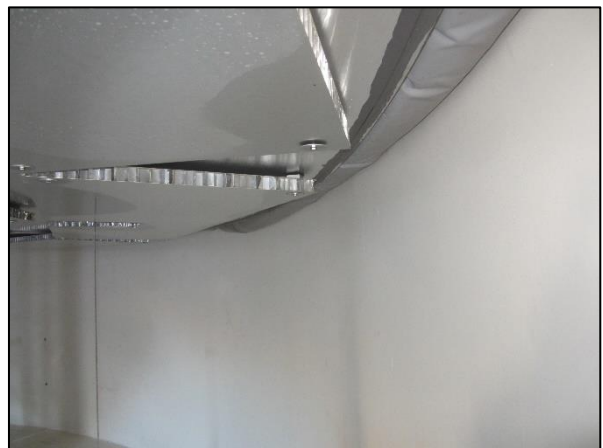
**h. Replace Floating Pan Penetration and Perimeter Seals**

**OBSERVATION:** The internal floating pan's original penetration seals are deteriorated. The internal floating pan's original double wiper perimeter foam log seal is showing signs of wear. An area of the primary perimeter foam log seal near the internal ladder is starting to sag and retain fuel.

**REFERENCE:** Guidance for new construction provided in DoD Standard Design AW 78-24-27 and UFGS Specification 33 56 13.13 includes double wiper squeegee urethane perimeter seals.

**RECOMMENDATION:** Replace the floating pan perimeter seals with urethane double wiper squeegee perimeter seals. Replace the floating pan penetration seals with urethane wiper seals.

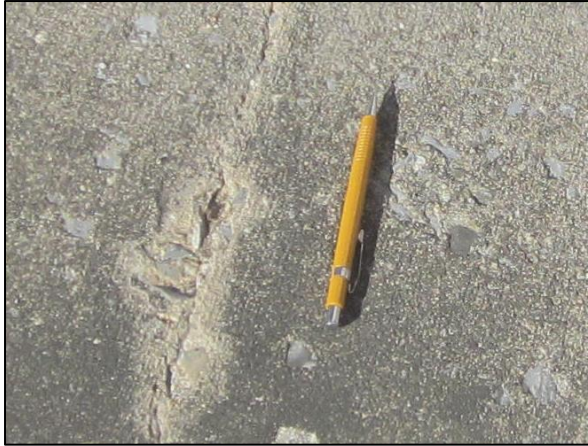
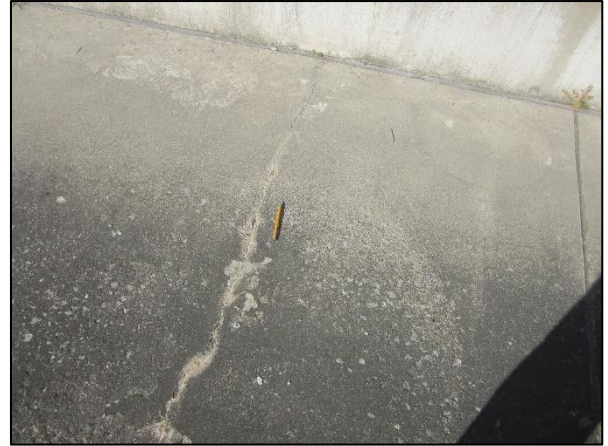
**i. Seal Secondary Containment**

**OBSERVATION:** There are approximately 60 feet of unsealed cracks in the shared dike walls and 30 feet of unsealed cracks in the shared dike basin. Rainwater entering the concrete through the cracks may cause deterioration of the reinforcing steel and/or freeze and expand causing widening of the cracks and further deterioration. In addition, the expansion joint sealants between the dike basin and the dike wall and foundations, and 10 feet of dike basin expansion joint have failed.

**REFERENCE:** NFPA 30 paragraph 22.11.2.4 and CFR 112.7(c)(1) require dikes to be liquid tight.

**RECOMMENDATION:** Rout and seal 50 feet of unsealed cracks in the shared dike walls and 30 feet of unsealed cracks in the shared dike basin. Replace the sealants between the dike basin and the dike wall and foundations and in 10 feet of dike basin expansion joint.

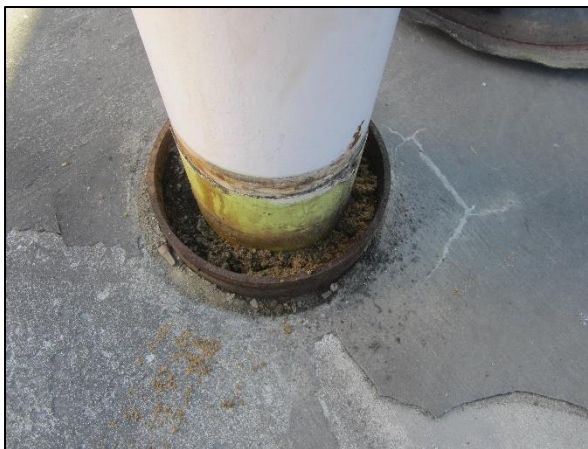
**j. Provide Penetration Seals**

**OBSERVATION:** The receipt piping and the issue piping both penetrate the dike basin through pipe sleeves without any seals between the sleeves and the piping. Drawings for the dike basin and penetrations were not available at the time of the inspection to confirm if there is a liner under the concrete sealed to the piping.

**REFERENCE:** NFPA 30 paragraph 22.11.2.4 and CFR 112.7(c)(1) require dikes to be liquid tight.

**RECOMMENDATION:** If as-built drawings indicating a liner sealed to the piping under the dike basin cannot be located, the gap between the product piping and the dike basin penetration sleeves should be sealed using a modular elastomeric compression seal.

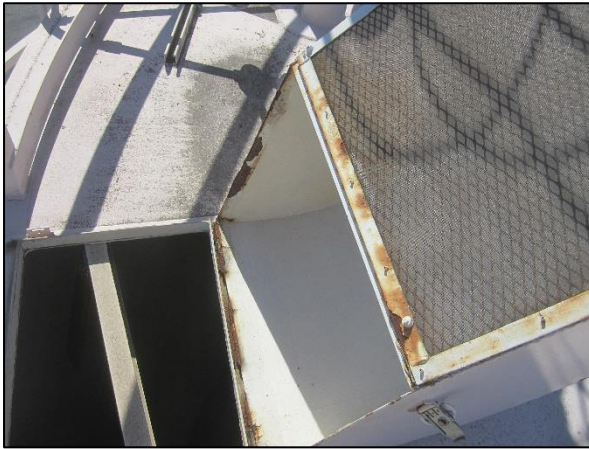
**REFERENCE:** API 650 paragraph H-5.2.2 requires vent screens with 1/2-inch openings.

**RECOMMENDATION:** Remove the insect screens from the perimeter vents and shell overflows.

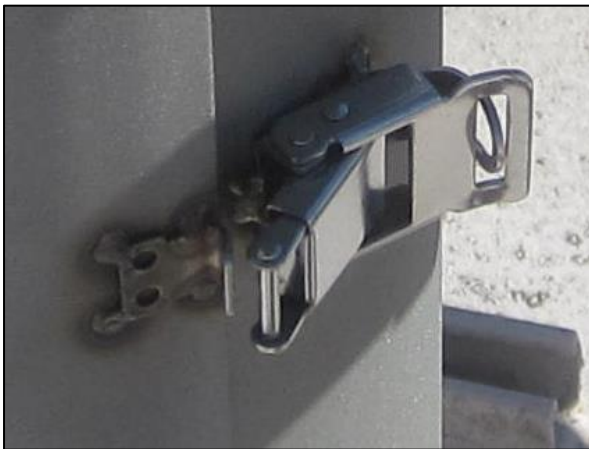
**b. Adjust Enraf Door Latches**

**OBSERVATION:** The Enraf ATG access door latches are out of adjustment and do not properly engage the door seal so as to prevent rainwater from entering the tank.

**RECOMMENDATION:** Adjust the Enraf access door latches so that all latches engage the door seal.

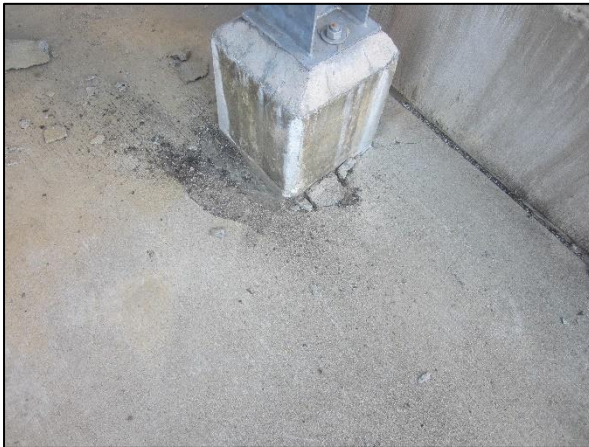
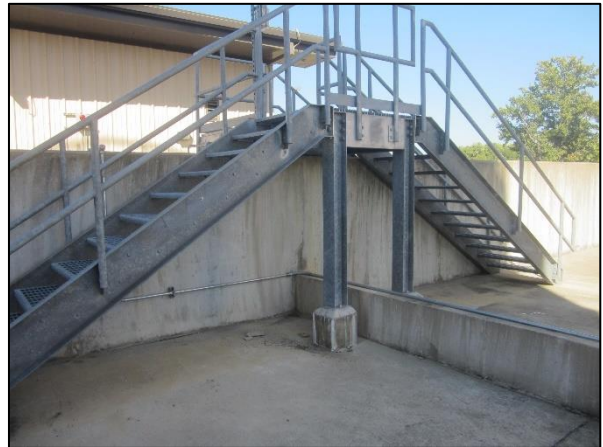
**c. Repair Concrete**

**OBSERVATION:** The concrete dike basin is spalled around the base of the dike access steps support pedestal.

**Reference:** NFPA 30 paragraph 22.11.2.4 and CFR 112.7(c)(1) require dikes to be liquid tight.

**RECOMMENDATION:** Repair the concrete where it is spalled around the base of the dike access steps support pedestal.

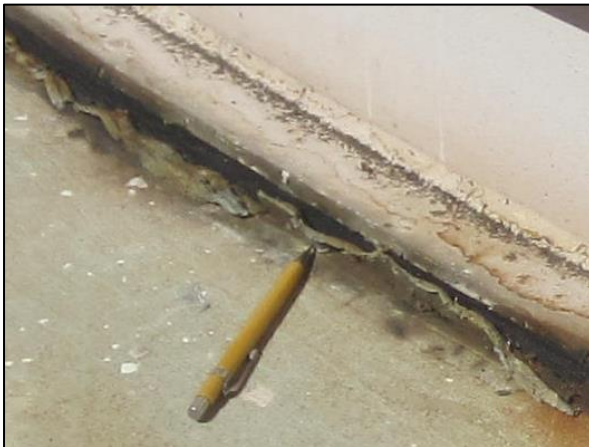
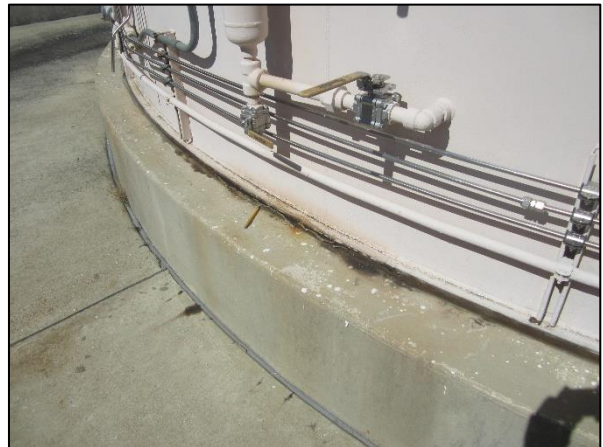
**d. Repair Tank Bottom-to-Foundation Seal**

**OBSERVATION:** Approximately a quarter of the tank bottom to foundation seal has failed.

**REFERENCE:** Guidance for maintenance of fuel storage facilities provided in UFC 3-460-03 paragraph 8-4.1. B. includes monthly inspection and repair of the tank bottom to foundation seal.

**RECOMMENDATION:** Replace the failed areas of the tank bottom to foundation seal.

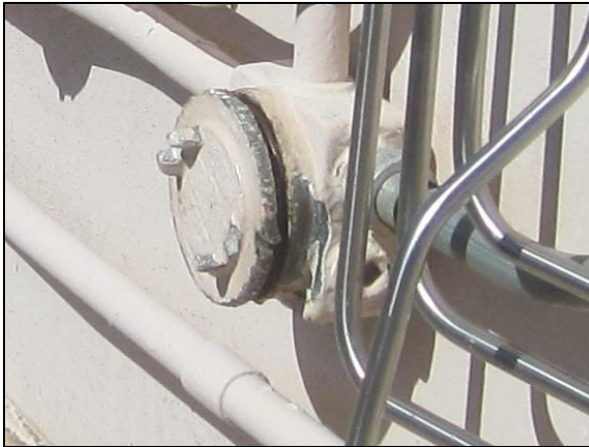
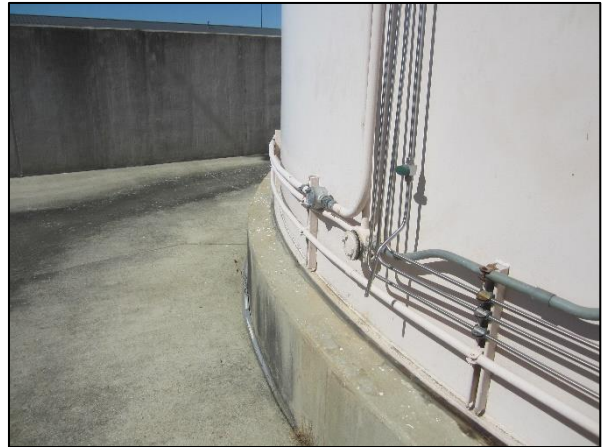
**e. Provide Junction Box Gasket**

**OBSERVATION:** A conduit junction box with a threaded cover is missing its gasket/ O-ring.

**REFERENCE:** NFPA 70 paragraph 500.5(B)(2)(1) and guidance for new construction provided in UFC 3-460-01 Paragraph 2-12.1.1 considers all outdoor locations within 5 feet of fuel storage tanks to be Class 1 Division 2. NFPA 70 paragraph 500.7 requires electrical equipment that is not intrinsically safe and used in Class I Division 2 locations to be explosion proof.

**RECOMMENDATION:** Provide a gasket/O-ring for the electrical junction box shown to ensure the electrical junction box is explosion proof.

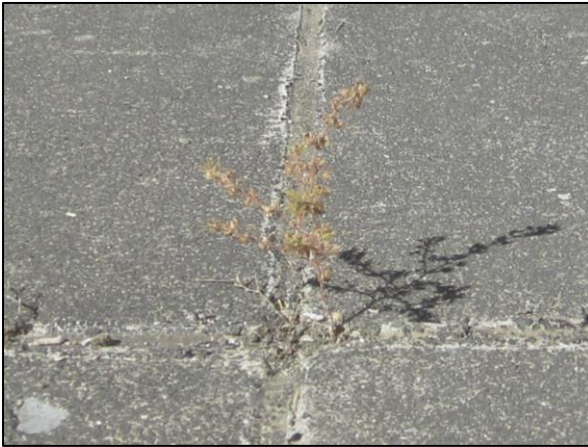
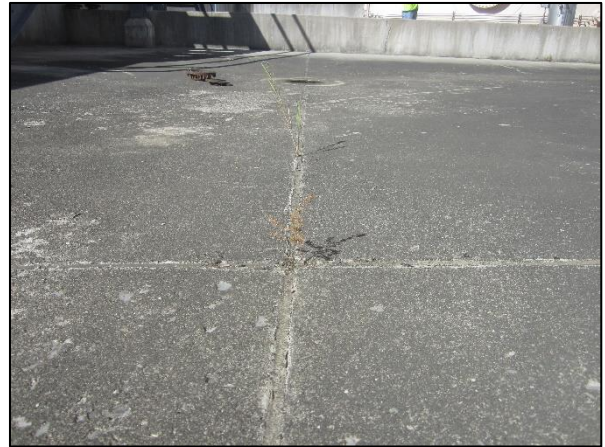
**g. Remove Vegetation**

**OBSERVATION:** There is a small amount of vegetation growing out of the secondary containment expansion joints.

**Reference:** Guidance for maintenance of fuel storage facilities provided in UFC 3-460-03 paragraph 8-10.2.2 includes daily inspection of concrete secondary containment for cleanliness and removal of vegetation.

**RECOMMENDATION:** Continue to inspect and remove vegetation from the expansion joints of the concrete secondary containment.

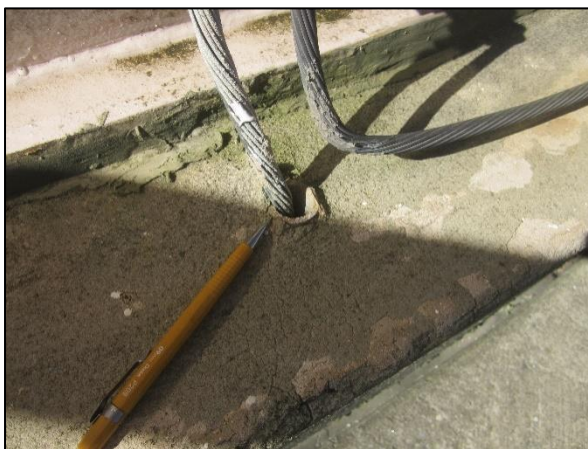
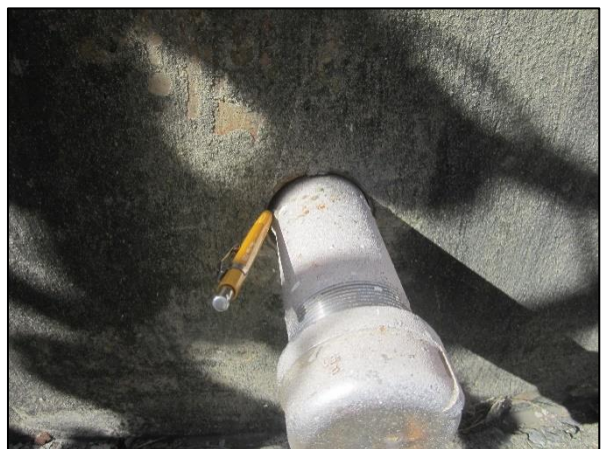
**h. Seal Secondary Containment**

**OBSERVATION:** The grounding cables penetrate the concrete ringwall foundation through unsealed pipe. The three (3) leak detection tell-tale pipes also penetrate the concrete ringwall through unsealed penetrations.

**REFERENCE:** NFPA 30 paragraph 22.11.2.4 and CFR 112.7(c)(1) require dikes to be liquid tight.

**RECOMMENDATION:** Seal the grounding cables where they penetrate the concrete ringwall foundation through pipe sleeves. Seal the three (3) leak detection tell-tale pipes where they penetrate the concrete ringwall through pipe sleeves.

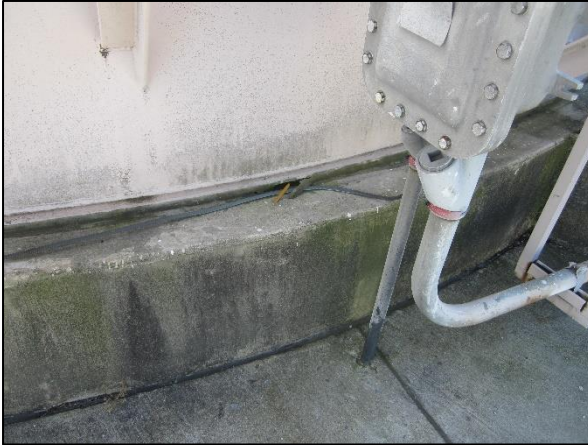
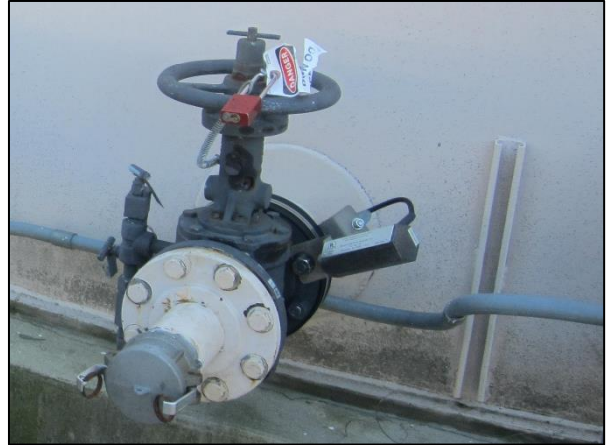
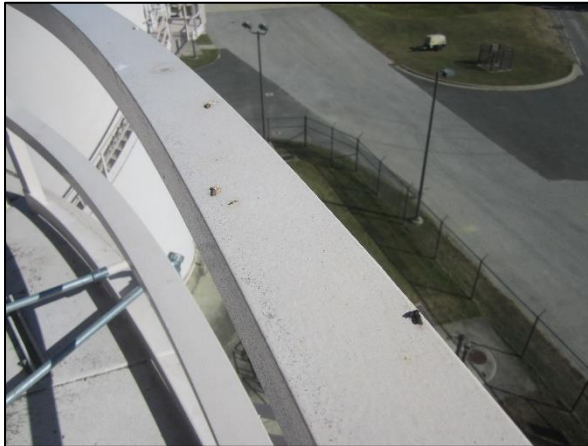
**i. Pressure Wash Exterior**

**OBSERVATION:** The isolated areas of the exterior of the shell and roof are covered with mold and algae, which can lead to coating failure. In addition, bird droppings were observed on the roof guardrail. API 570 paragraph 4.3.2.3.h) reads, “bird turds can also cause accelerated corrosion and unsightly stains.”

**RECOMMENDATION:** Pressure wash the exterior of the tank regularly.

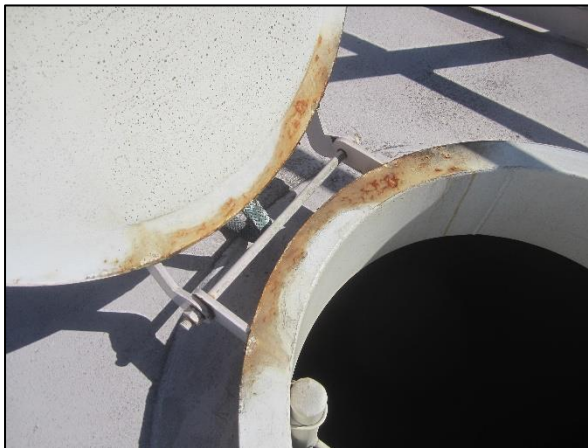
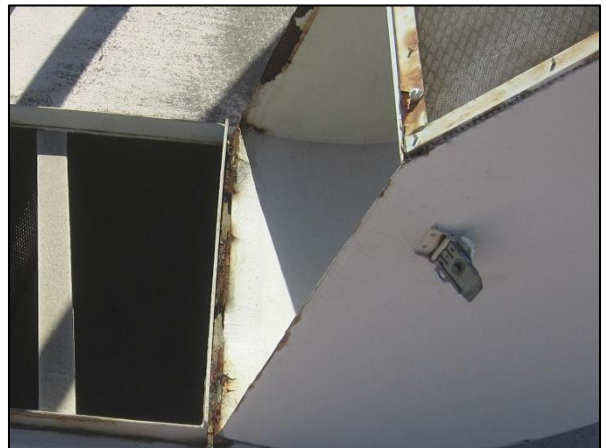
**j. Repair Appurtenance Coatings**

**OBSERVATION:** There is coating failure and corrosion on the receipt and issue DBB valves, TRV valves and their connecting flanges, and on the roof perimeter vent/inspection hatches at the roof penetration frames, hinges and edges of the covers. There is coating failure on the cathodic protection conduit, underside of the roof manhole cover and on the flange; level alarm sensor mounting flanges, and underside of the center vent cover.

**RECOMMENDATION:** Repair the coatings on the cathodic protection conduit, receipt and issue DBB valves; TRV valves and their connecting flanges; the roof perimeter vent/inspection hatches at the roof penetration frames, hinges, and edges of the covers; level alarm sensor mounting flanges; underside of the roof manhole cover and on the flange; and underside of the center vent cover.

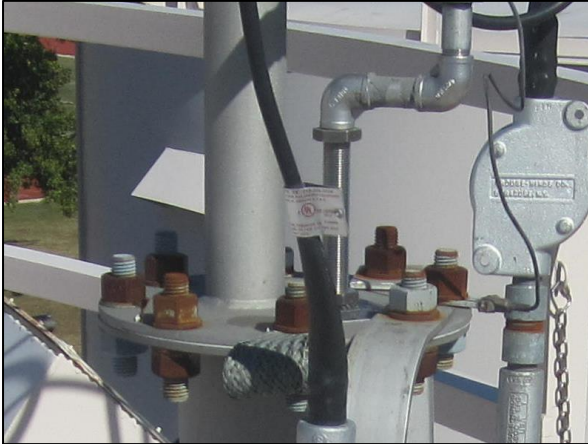
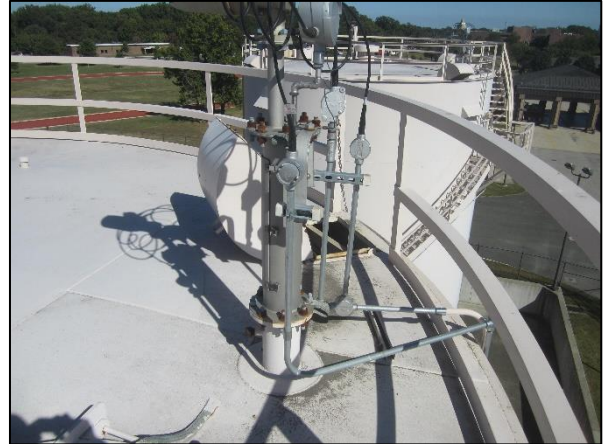
**k. Replace Nuts and Bolts**

**OBSERVATION:** The nuts and bolts on the Enraf access/mounting chamber are corroded.

**RECOMMENDATION:** Replace the bolting on the Enraf access/mounting chamber with corrosion resistant bolting.

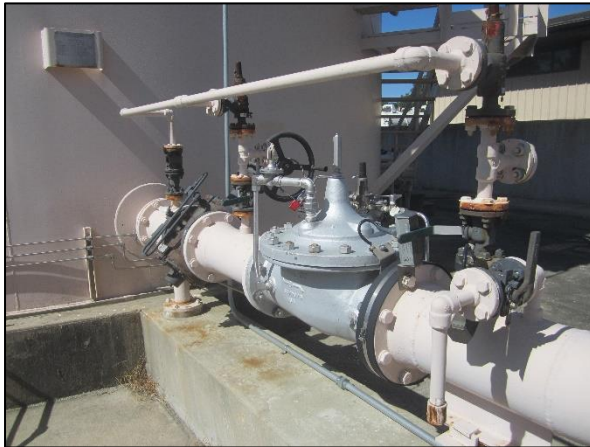
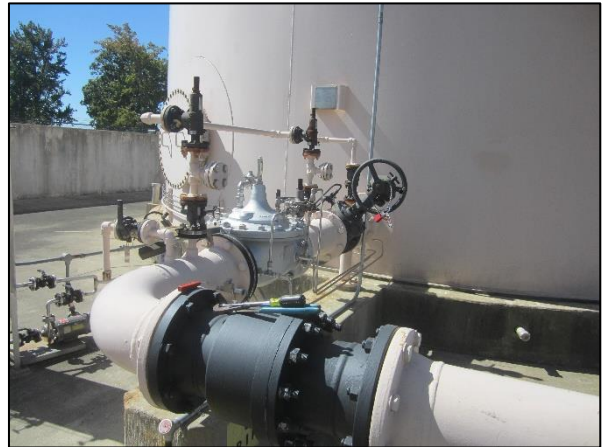
**REFERENCE:** Guidance provided in UFC 3-460-01 paragraph 7-6.3.4 and DoD Standard Design AW 78-24-27 include an isolation valve upstream and adjacent to the level control valve on new storage tanks.

**RECOMMENDATION:** If the ability to service the level control valve without having to drain the piping is desired, provide an isolation ball valve upstream and adjacent to the level control valve.

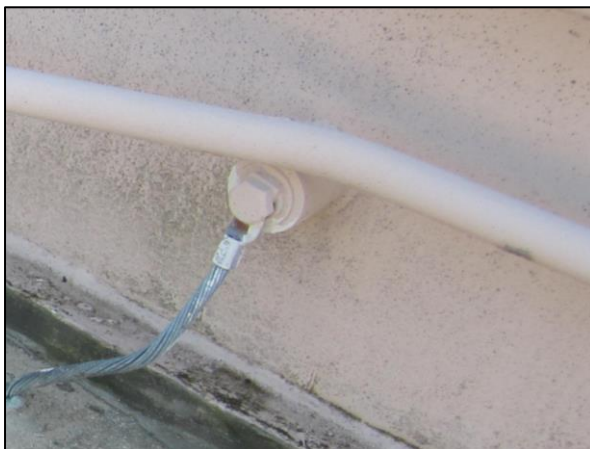
**c. Provide Exothermic Grounding Connections**

**OBSERVATION:** The tank's grounding cables are bolted to couplings welded to the shell.

**REFERENCE:** Guidance for new construction provided in DoD Standard Design AW 78-24-27 Detail 2/ED.02 includes exothermic-welding the grounding cables to stainless steel grounding lugs.

**RECOMMENDATION:** If in addition to lightning protection, a means to reliability control stray electrical currents is desired, provide grounding lugs and exothermically welded grounding connections.

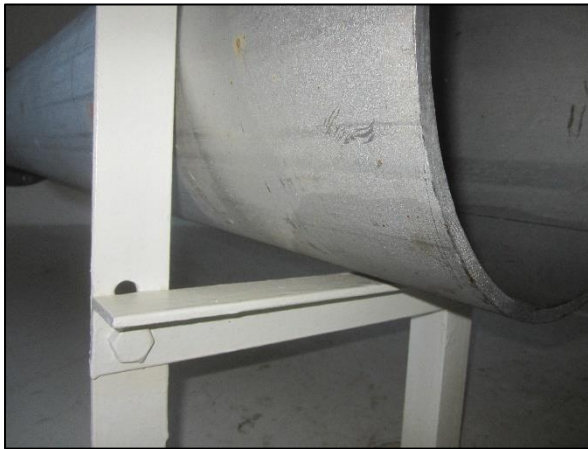
**REFERENCE:** DoD Standard Design AW 78-24-27 includes internal bolted pipe supports with slotted holes for adjusting the height of the support.

**RECOMMENDATION:** If supporting the internal piping when the tank is empty is a concern continue to readjust the internal pipe supports whenever the tank is taken out of service for cleaning.

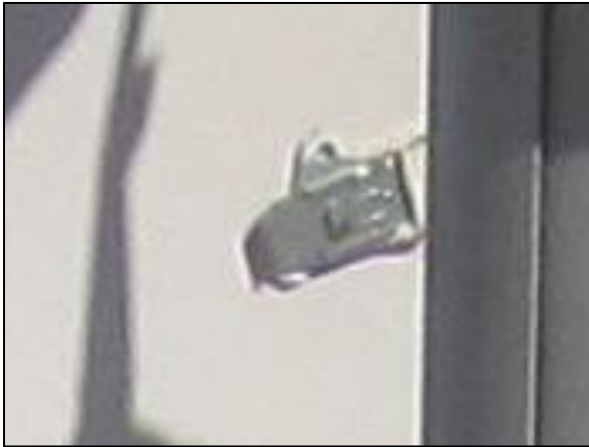
The four inspection hatches along the perimeter of the roof have insect mesh screening in addition to the bird screen. One of the latches on one hood does not engage due to improper installation. (first one counterclockwise from the Enraf nozzle).

**RECOMMENDATION:** The next time other welded repairs are performed on the tank, reinstall the faulty latch on one of the roof perimeter vent inspection hatches so that the latch is operable.

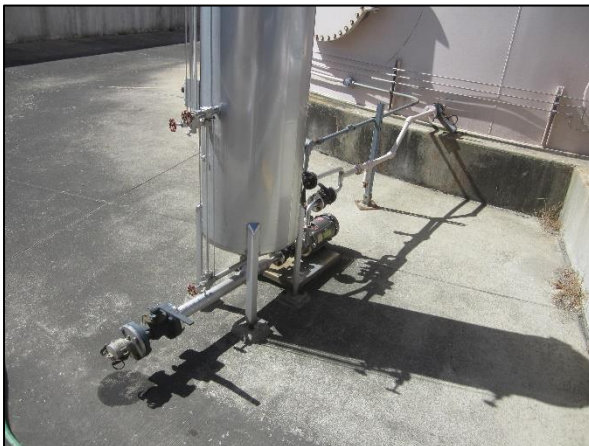
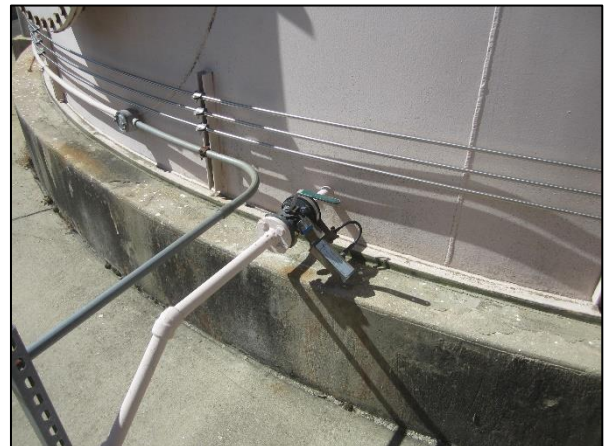
**OBSERVATION:** The product saver tank stainless steel piping is isolated from the tank by the isolation flange kit on the shell nozzle isolation valve. The piping between the stainless steel product saver tank piping and the water draw-off nozzle isolation valve is carbon steel. An electric motor is mounted on the product saver tank piping, but the product saver tank is not grounded.

**RECOMMENDATION:** If lightning protection is desired, provide a grounding system for the product saver tank. Do not bond the product saver tank to the same grounding system as that on the tank in order to maintain some degree of electrical isolation. Replace with stainless steel piping, the carbon steel piping between the stainless steel piping and the water draw-off nozzle isolation valve.

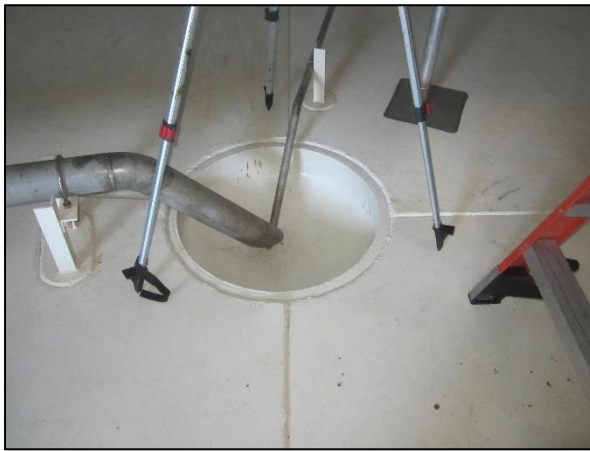
**OBSERVATION:** The receipt, issue, low suction and water draw-off nozzles are internal flanged and their internal piping is stainless steel. The ATG stilling well is also stainless steel. Galvanic corrosion of the interior of the tank may occur, if water is present. The issue internal piping terminates horizontally inside the tank.

**RECOMMENDATION:** If water is expected inside the tank, replace the stainless steel receipt, issue, low suction and water draw-off internal piping with carbon steel per DoD Standard Design AW 78-24-27. Replace the stainless steel stilling well with aluminum, or if 8-inch aluminum stilling wells are provided as recommended elsewhere in this report, demolish the 6-inch stainless steel stilling well.

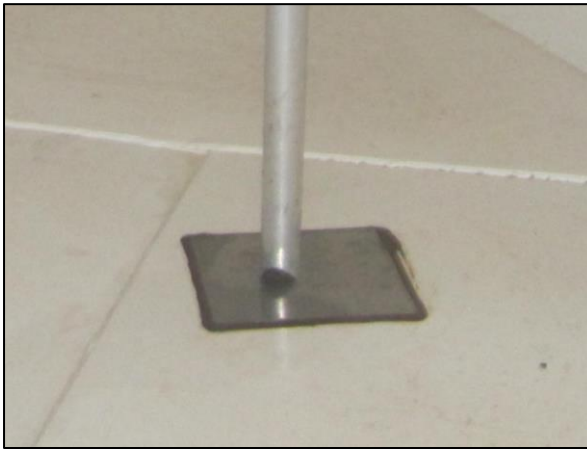
**OBSERVATION:** The internal floating pan support leg striker plates are stainless steel and glued to the tank bottom. Galvanic corrosion of the interior of the tank may occur, if water is present and the stainless steel striker plates make contact with the pan support legs or the tank bottom.

**RECOMMENDATION:** When major repairs to the internal coating are performed, remove the stainless steel IFR support leg striker plates, examine the tank bottom under the striker plates, repair the tank bottom and internal coating if indicated, and provide PTFE feet on the IFR support legs.

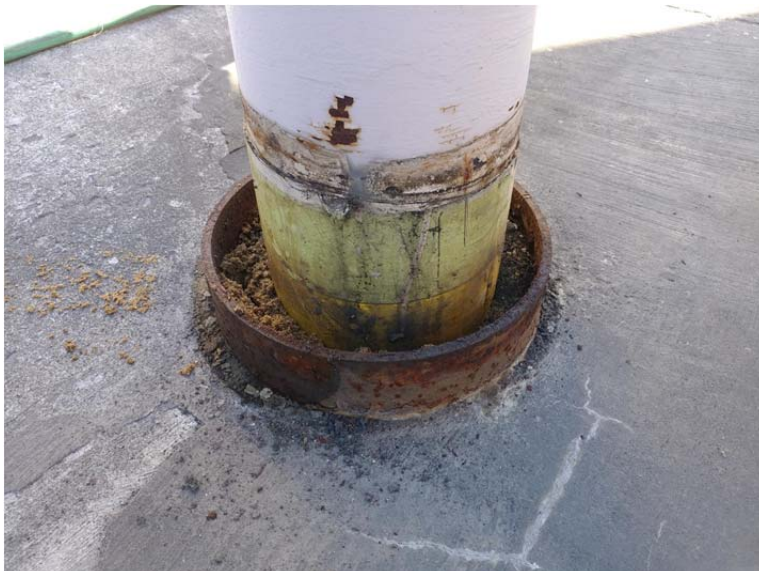
E.6 Issue/Receipt Line Not Sealed

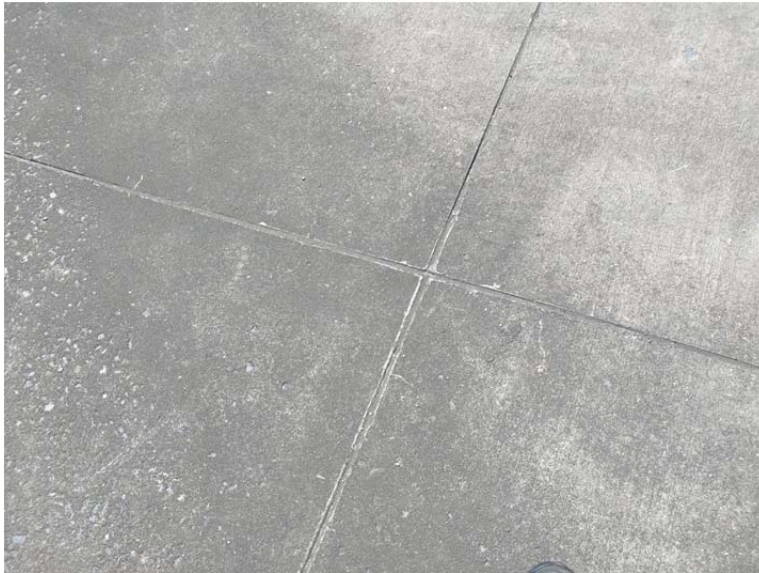
E.7 Secondary Containment Floor

4.2.2 **Secondary Containment:** Seal the cracks in the secondary containment walls and floor. Repair all expansion joints with a fuel resistant type caulking.

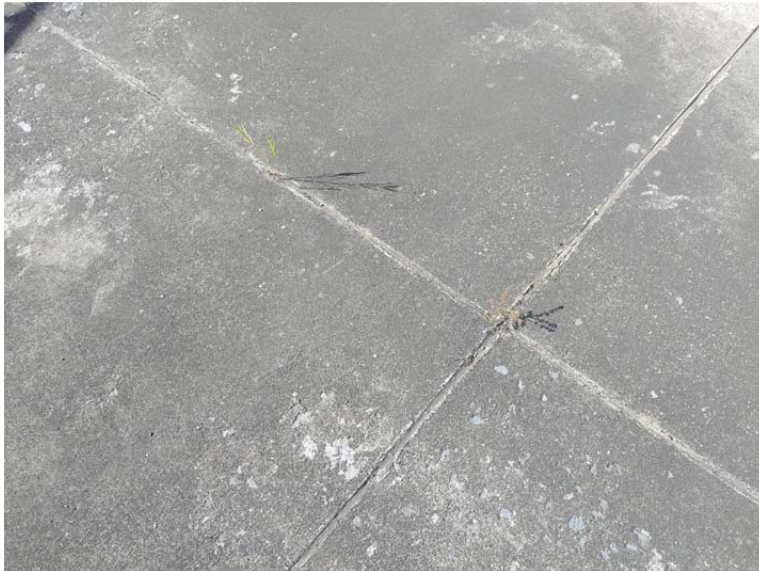
E.8 Vegetation in Secondary Containment Floor

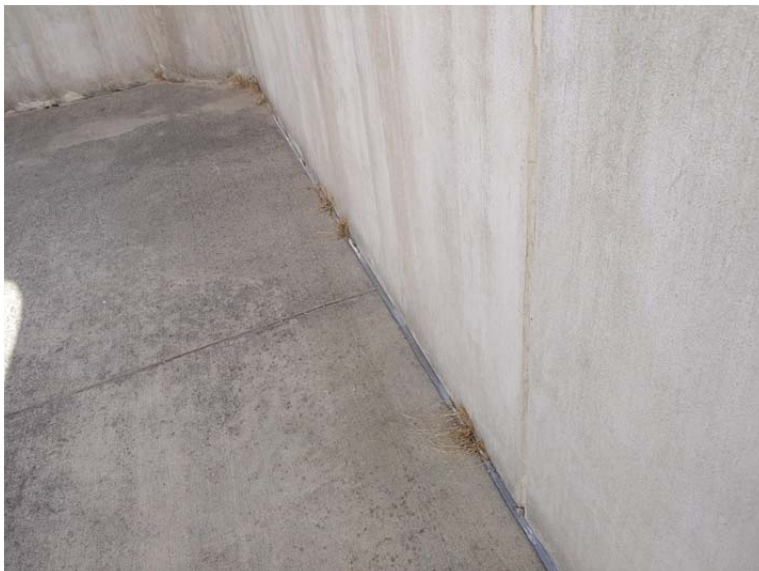
E.9 Vegetation in Secondary Containment

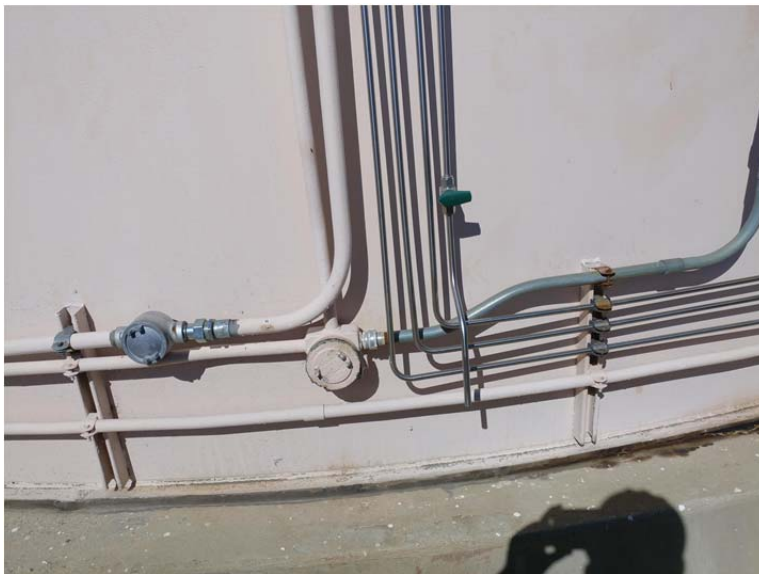
A junction box for the alarm conduit located on the back side on the tank near the low level alarm is not properly sealed with a gasket. The manholes have algae/mildew growth on the nozzle necks. One of the manholes on the first course has a grease fitting that has broken off.

E.26 Junction Box not Properly Sealed

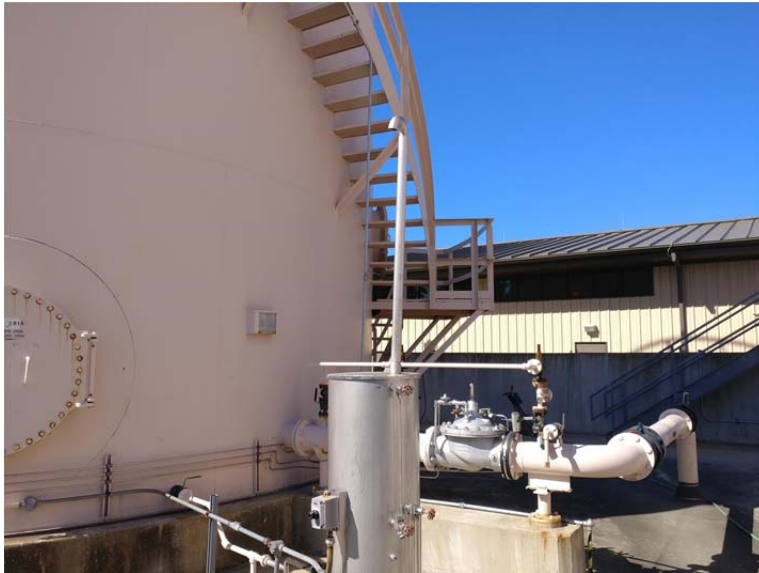
E.31 Product Saver Tank System

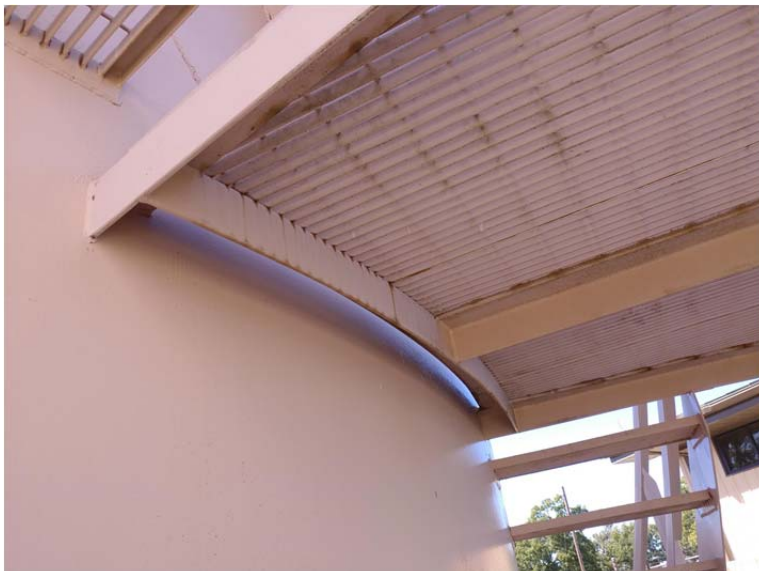
E.35 Circumferential Stairway

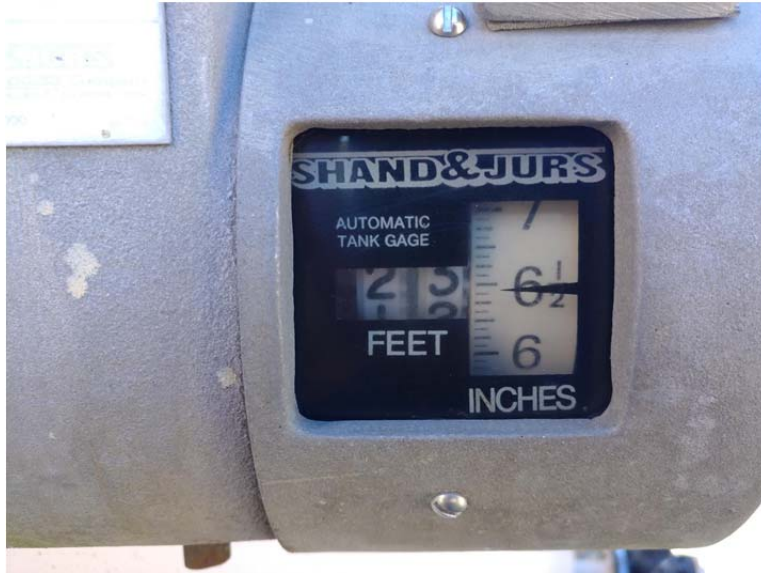
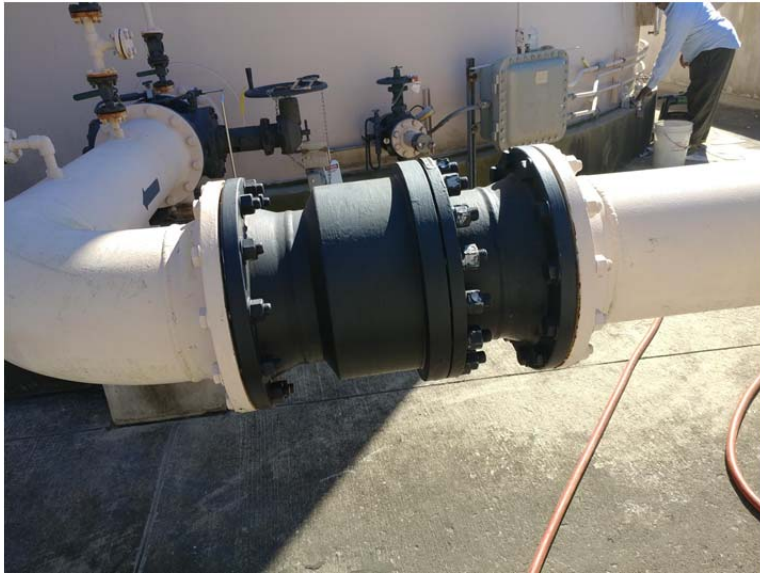
E.39 Mechanical Tape Gauge

E.40 Mechanical Tape Gauge

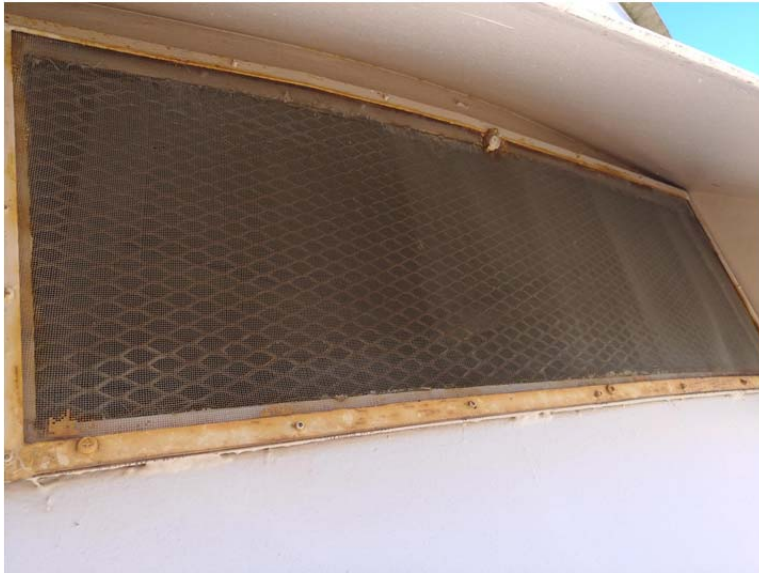
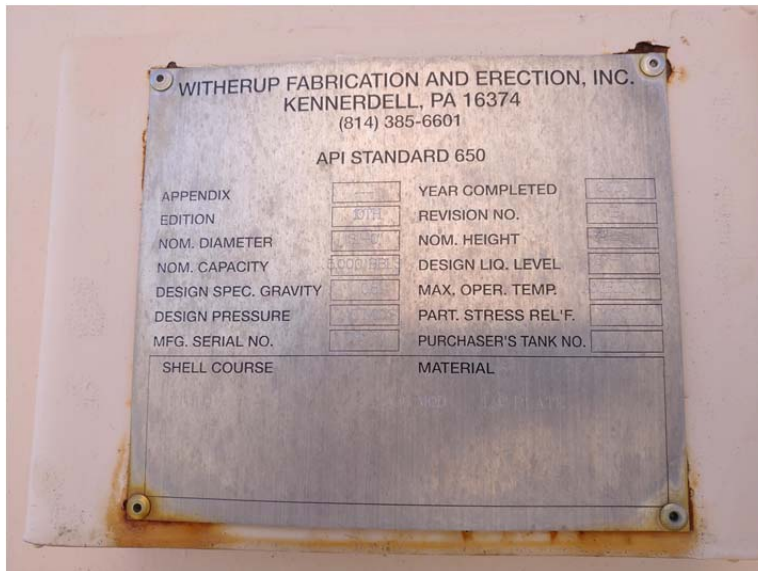
E.45 Overflow Vent

E.46 Overflow Vent

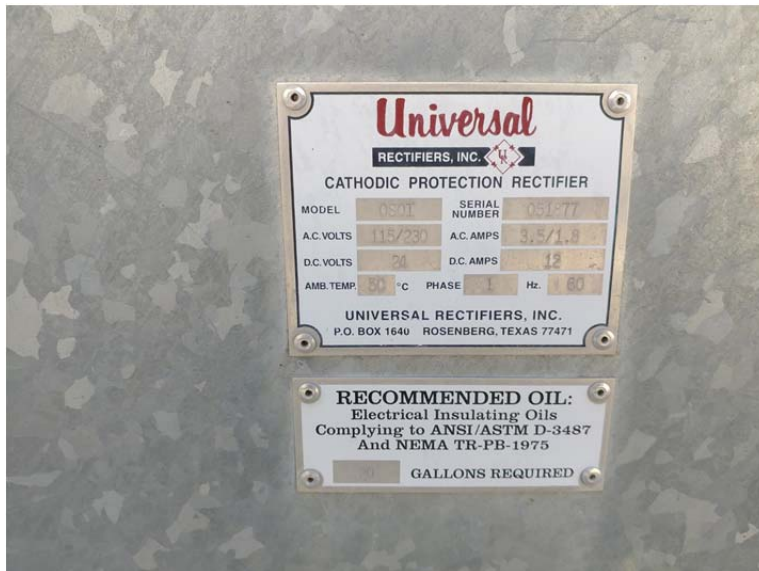
E.49 Cathodic Protection

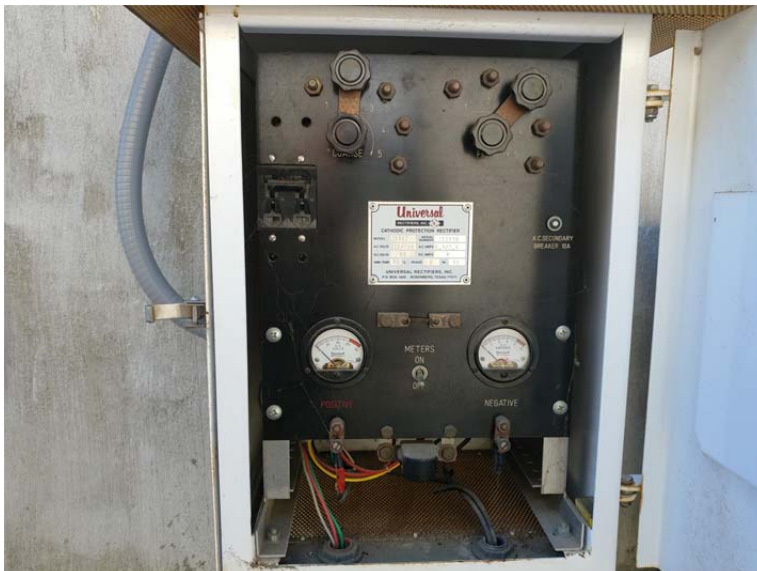
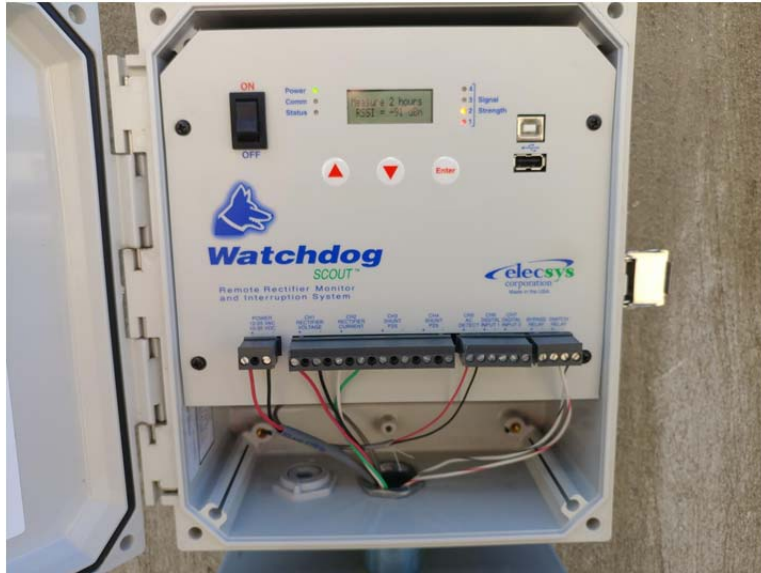
E.50 Cathodic Protection Rectifier

E.51 Cathodic Protection Rectifier

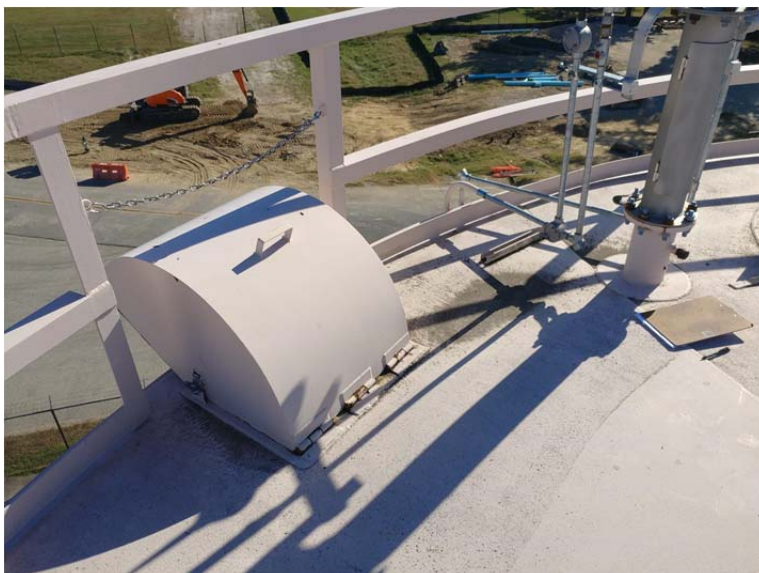
E.56 Roof Nozzles

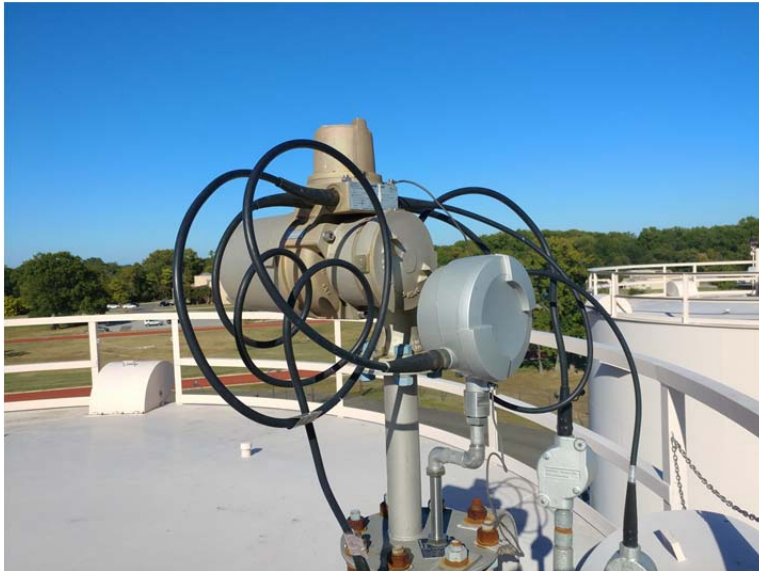
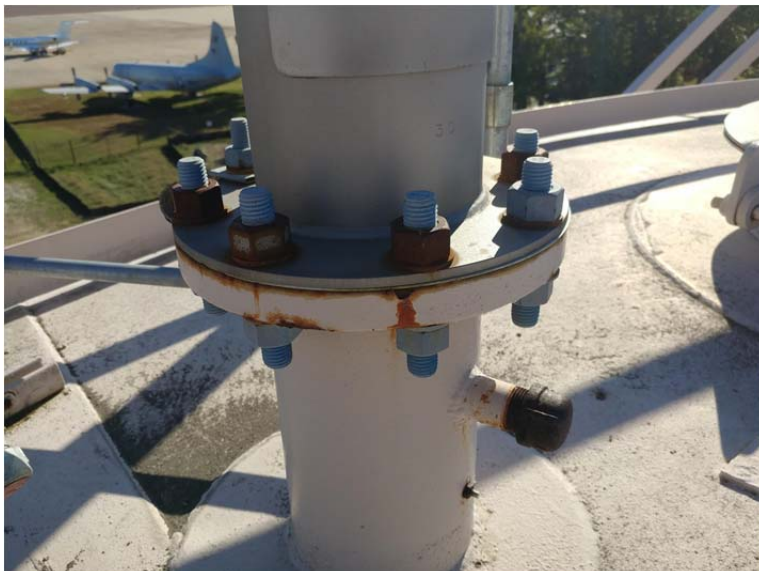
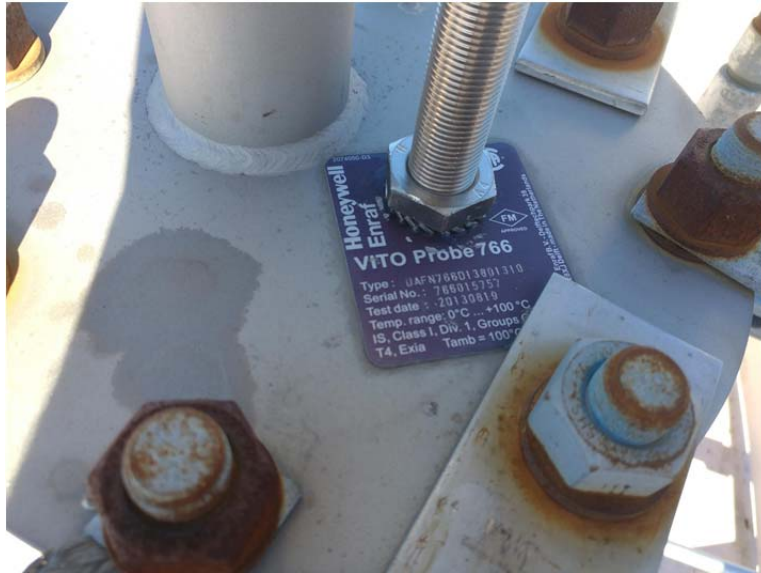
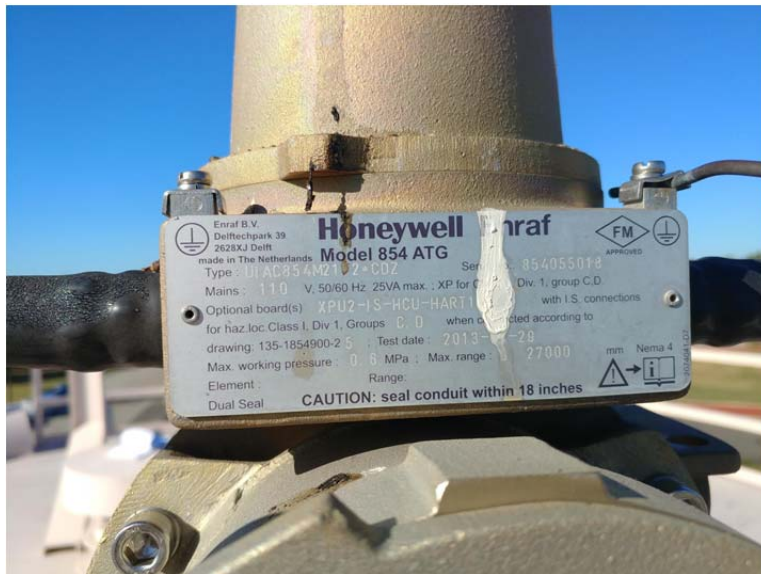
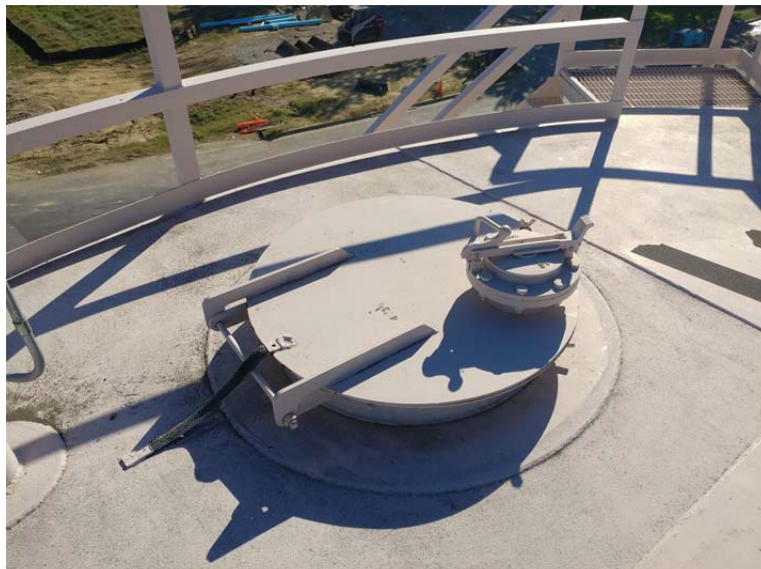
E.61 Roof Nozzle A, 6" Enraf/Vito Stilling Well

E.62 Roof Nozzle A, 6" Enraf/Vito Stilling Well

E.63 Roof Nozzle A, 6" Enraf/Vito Stilling Well

E.64 Roof Nozzle A, 6" Enraf/Vito Stilling Well

E.65 Roof Nozzle A, 6" Enraf/Vito Stilling Well
