**US Army Corps of Engineers  
Omaha District  
API 653 Out-of-Service  
Inspection Report**

**Andrews Air Force Base, Morningside, Maryland  
Facility 3473  
Tank 73**

**US Army Corps of Engineers Center of Expertise for Petroleum, Oils and Lubricants  
USACE POL-MCX**

**22 February 2017**

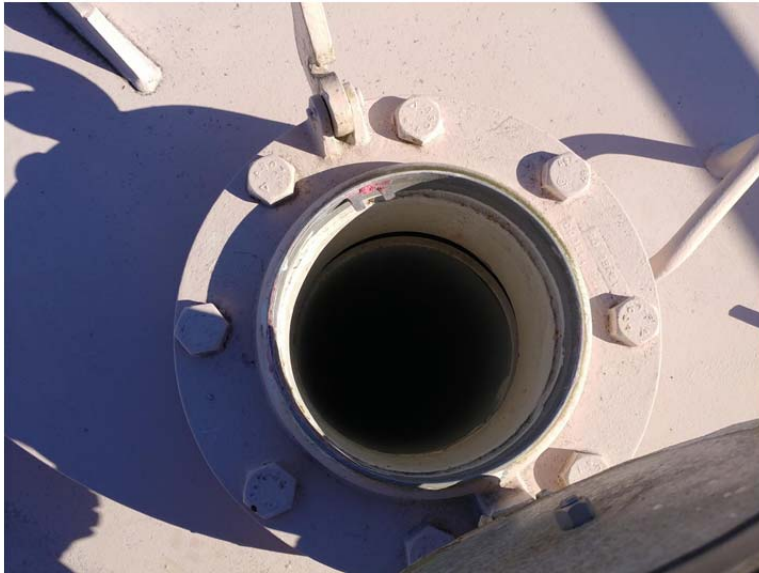
E.66 Roof Nozzle B, 36" Manhole with 8" Manual Gauge Hatch(Not Bolted)

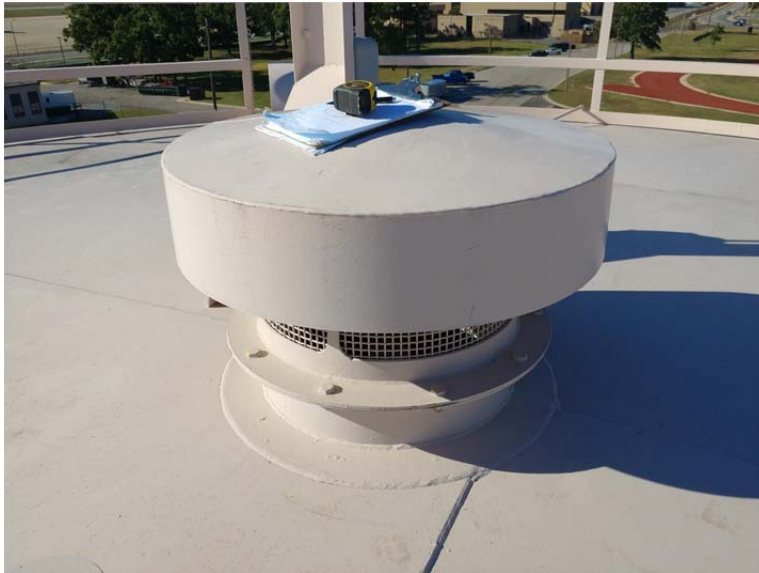
E.69 Roof Nozzle D, 2 1/2" Cap

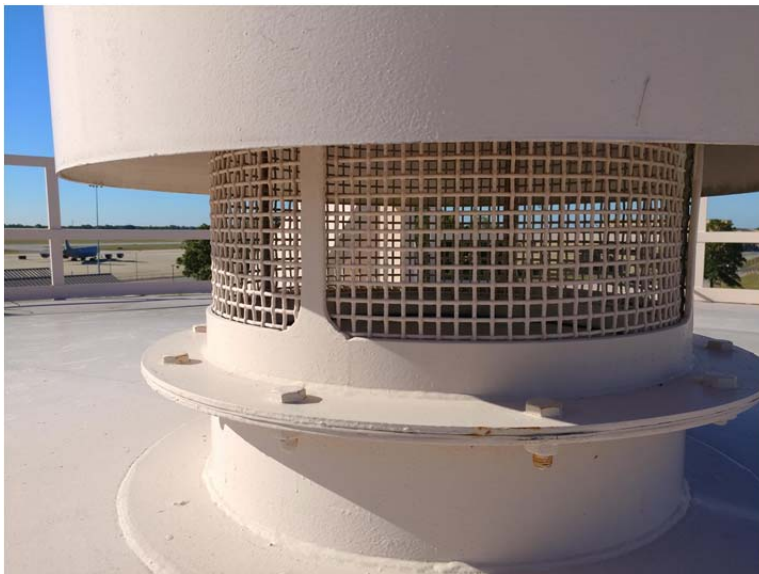
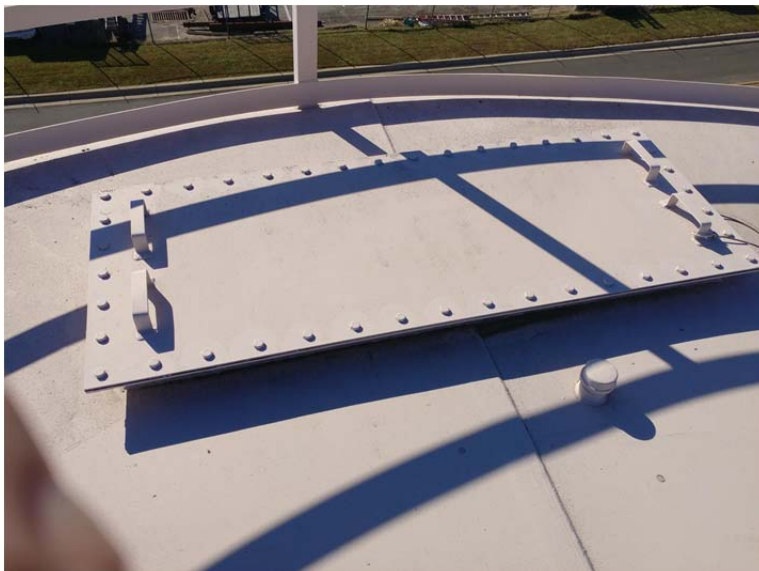
E.70 Roof Nozzle E, 24" Vent

E.71 Roof Nozzle E, 24" Vent

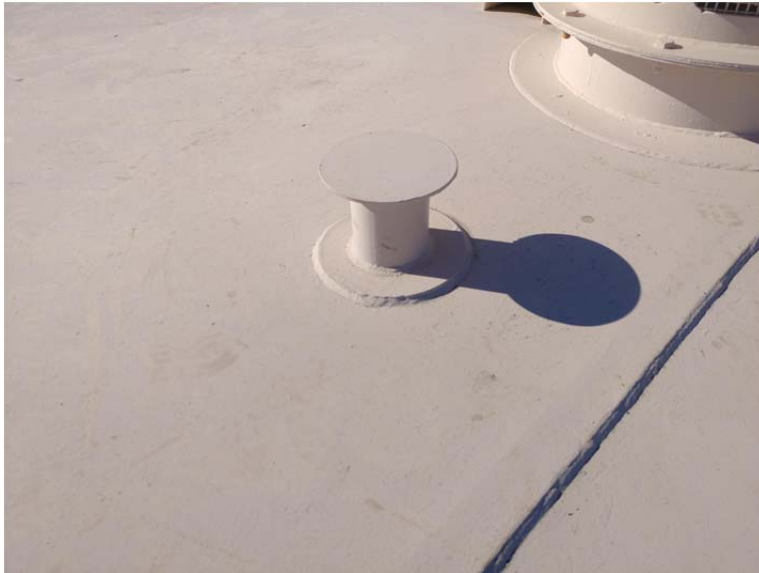
E.72 Roof Nozzle F, 30" x 72" Pan Installation Hatch, Nozzle G, 2 1/2" Cap

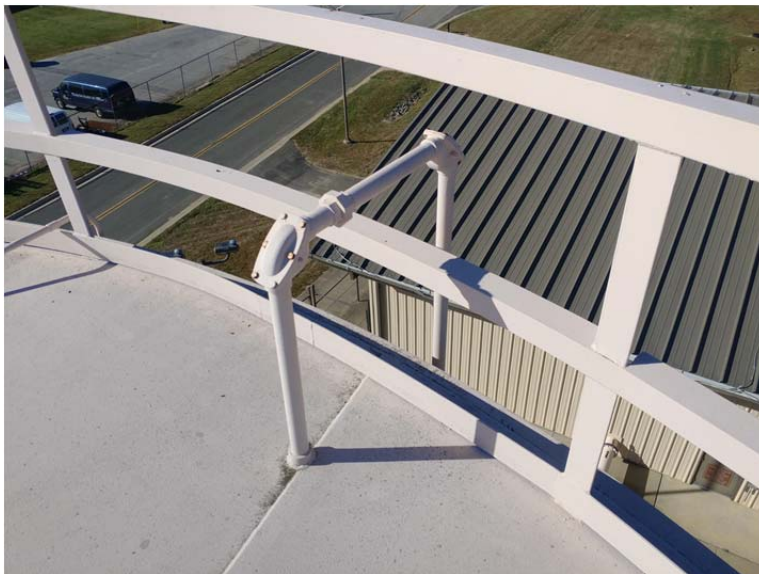
E.73 Roof Nozzle H, 3" Tie-Off

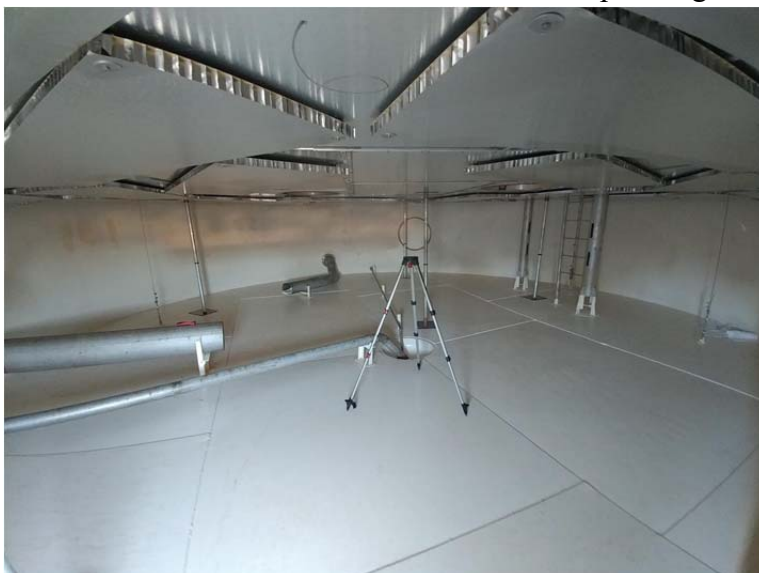
E.74 Roof Nozzle J, 1 1/2" Mechanical Tape Gauge

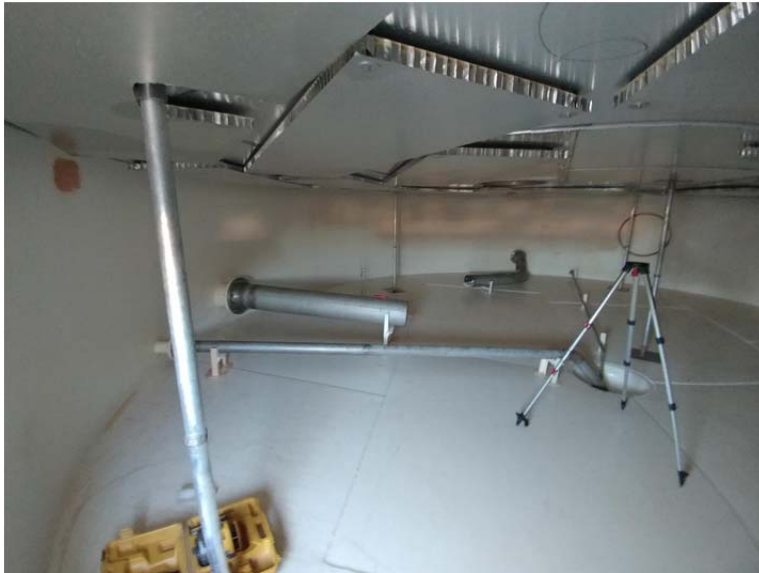
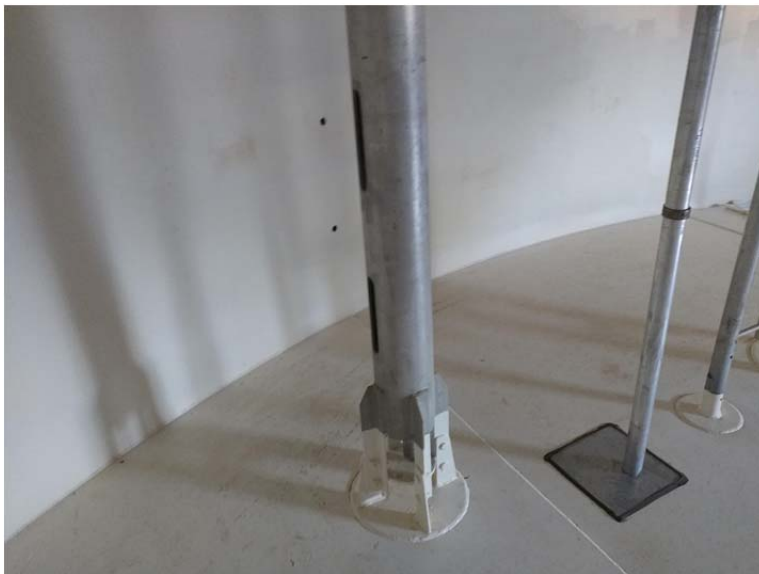
E.75 Tank Bottom

E.76 Tank Bottom

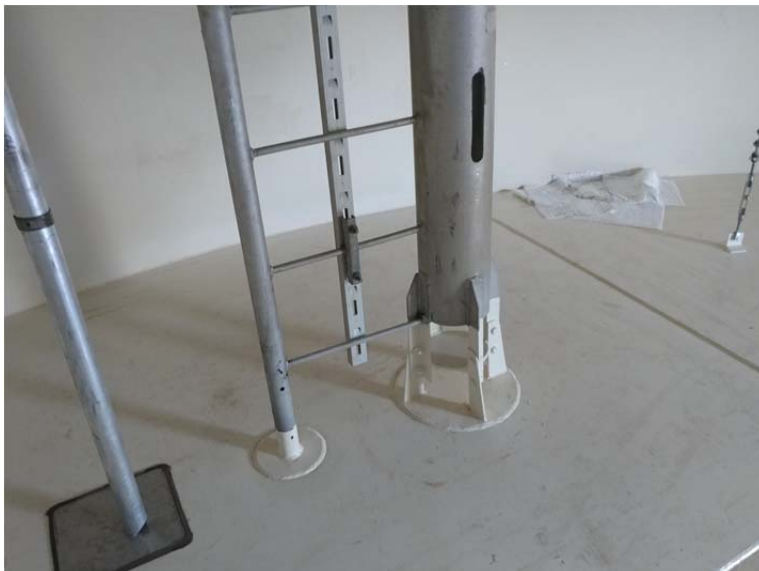
E.77 Bottom Nozzle A, 6" Enraf/Vito Stilling Well

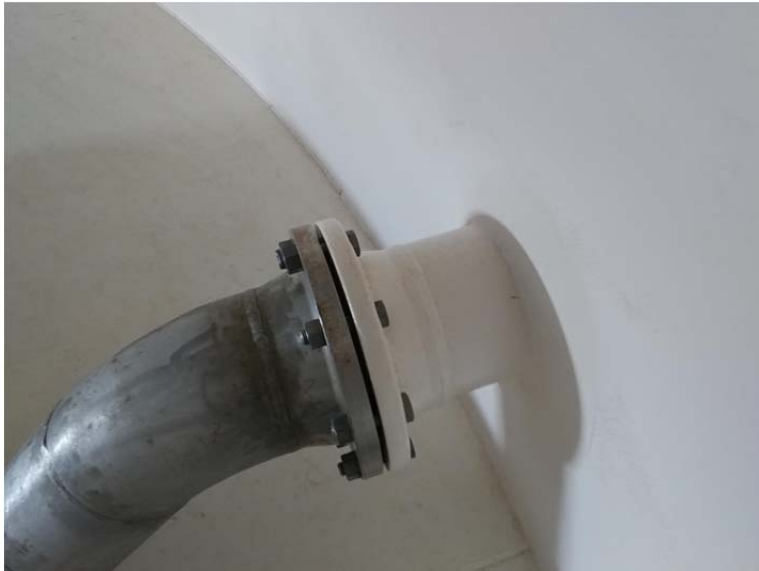
E.88 12" Issue Not Fully Resting on Support

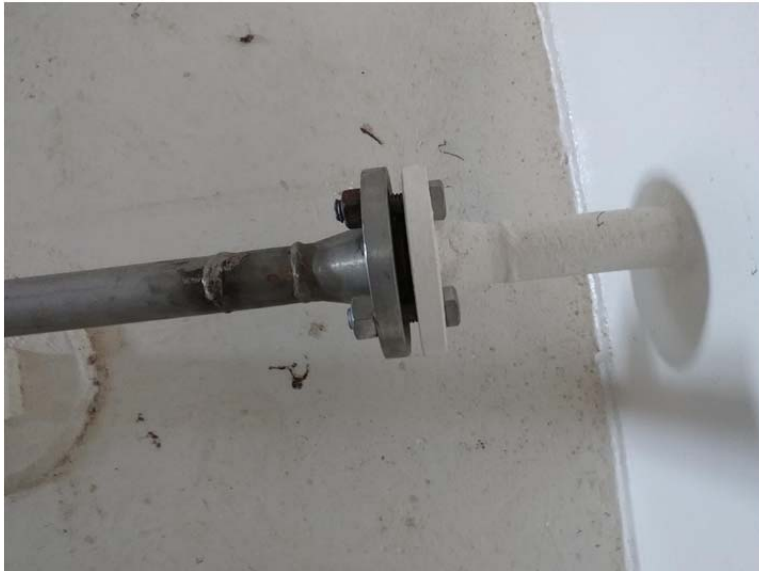
E.91 Carbon Steel Connected to Stainless Steel Flange

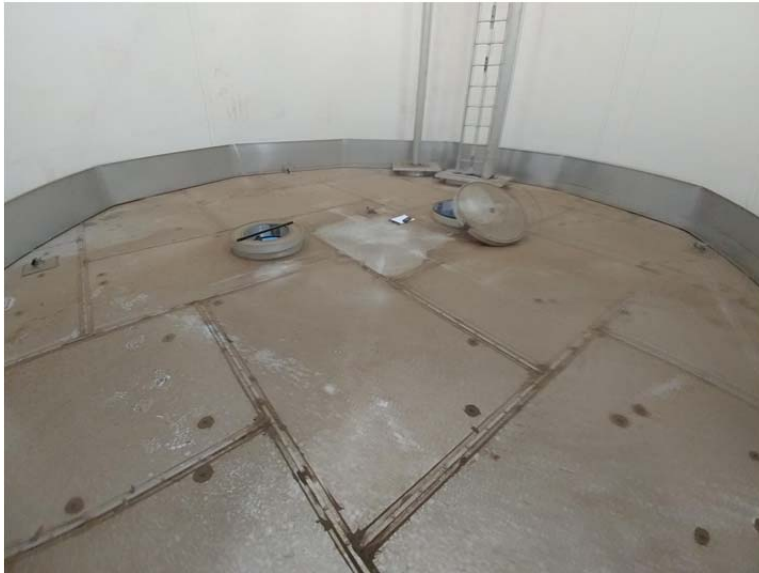
E.96 IFR Ladder Penetration Deteriorated

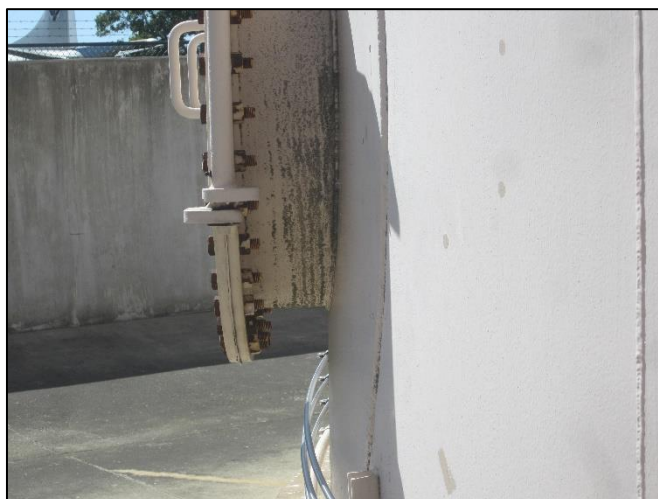
**B.10: Mold/Mildew Under Manhole Neck**

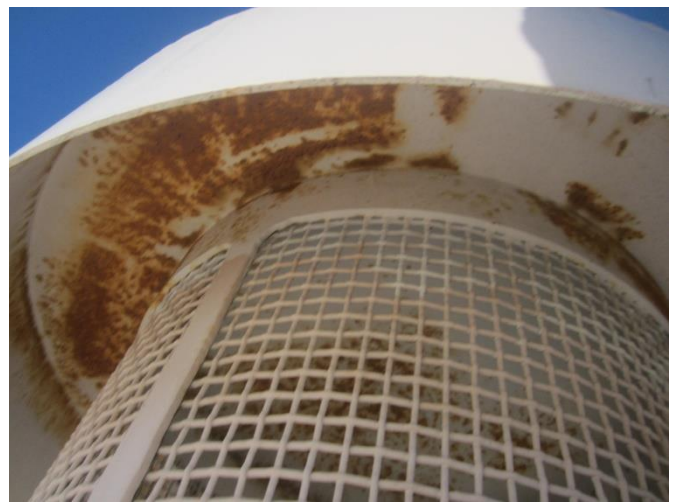
**B.13: Roof Center Vent and Scaffold Cable Support**

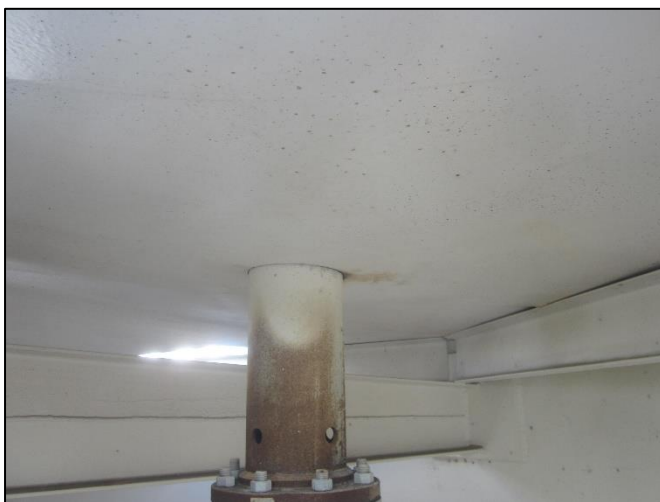
**B.16: Coating Failure on Roof at Roof Perimeter Vent**

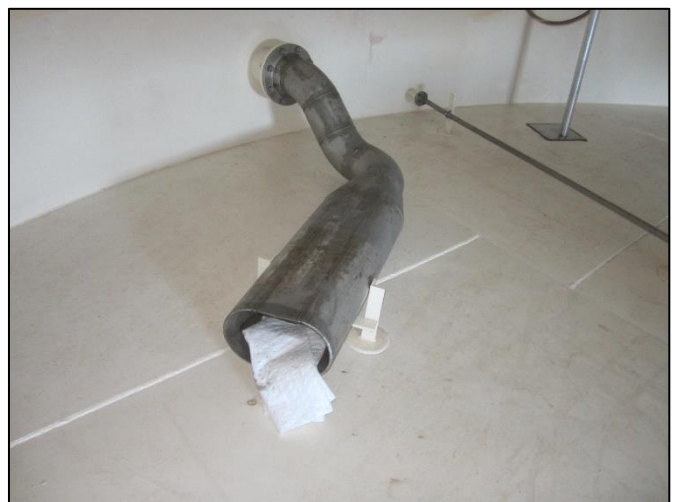
**B.17: ATG/Water Bottom Sensor and Well**
