## **VOLUME II ASBESTOS CONTAINING MATERIAL & LEAD CONTAINING PAINT SURVEY REPORTS**

**VISN 1**  
**Brockton VA Medical Center**  
940 Belmont Street  
Brockton, Massachusetts

Project No. 2009023.003

June 21, 2010

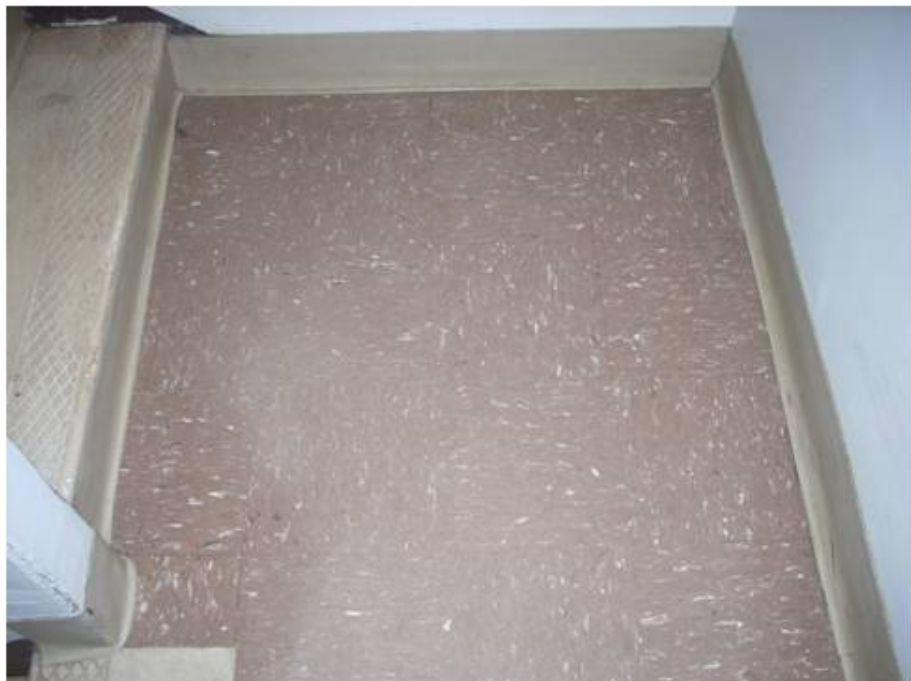
12"x12" Brown Floor Tile and Mastic, Samples 14A, 15A

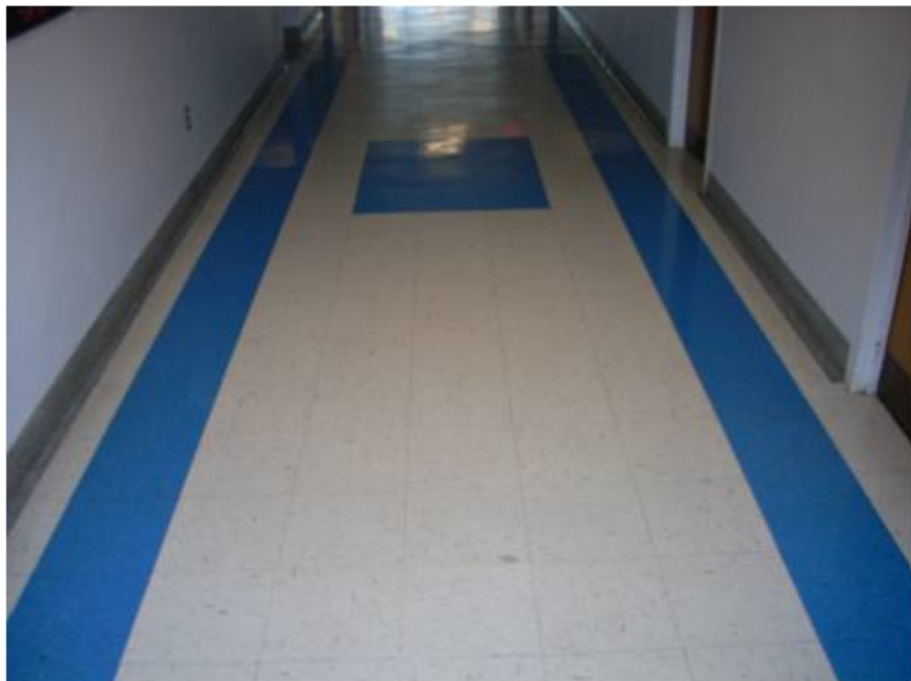
12"x12" Tan Floor Tile and Mastic, Samples 19A, 20A

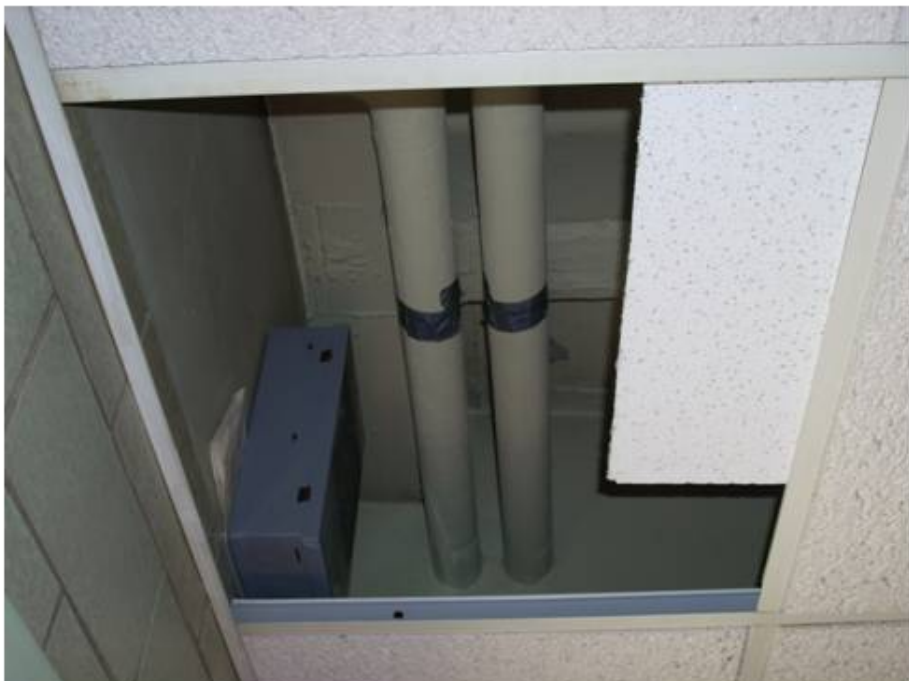
4" Pipe Insulation Above Ceiling, Sample 23A

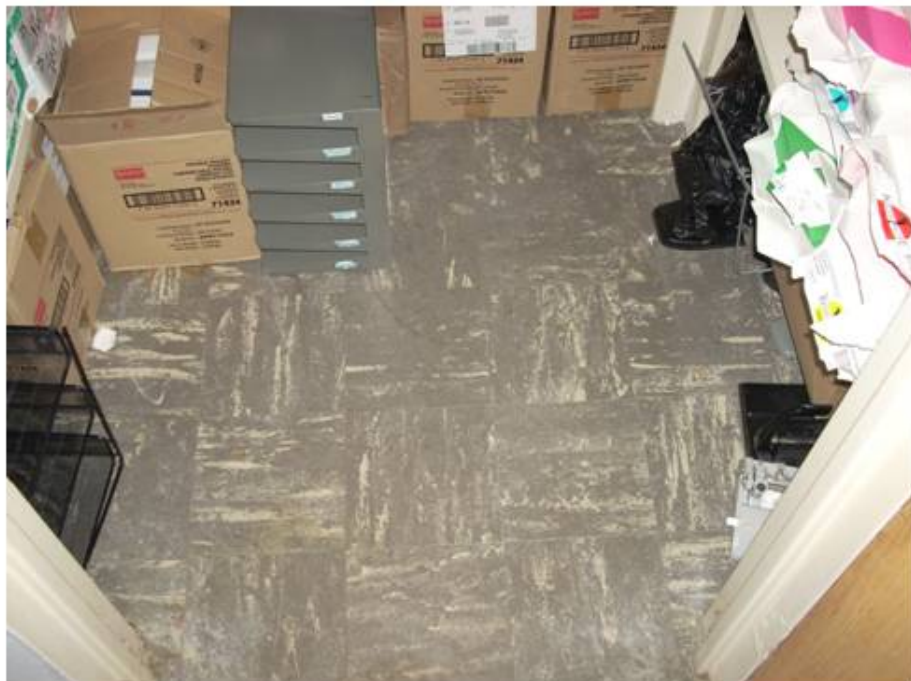
9"x9" Gray Floor Tile, Sample 30A

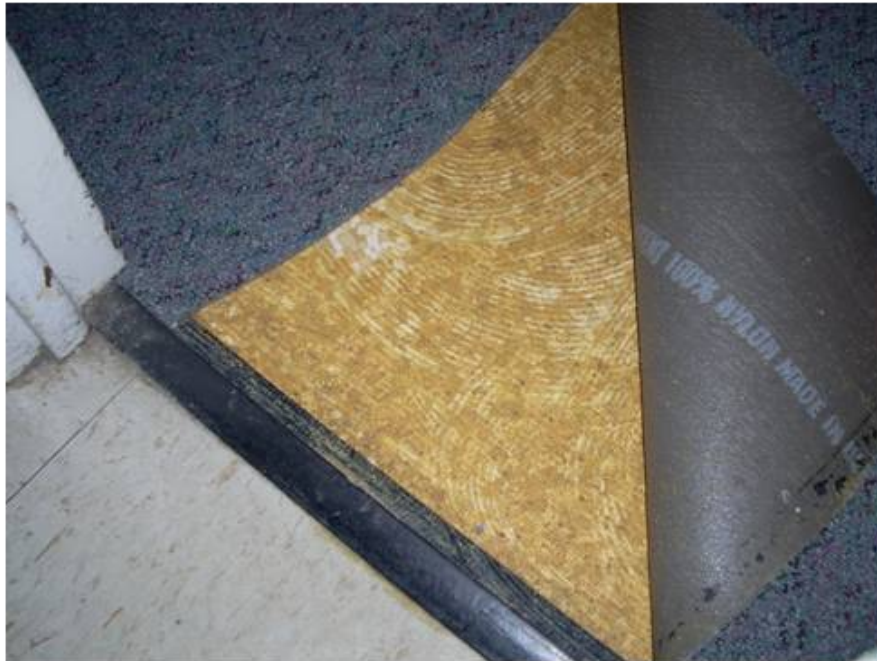
Sheet Flooring Under Carpet, Sample 32A

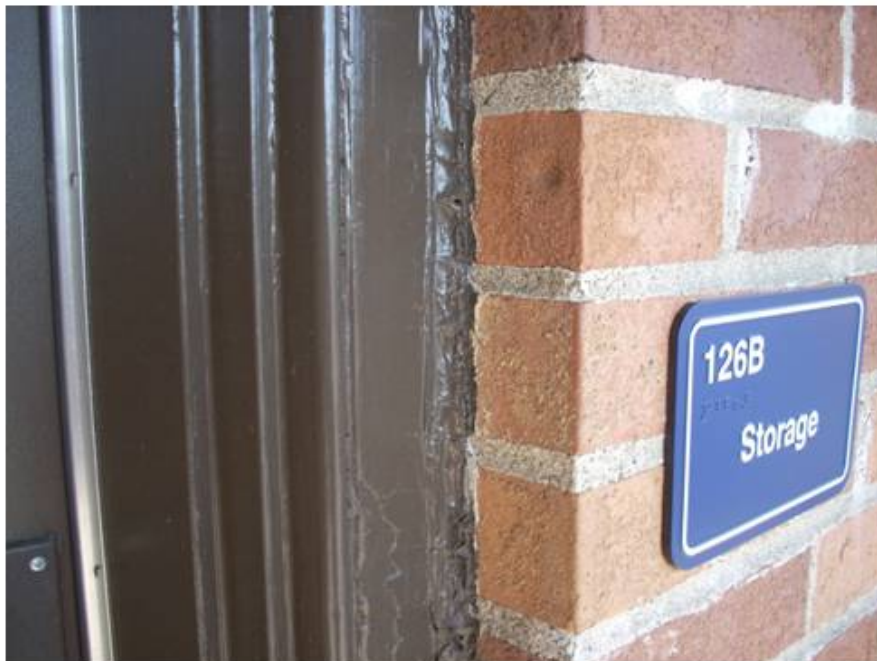
Old Door Frame Caulk, Sample 41B

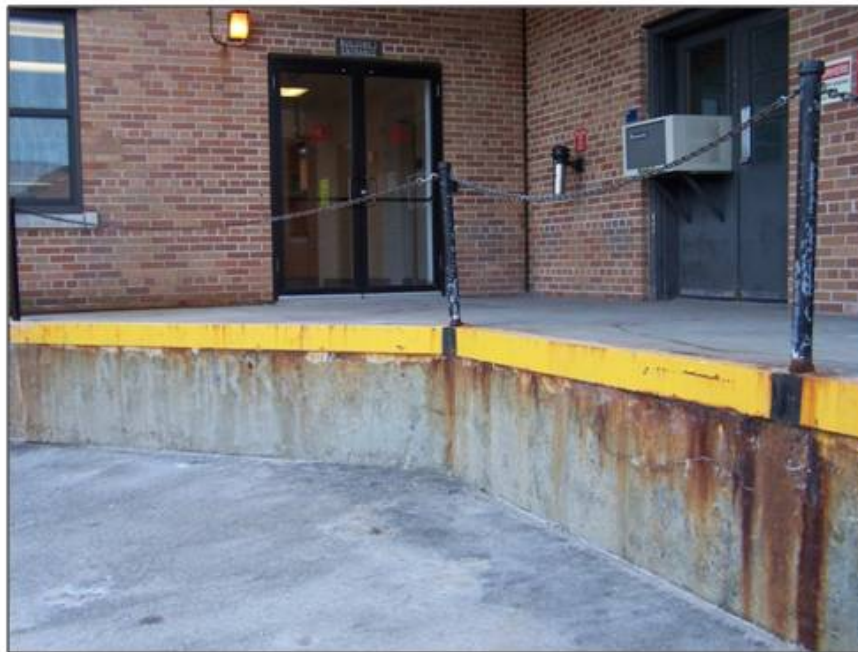
Concrete Trim and Metal Handrail, Readings 429 and 430

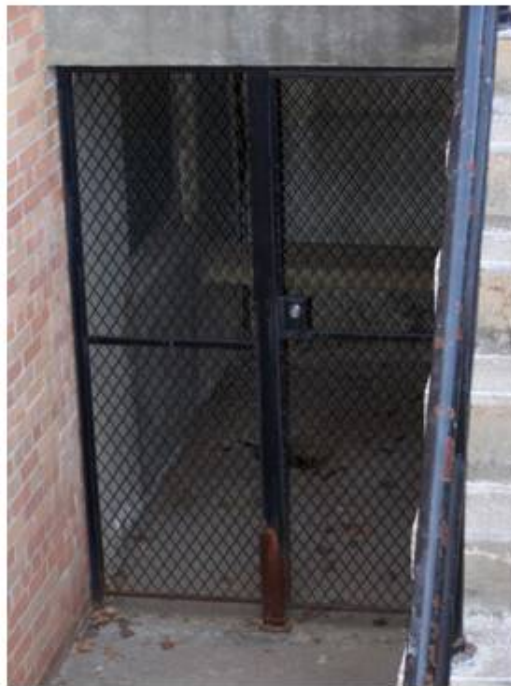
Metal Safety Gate, Reading 432 and 433

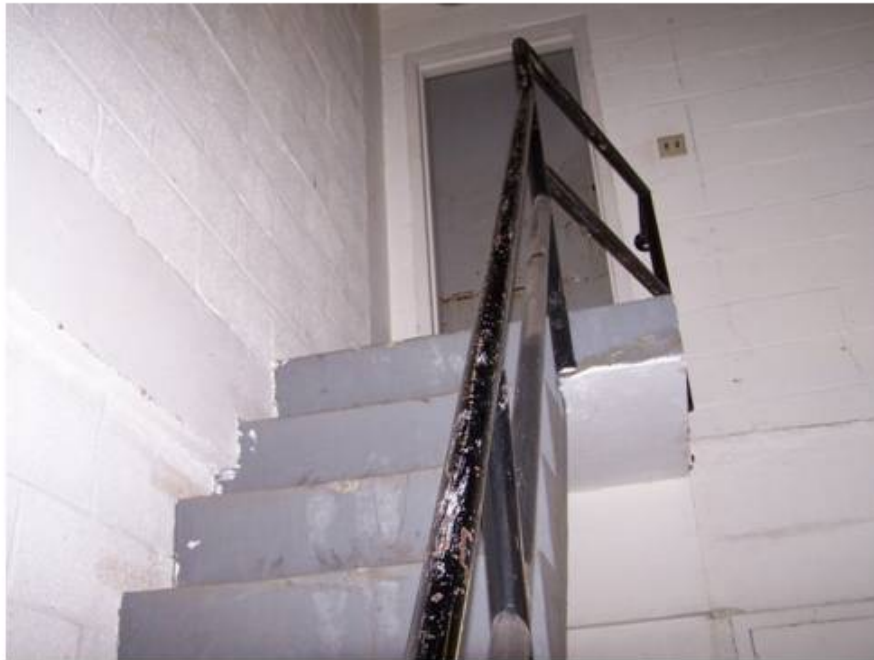
Metal Handrail, Reading 457

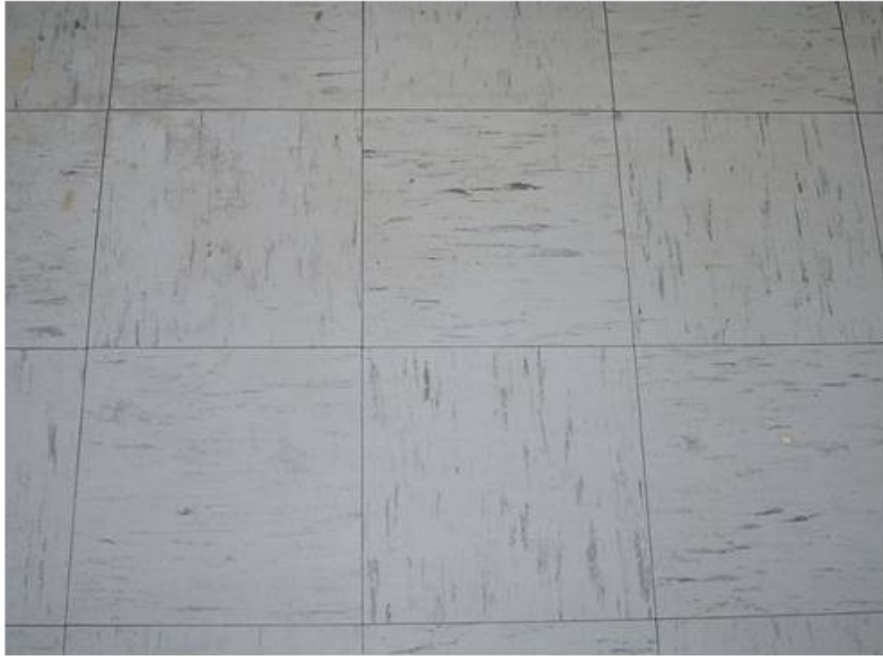
9"x9" Gray Floor Tile and Mastic, Samples 18A, 19A

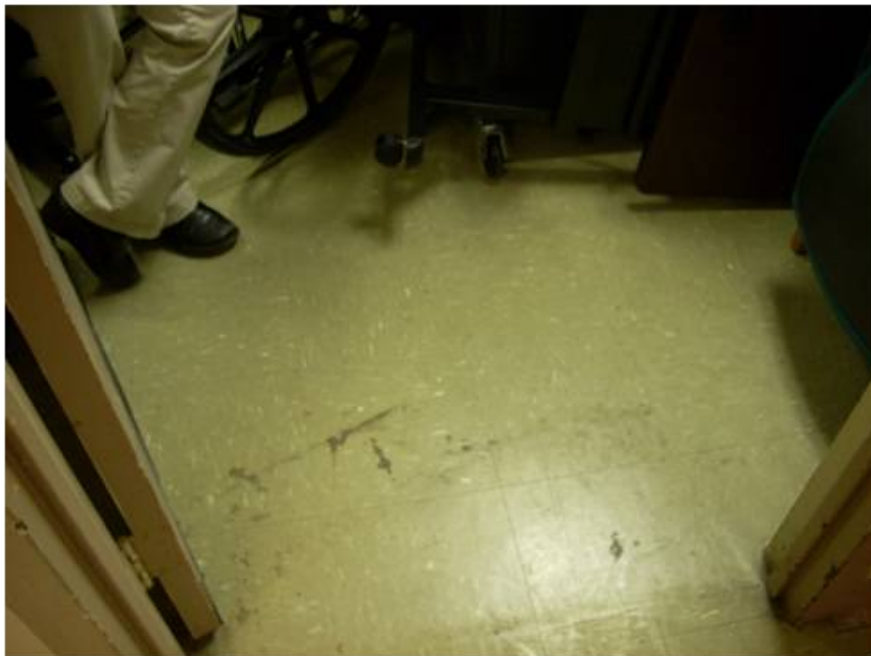
12"x12" Green Floor Tile, Sample 29A

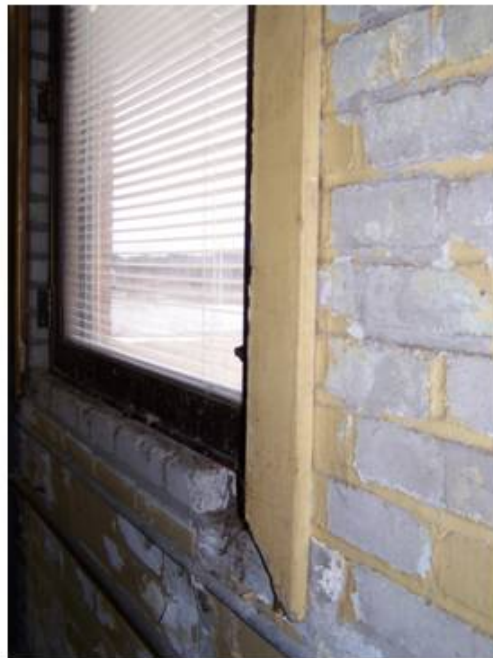
Wood Window Casing, Reading 1269

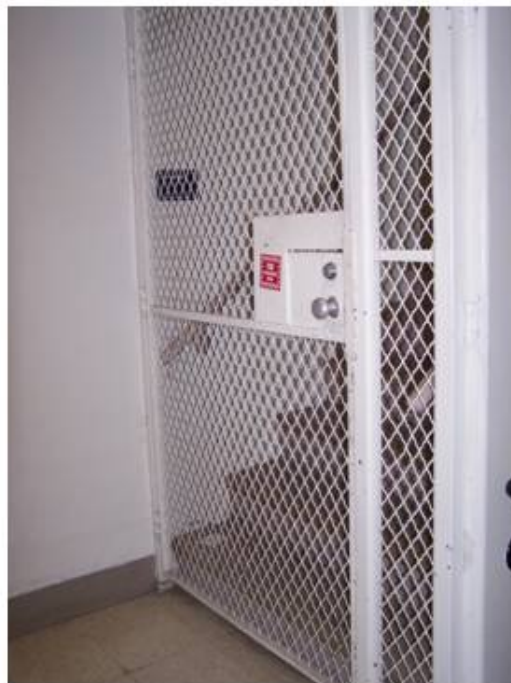
Metal Security Gate, Reading 1397

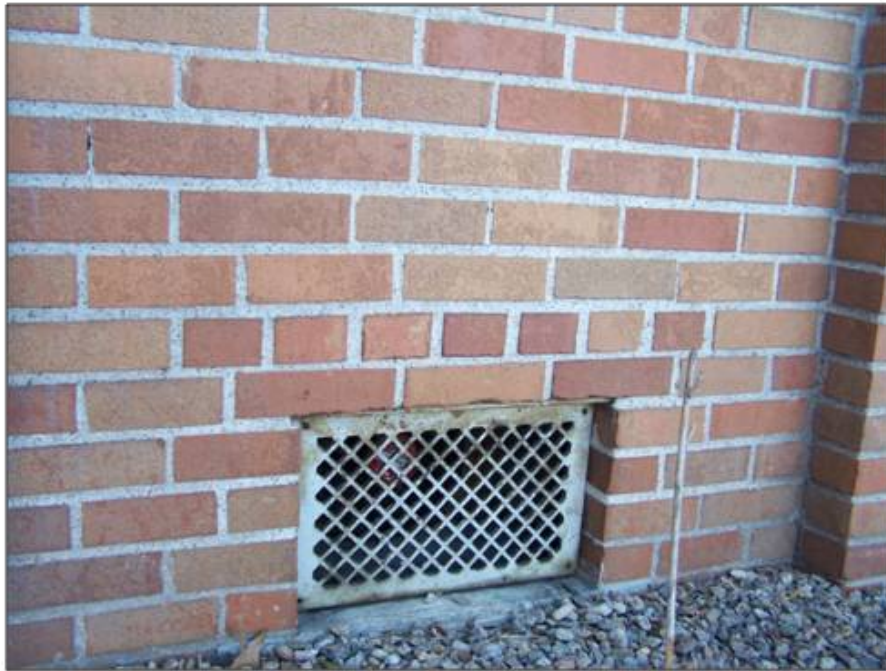
Metal Vent, Reading 1405

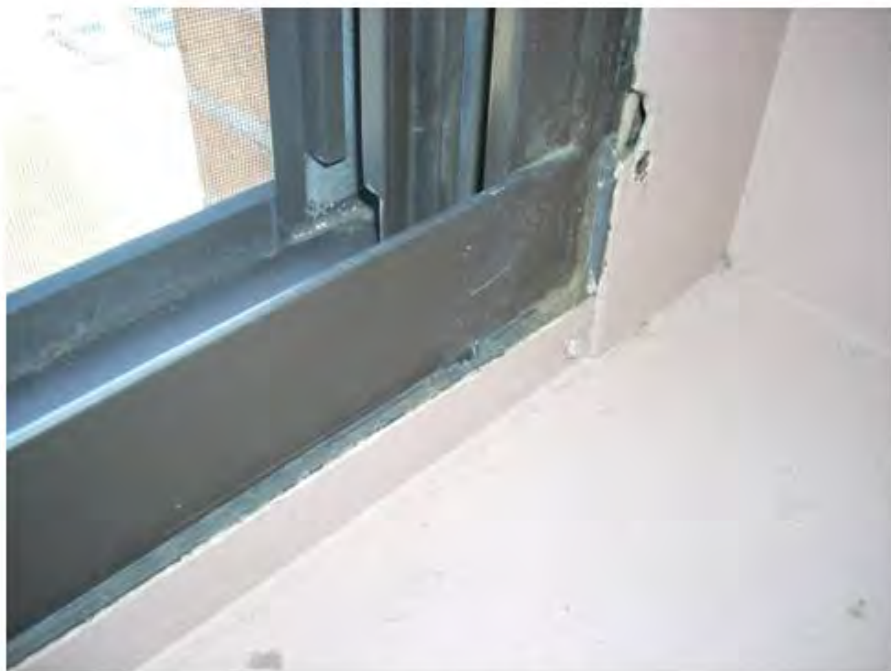
Window Caulk, Sample 8A

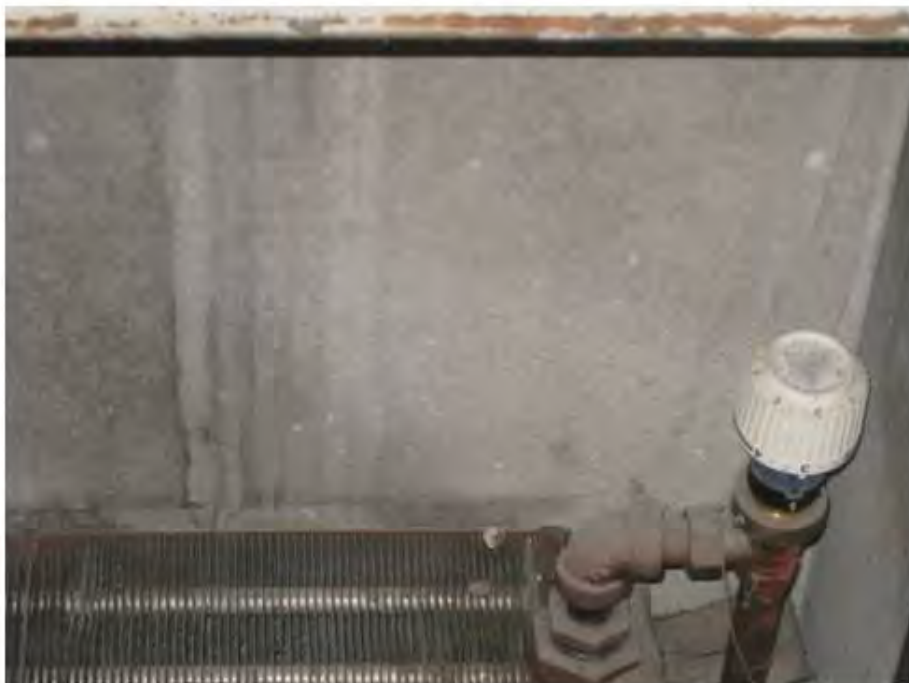
Transite Heater Panel, Sample 13A

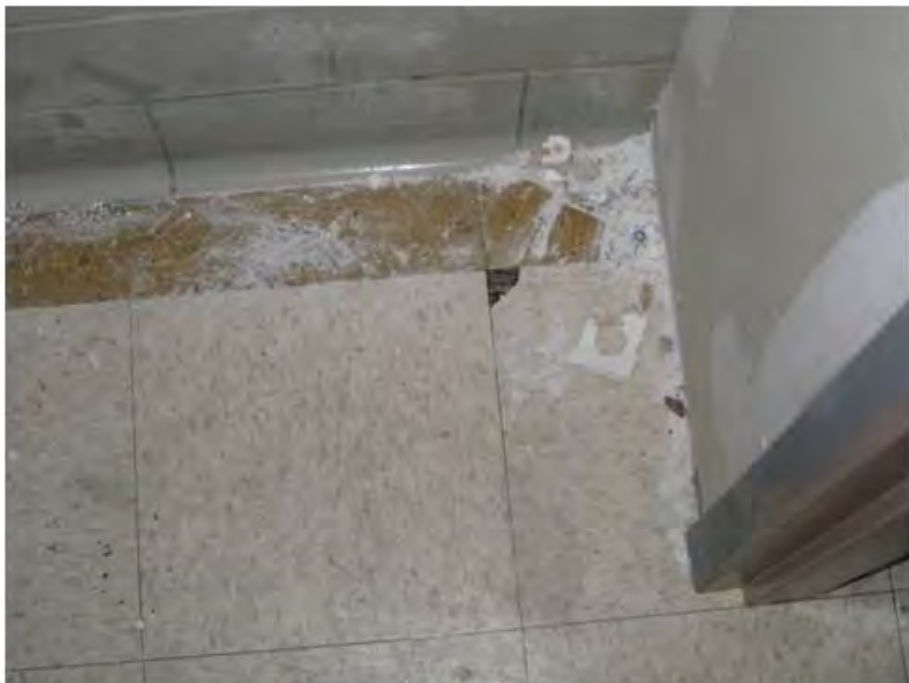
12"x12" Floor Tile and Mastic (6<sup>th</sup> Floor Old), Samples 31A and 32A

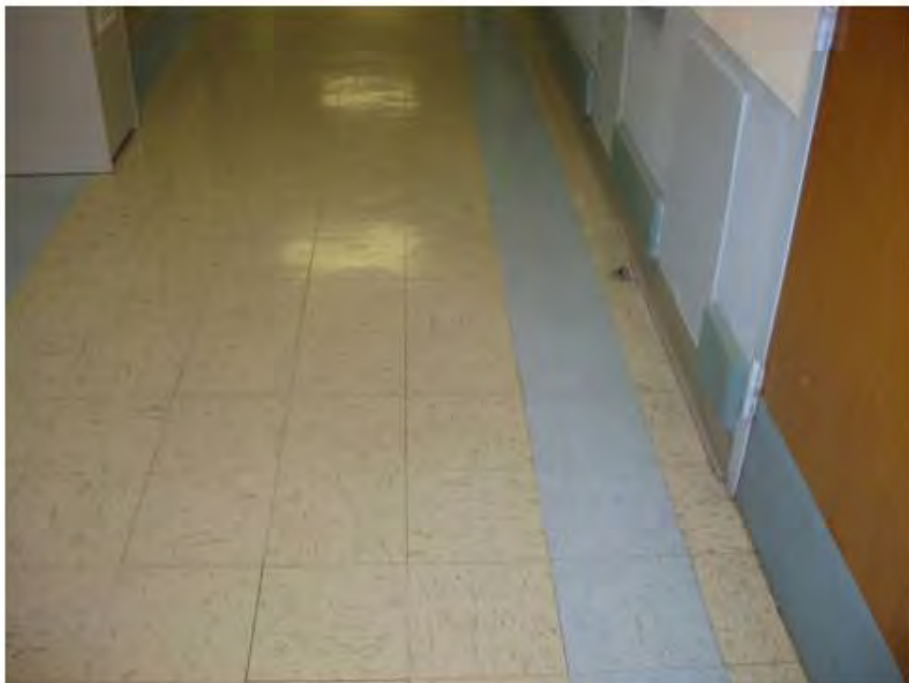
12"x12" Floor Tile and Mastic (5<sup>th</sup> Floor New), Samples 39A and 40A

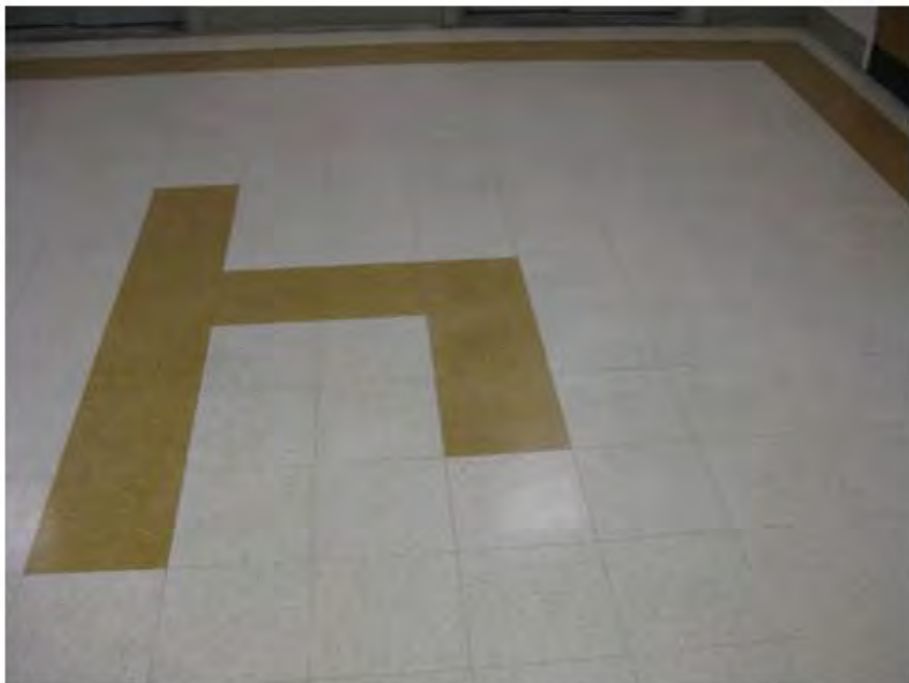
12"x12" Floor Tile and Mastic (4<sup>th</sup> Floor Old), Samples 45A and 46A

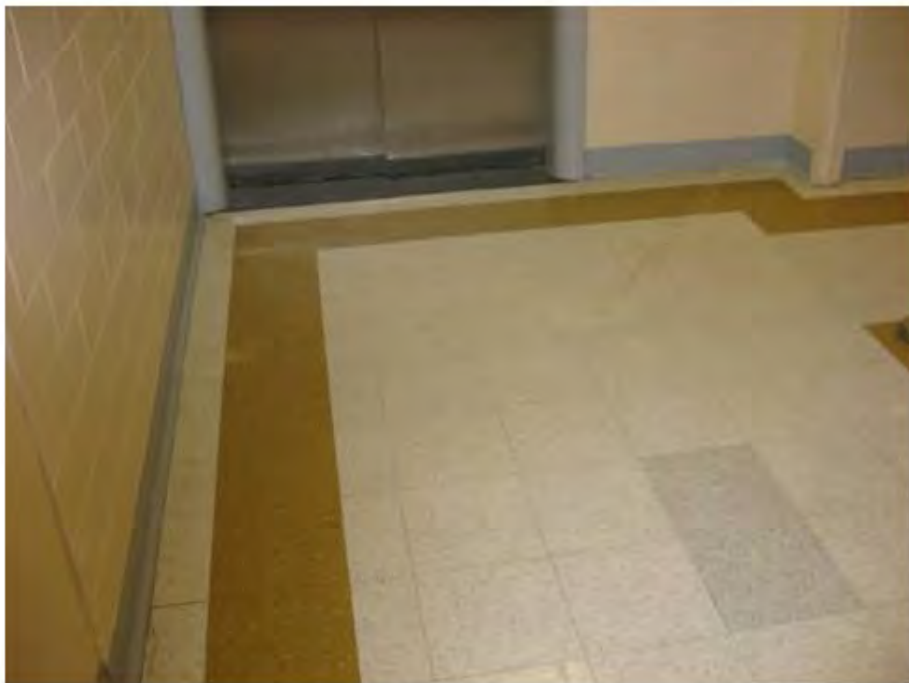
12"x12" Floor Tile (2<sup>nd</sup> Floor Old), Sample 55A

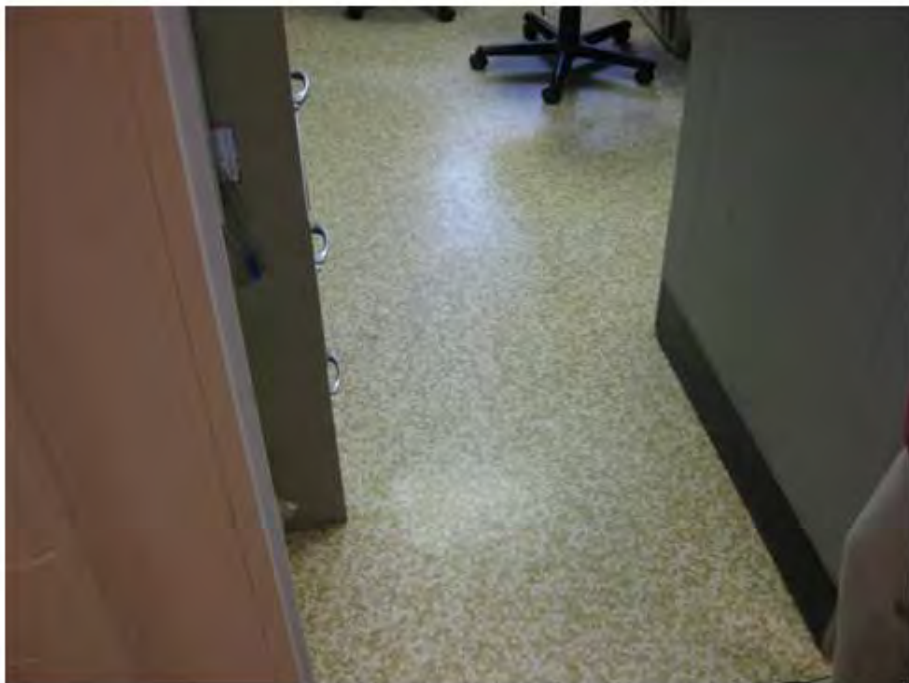
Sheet Flooring-Type II (Old), Sample 62A

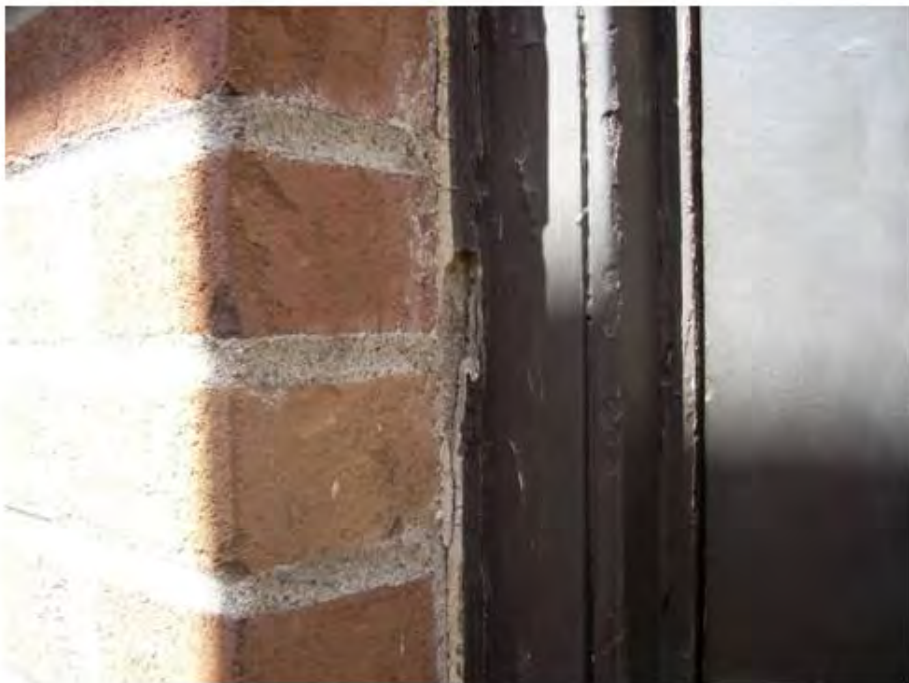
Door Frame Caulking, Sample 71A

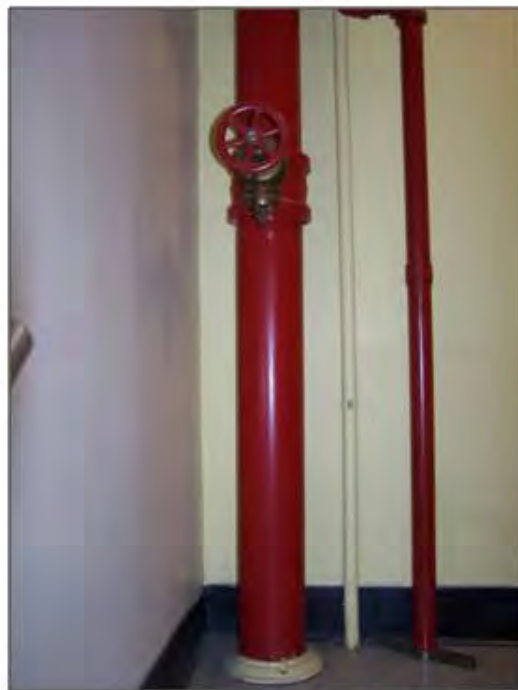
Metal Sprinkler Pipe, Reading 877

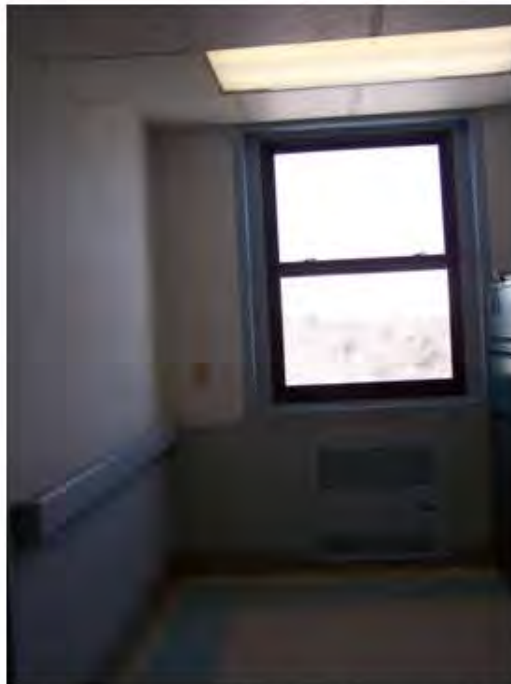
Metal Window Casing and Sill, Readings 885 and 886

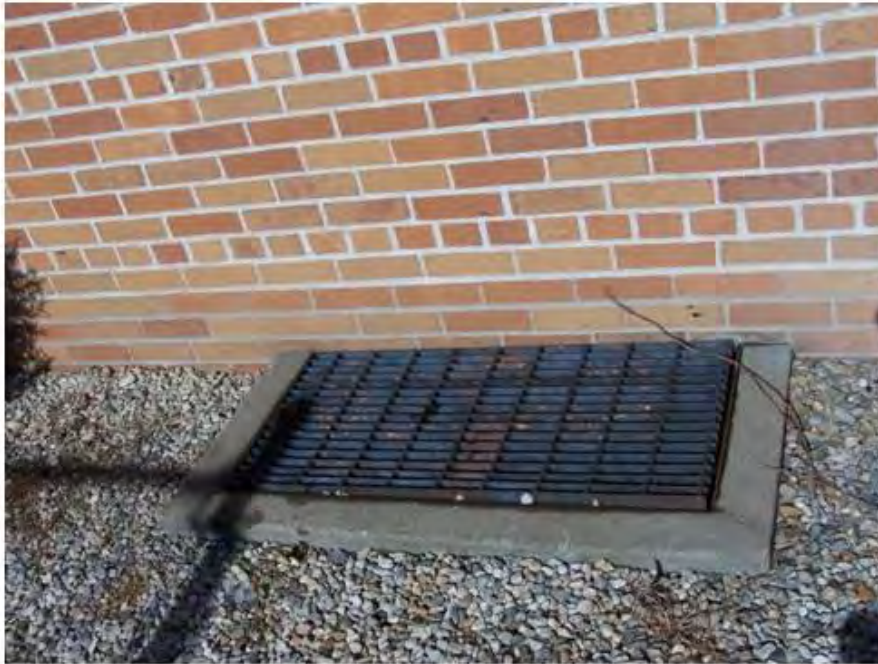
Metal Window Well Security Gate, Reading 1228

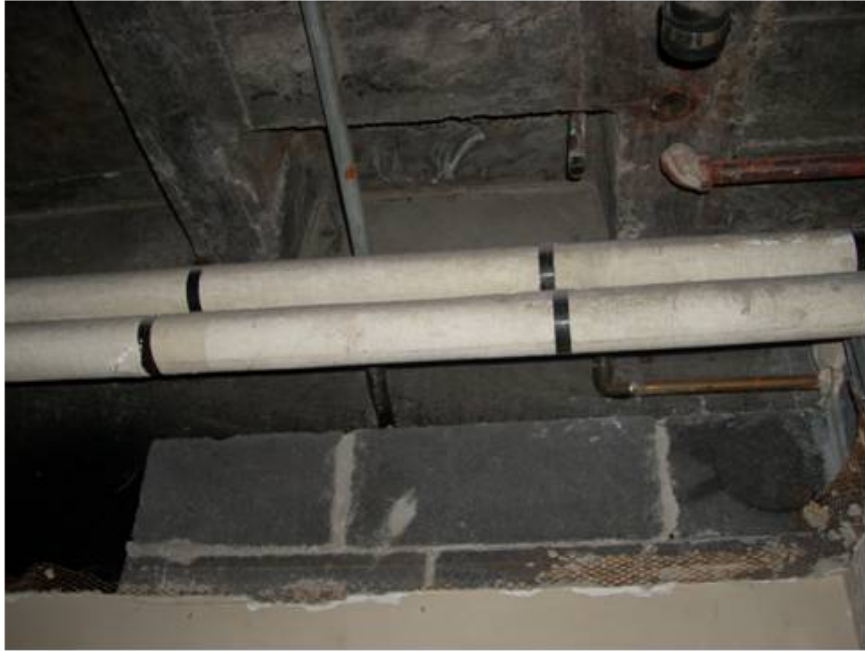
Pipe Insulation, Samples 2A and 2B

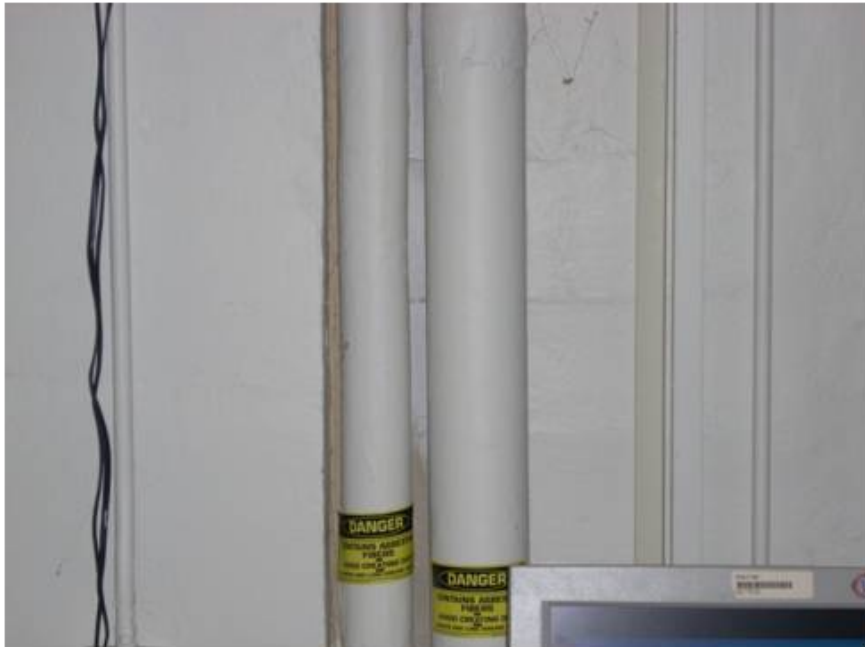
Pipe Insulation, Sample 2C

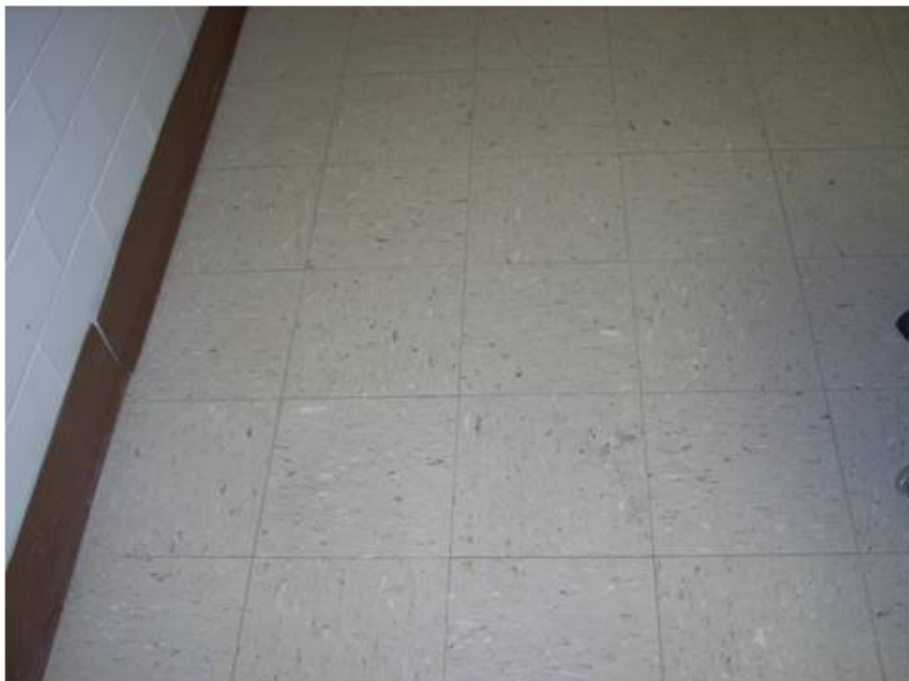
12"x12" Light Brown Floor Tile and Mastic, Samples 29A and 30A

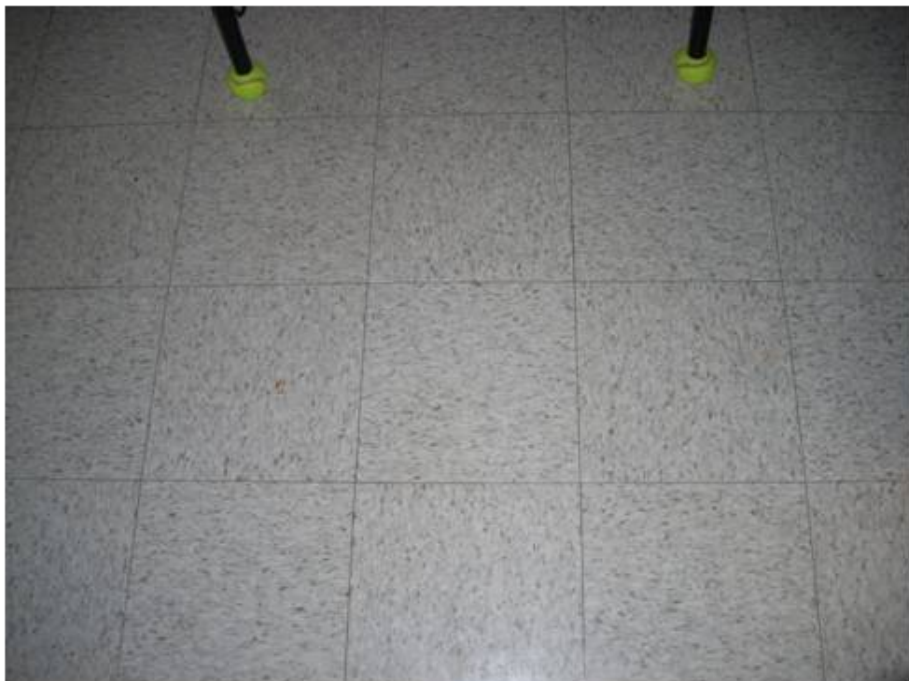
Mastic Associated with 12"x12" Gray Floor Tile Type II, Sample 36A

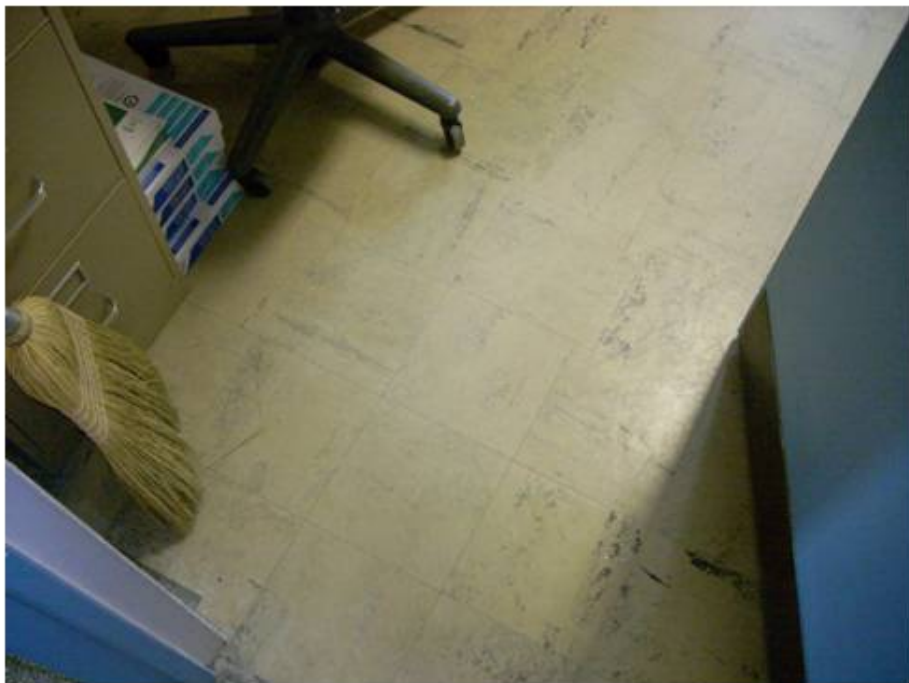
9"x9" Tan Floor Tile, Sample 42A

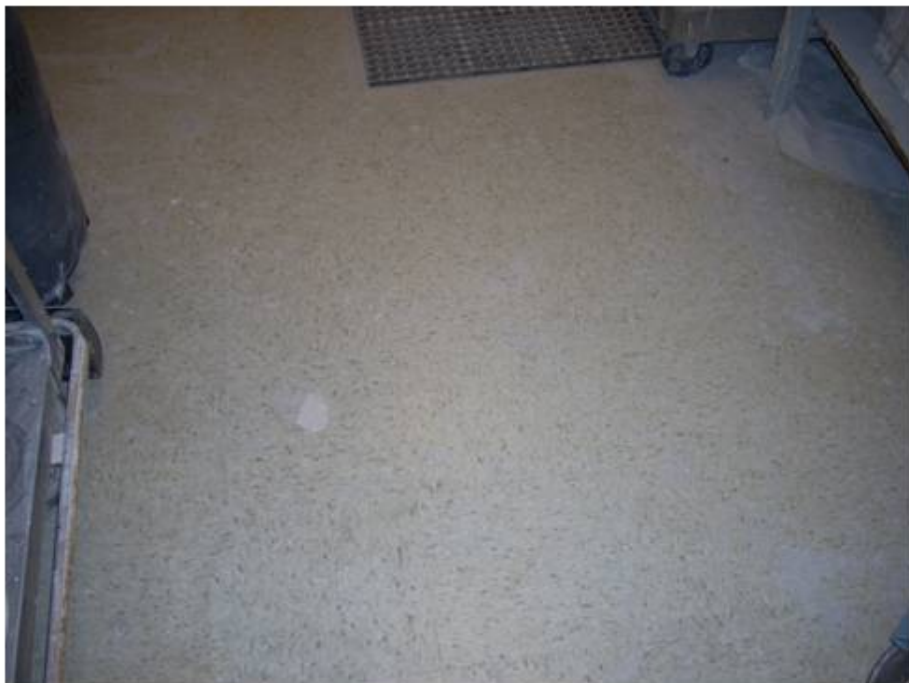
Mastic Associated with 12"x12" Light Green with Brown Spots Floor Tile, Sample, 47A

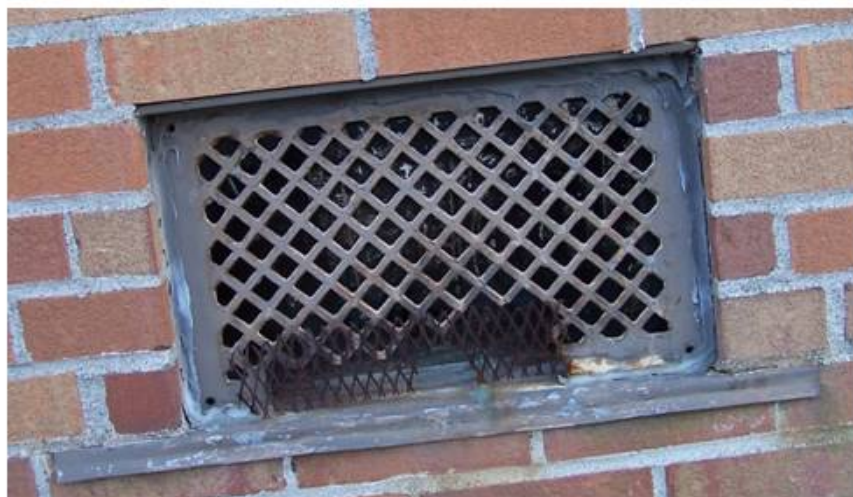
Metal Vent, Reading 1616

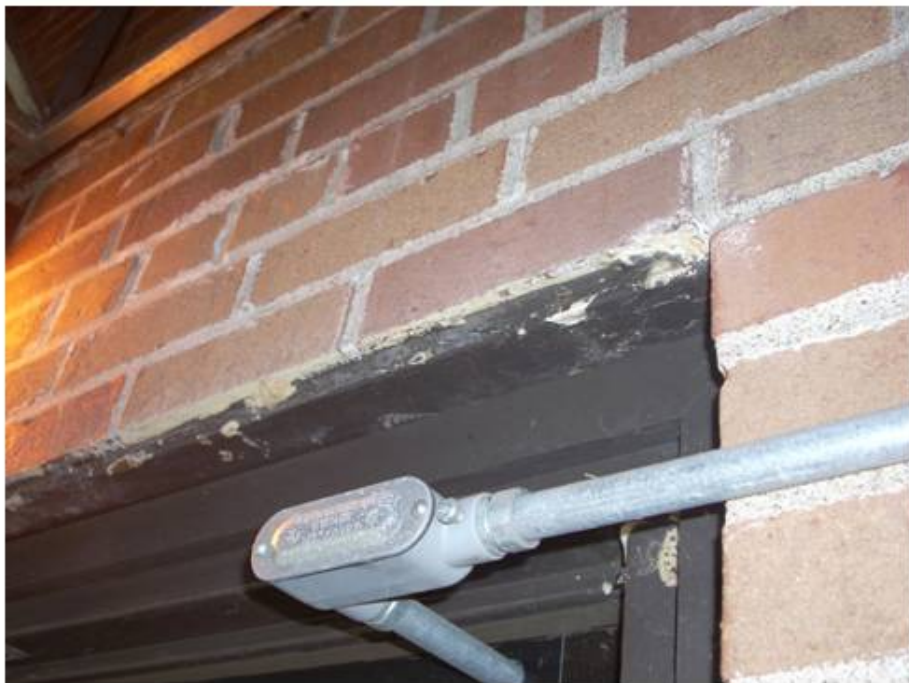
Exterior Door Caulking, Sample 20A

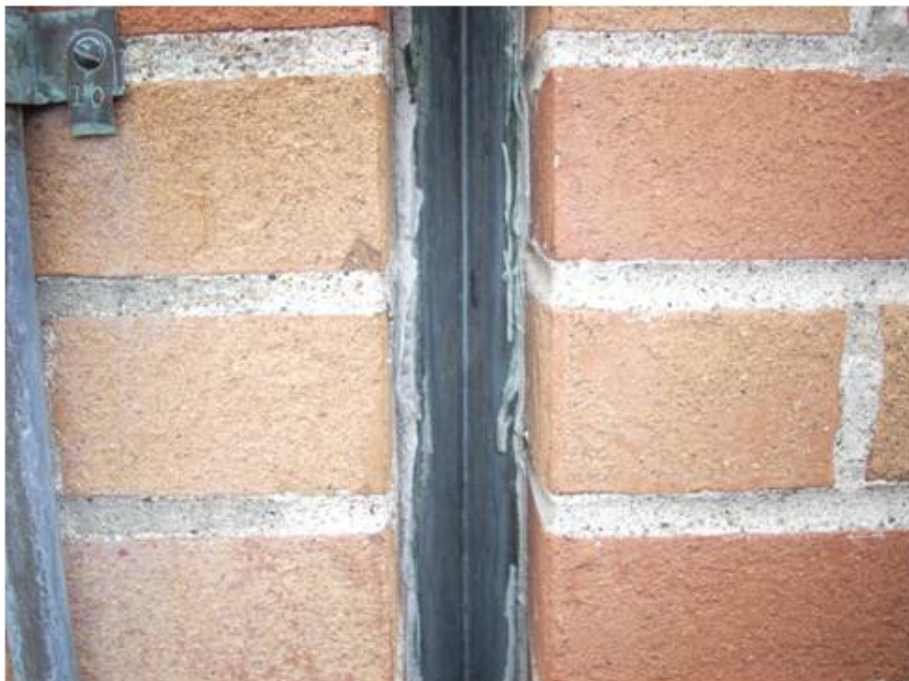
Expansion Joint Caulking, Sample 22A

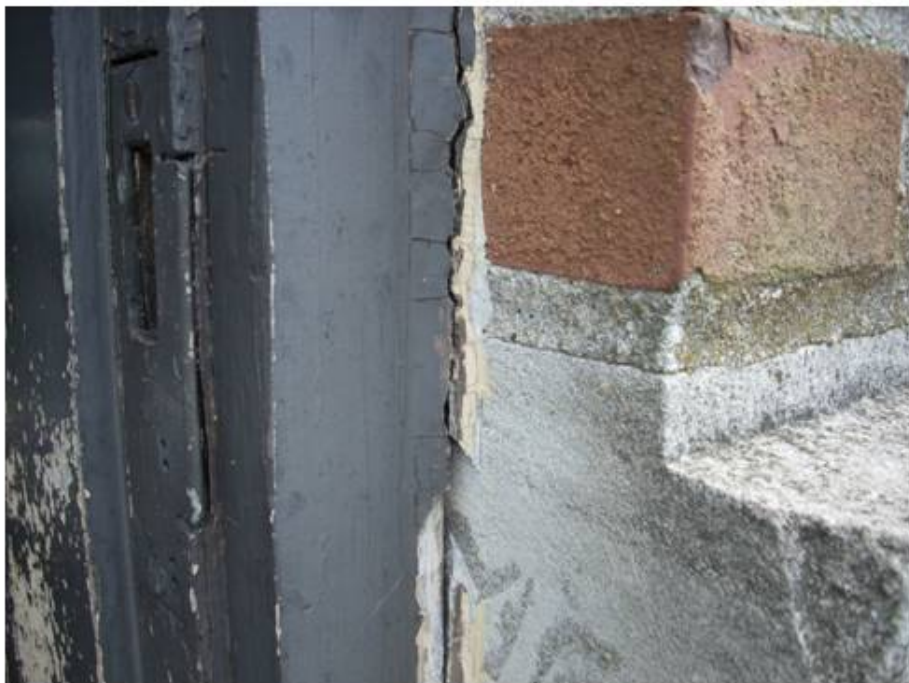
White Door Caulking (Exterior), Sample 24C

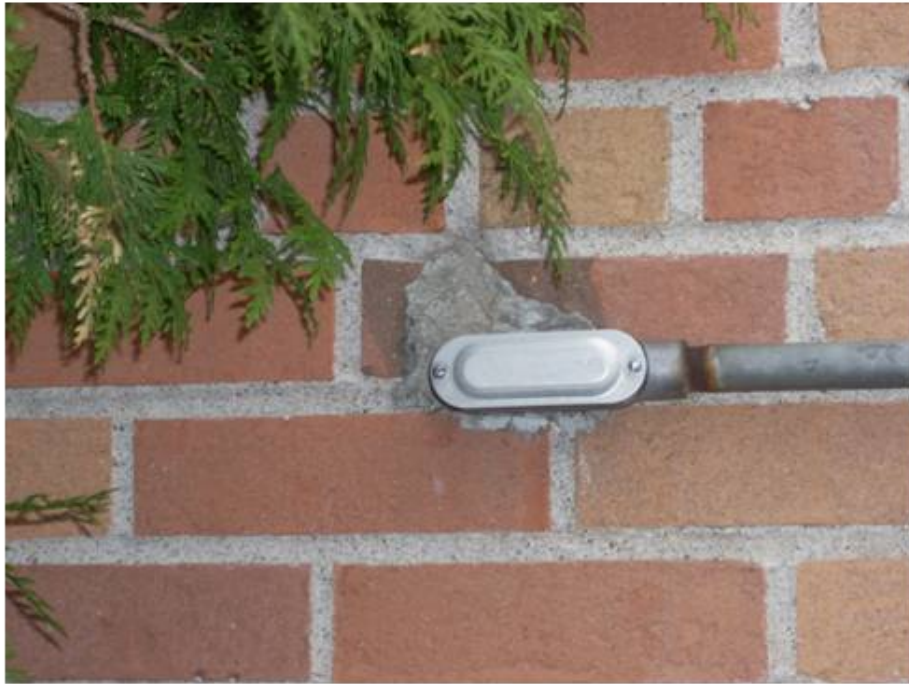
Penetration Caulking, Sample 25

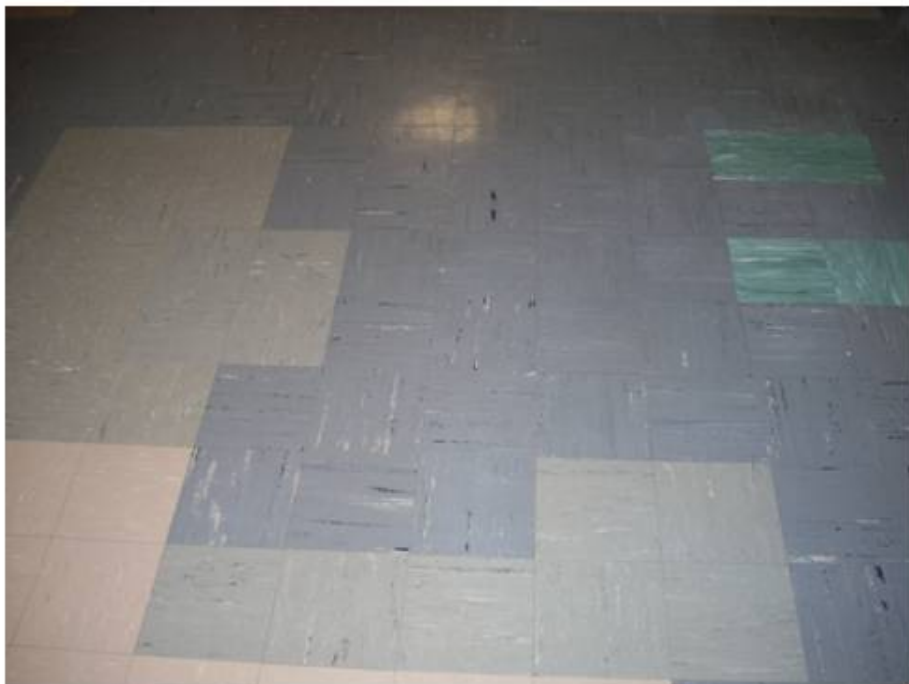
9"x9" Gray Floor Tile, Sample 26A

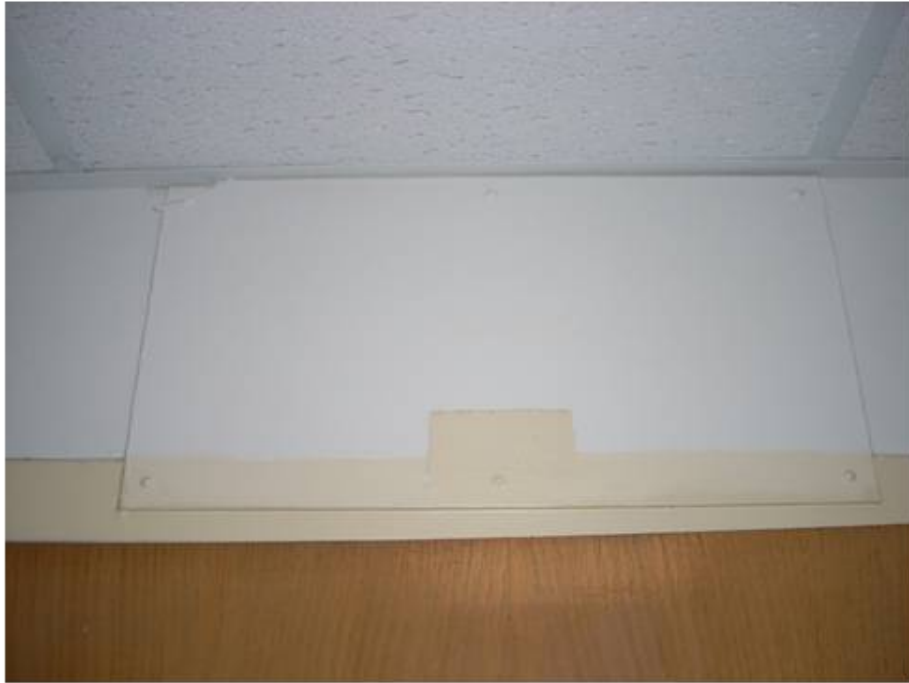
Transite Panel Above Door – Identified in previous survey and verified in the field

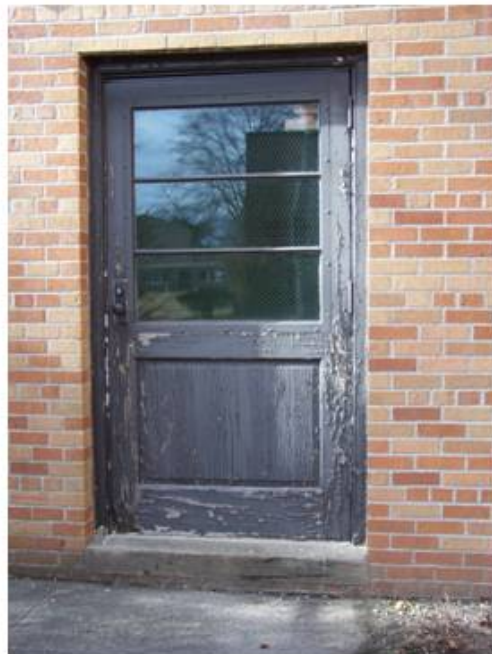
Wood Door and Wood Door Casing, Readings 211 and 212

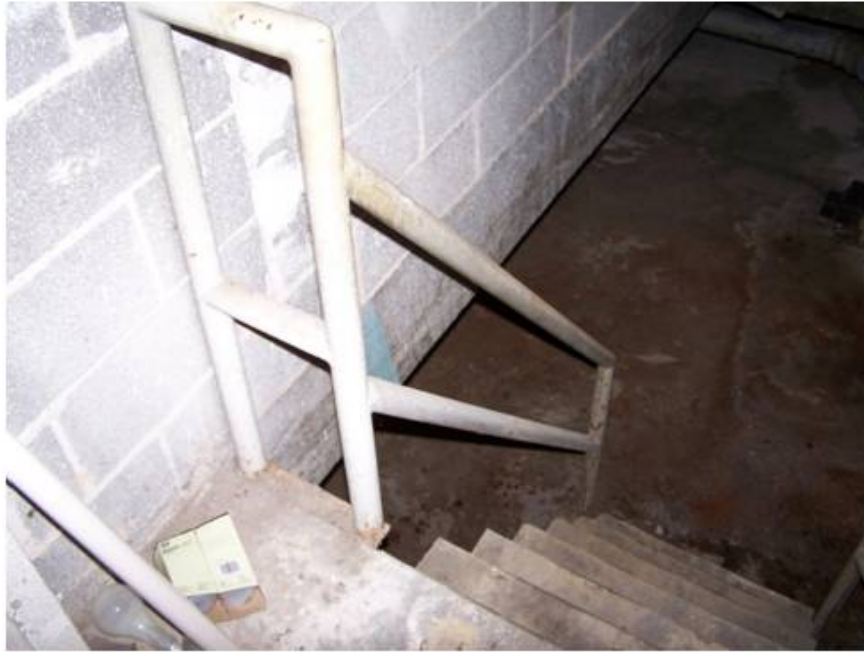
Metal Handrail, Reading 2400
