## **VOLUME II ASBESTOS CONTAINING MATERIAL & LEAD CONTAINING PAINT SURVEY REPORTS**

**VISN 1**  
**Brockton VA Medical Center**  
940 Belmont Street  
Brockton, Massachusetts

Project No. 2009023.003

June 21, 2010

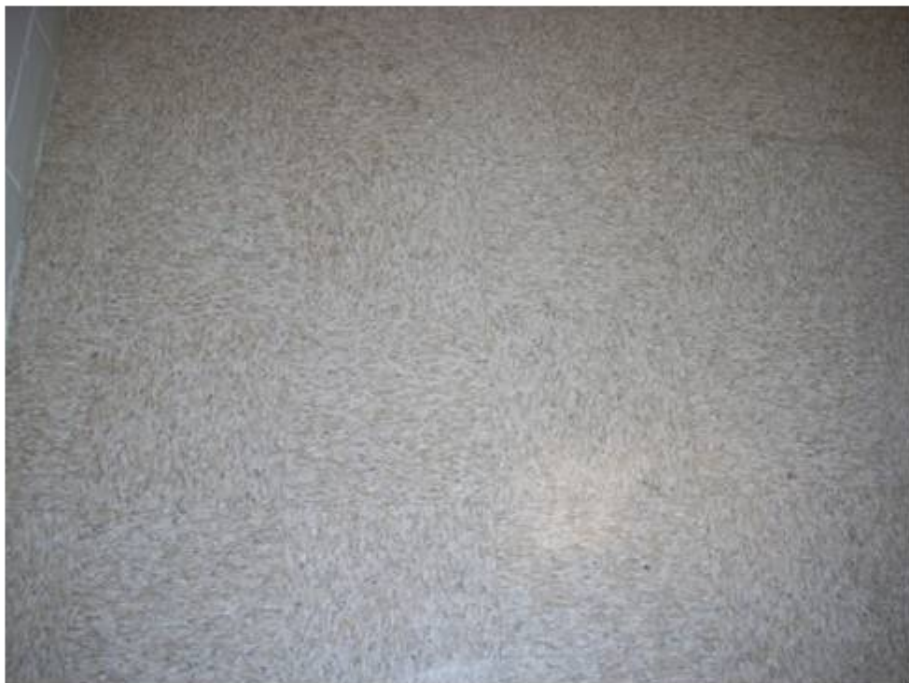
Mastic Associated with 12"x12" Brown Marble Floor Tile, Sample 13B

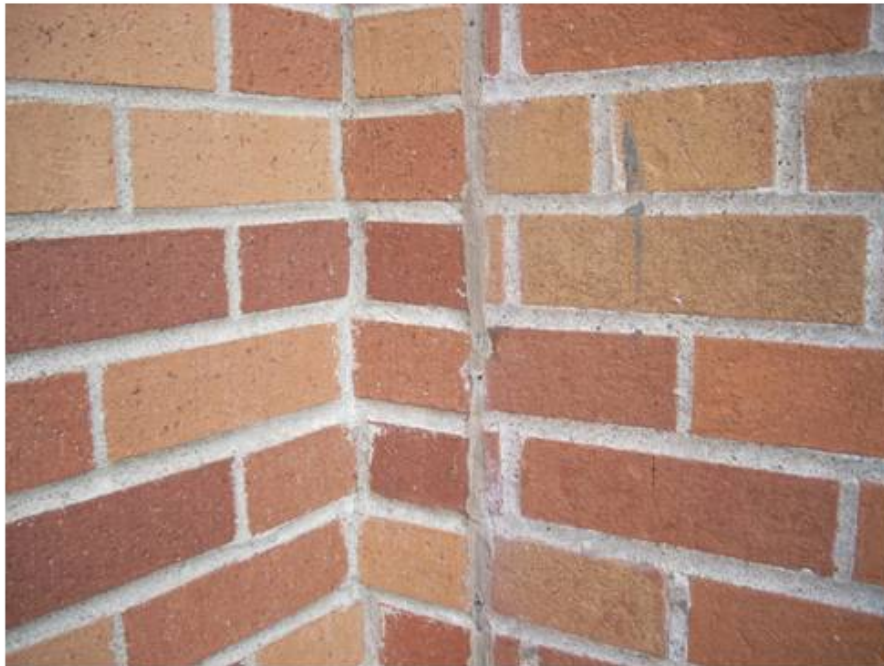
Exterior Expansion Joint, Sample 31B

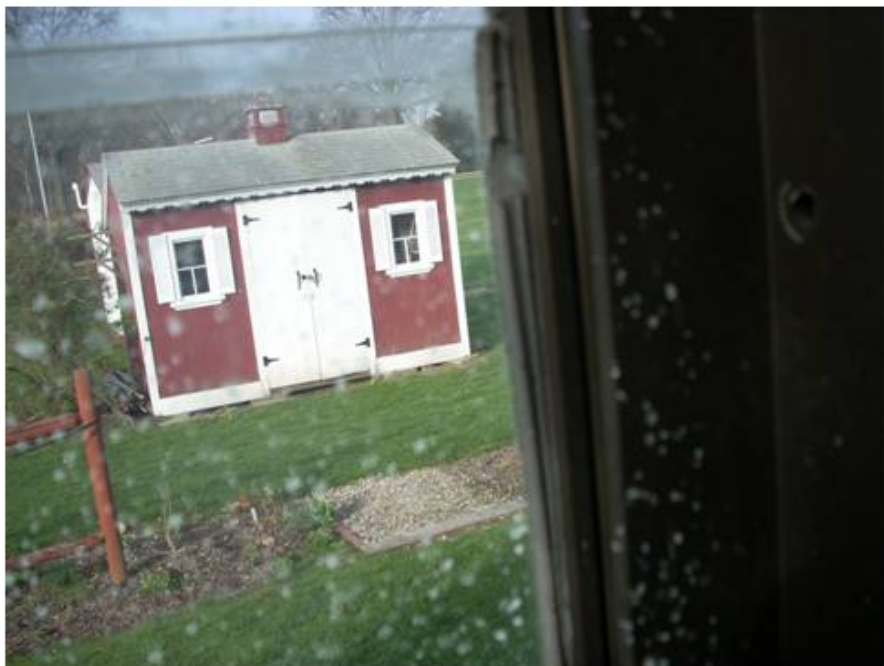
Table 2 - Summary of Positive ACM Samples Brockton VA Medical Center, Building 7							
Sample No.	Sample Location	ACM Location	Description of Material	Percent and Type of Asbestos	Estimated Quantity	Condition	VISN 1 RISK AHERA Hazard Category 1-4*
8A	8	Throughout Basement, First and Second Floors	12"x12" Tan With Brown Spots Floor Tile Mastic	10% Chrysotile	54,000 SF	Good	4
8B	B101						
8C	4						
13B	A106		12"x12" Brown Marble Floor Tile	10% Chrysotile		Good	4
13C							
28A	A106		12"x12" Brown Floor Tile Mastic	10% Chrysotile		Good	4
28B	Hallway						
28C	Lobby						
31B	Exterior	East Side Expansion Joints	Caulking Material	5% Chrysotile	1,200 LF	Good	4
31C	Exterior						
32C	Greenhouse	Greenhouse Windows	Interior Window Glazing	5% Chrysotile	2,100 LF	Good	4

Interior Window Glazing, Sample 32C

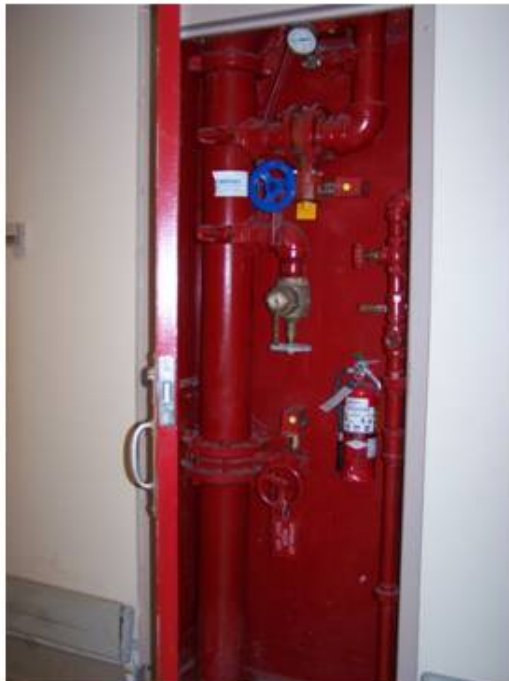
Wood Door, Reading 1935

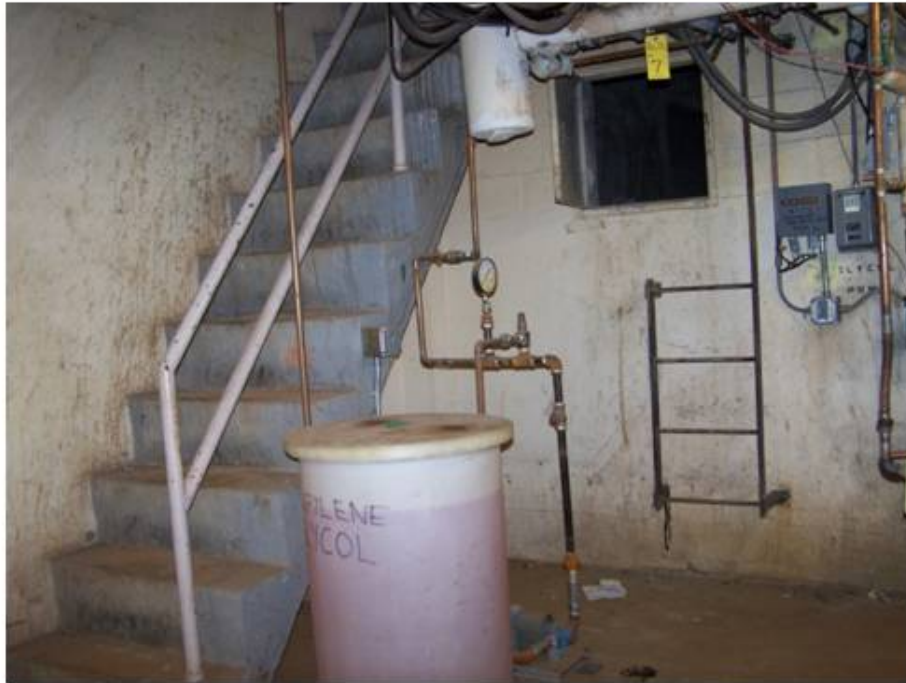
Metal Ladder, Reading 1958

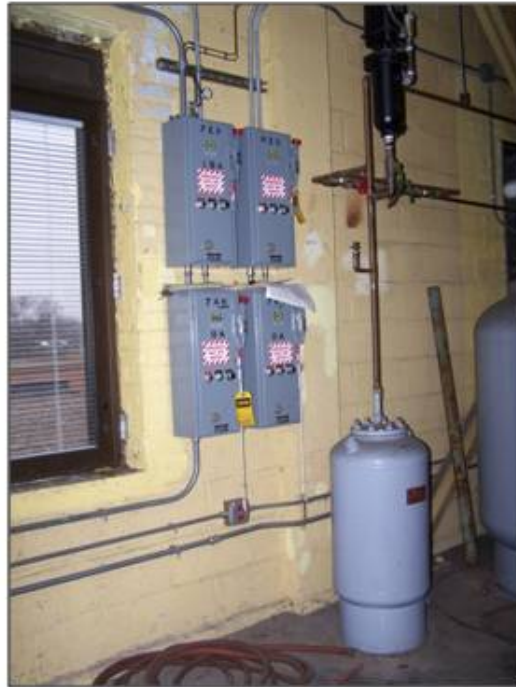
Concrete Column, Reading 2188

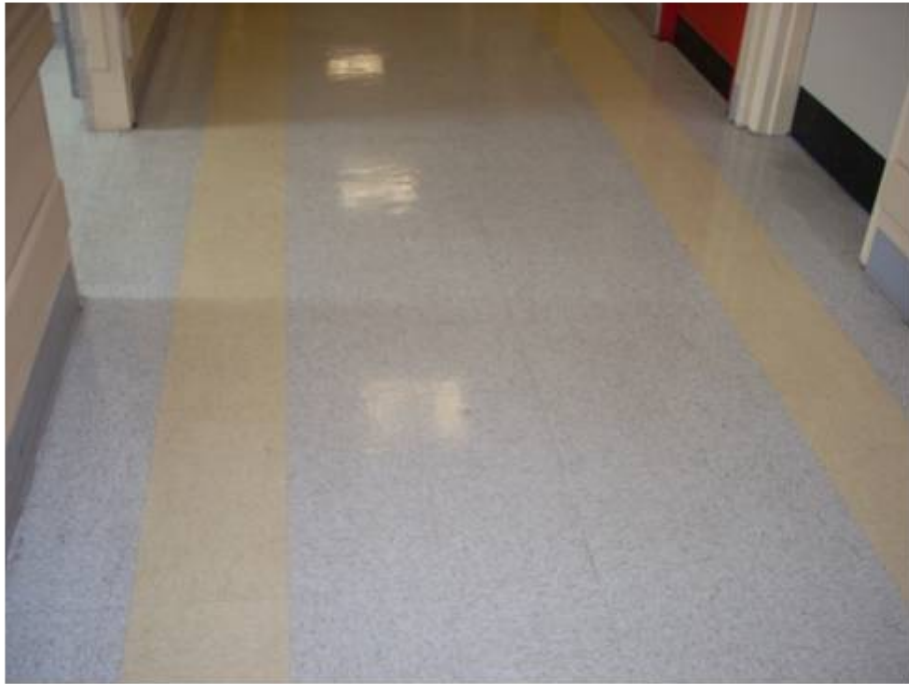
Mastic Associated with 12"x12" Shelter White Floor Tile, Sample 3A

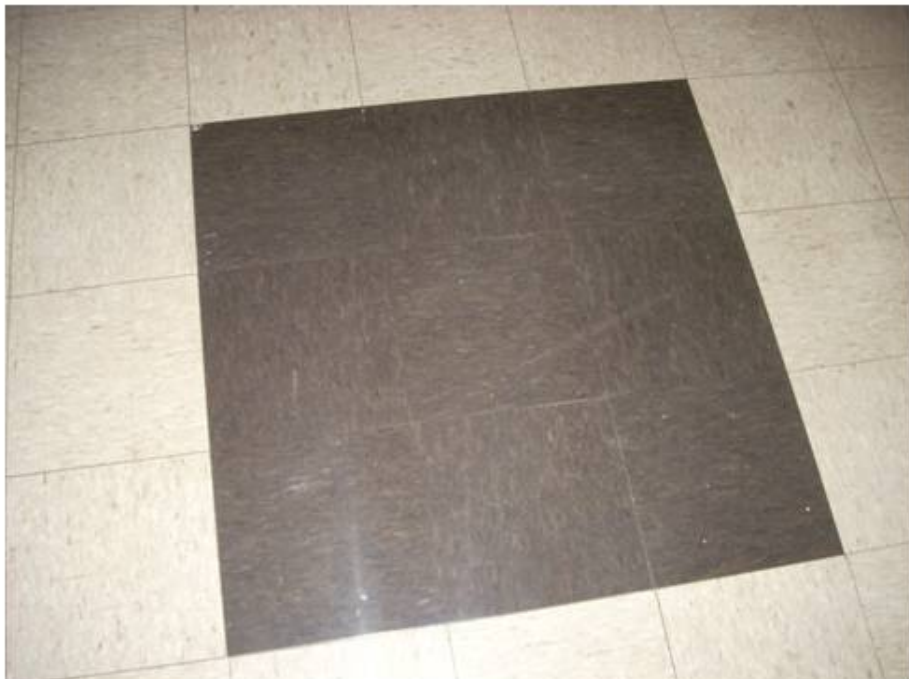
12"x12" Black Floor Tile and Mastic, Samples 13A and 14A

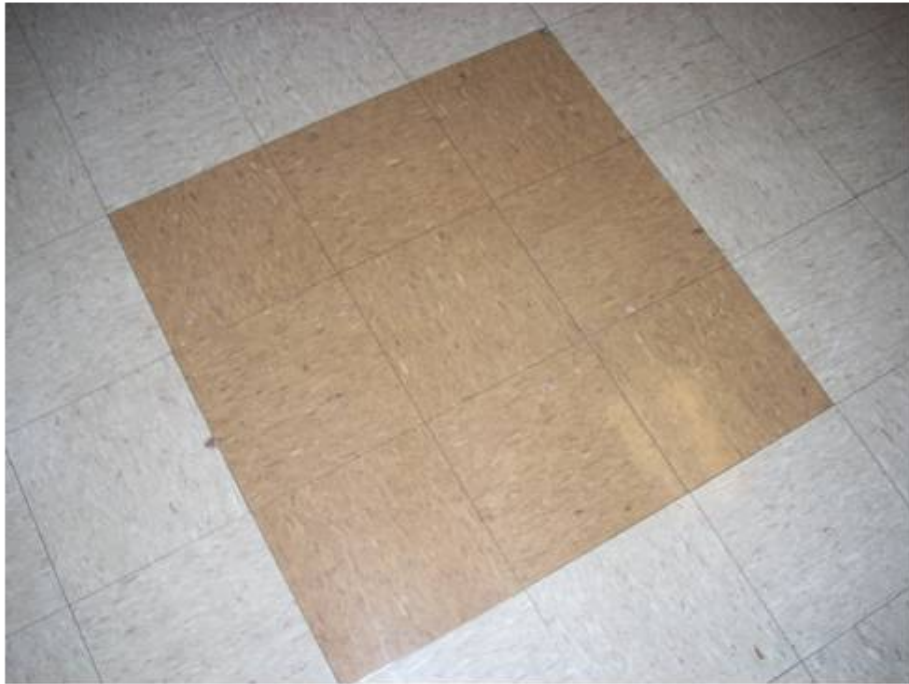
12"x12" Orange Floor Tile and Mastic, Samples 15A and 16A

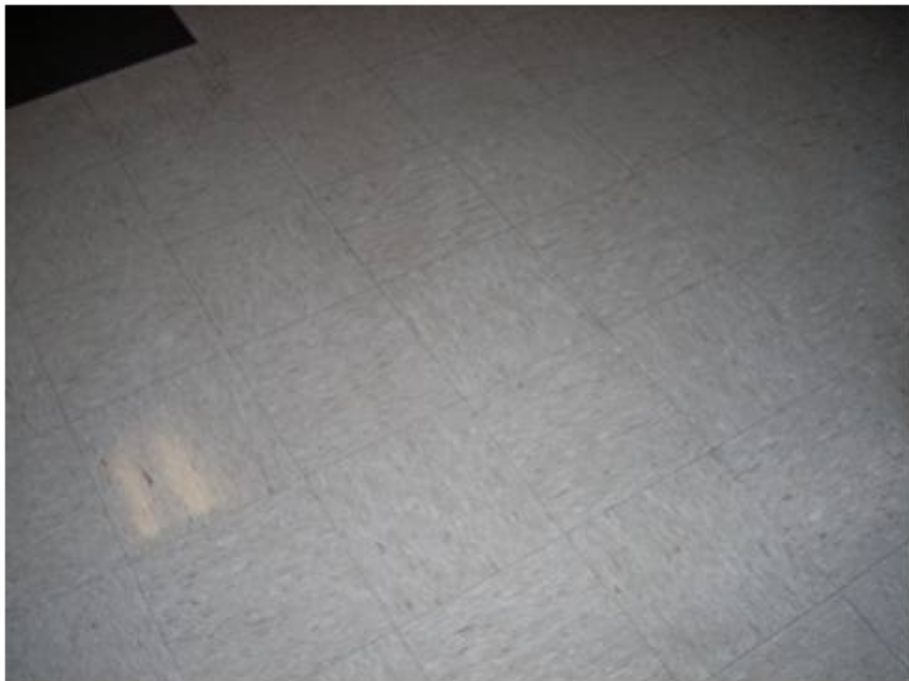
12"x12" Light Brown Floor Tile and Mastic, Samples 17A and 18A

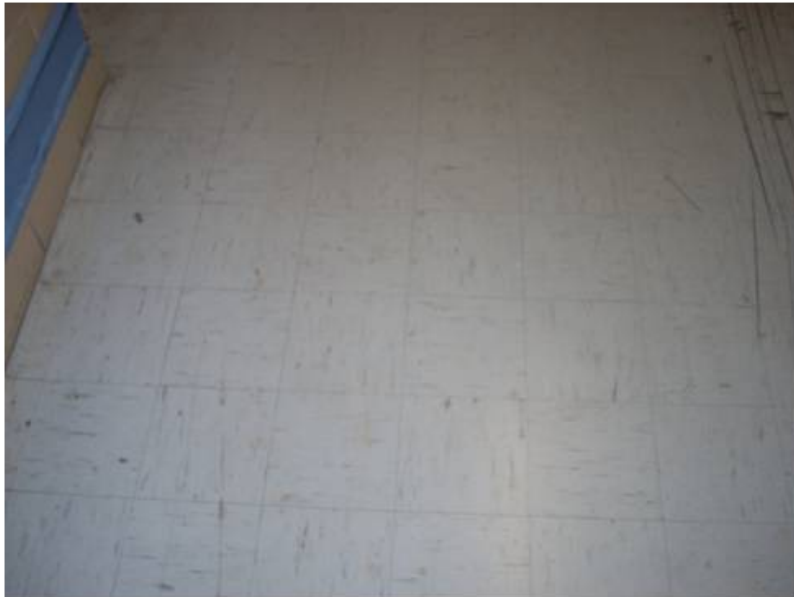
9"x9" White Floor Tile and Mastic, Samples 23A and 24A

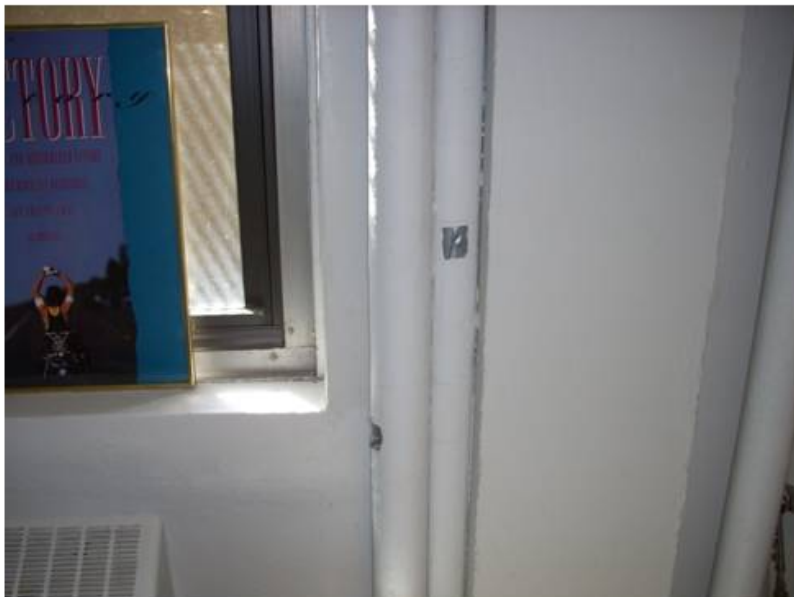
Pipe Insulation, Sample 33A

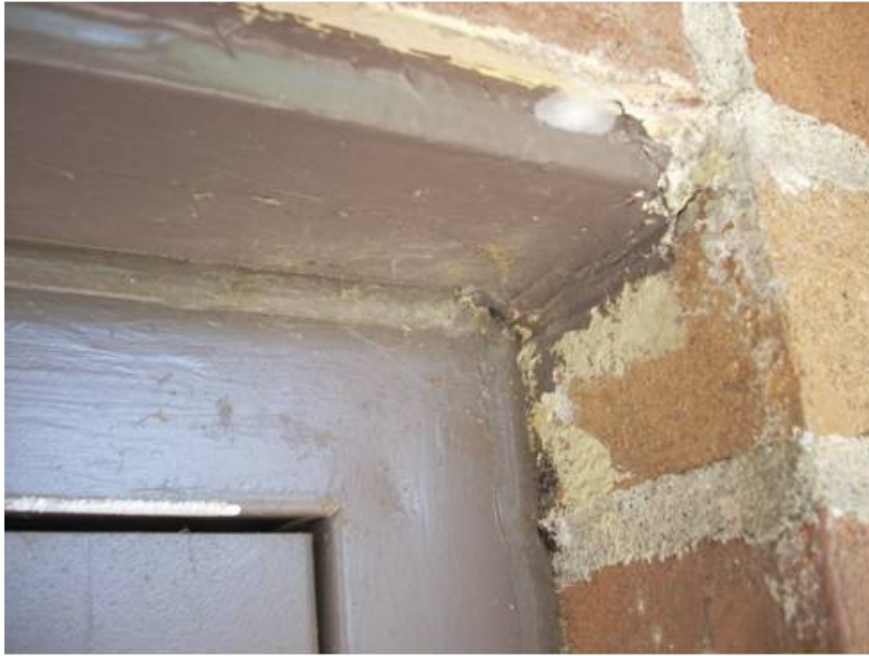
Exterior Door Caulk, Sample 37B

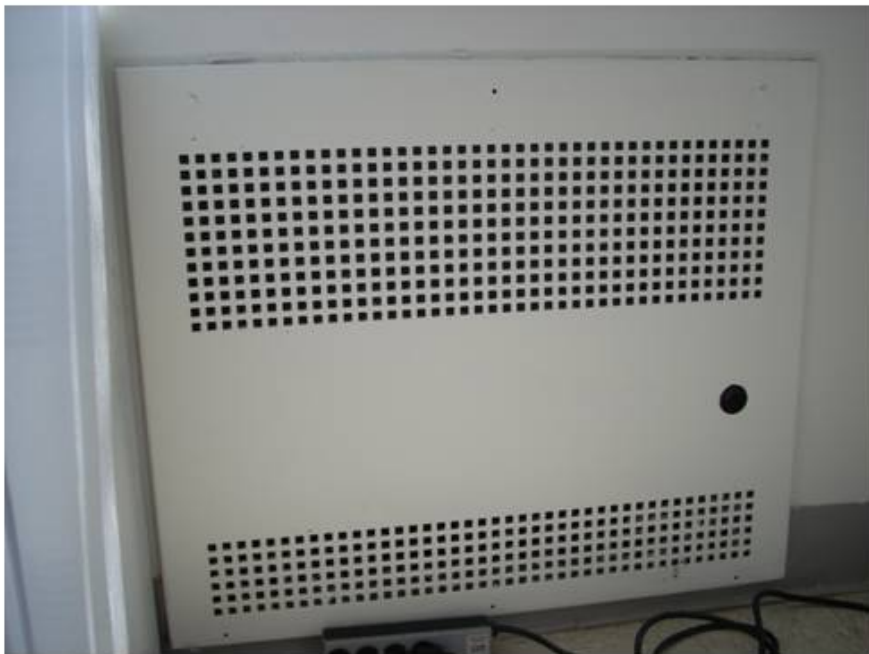
Transite Panel at Radiators

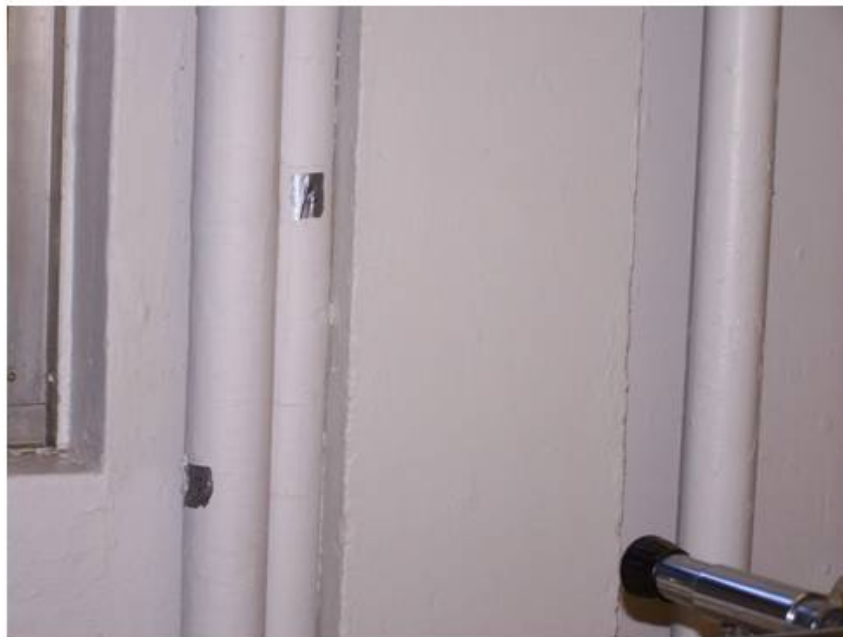
Pipe Insulation White Block Pipe Insulation, Reading 1836

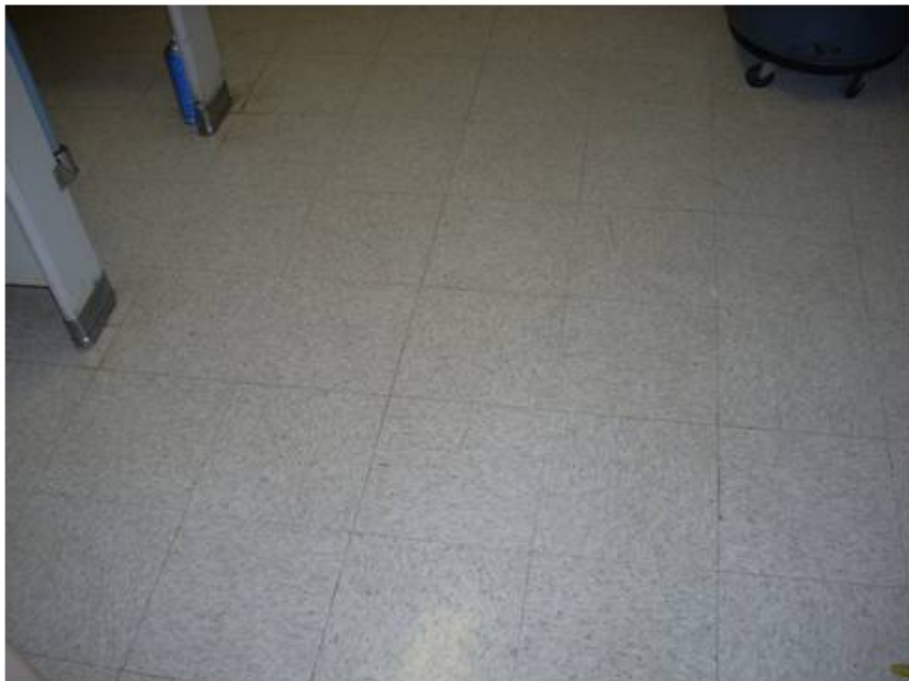
Mastic Associated with 12"x12" White with Gray Streaks Floor Tile, Sample 10C

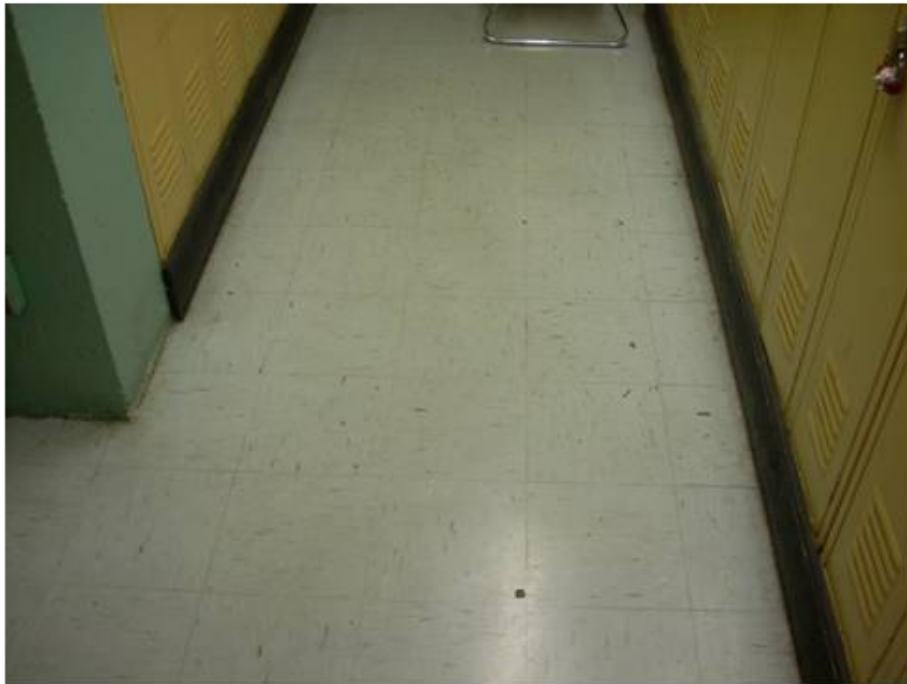
12"x12" Light Blue Floor Tile and Mastic, Samples 23A and 24A

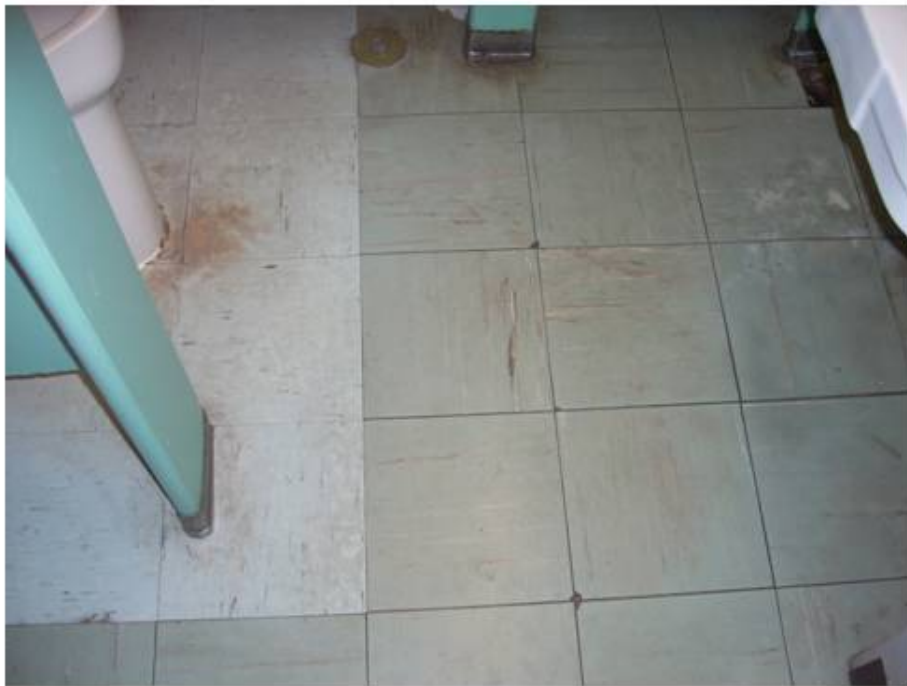
12"x12" Green Floor Tile and Mastic, Samples 25A and 26A

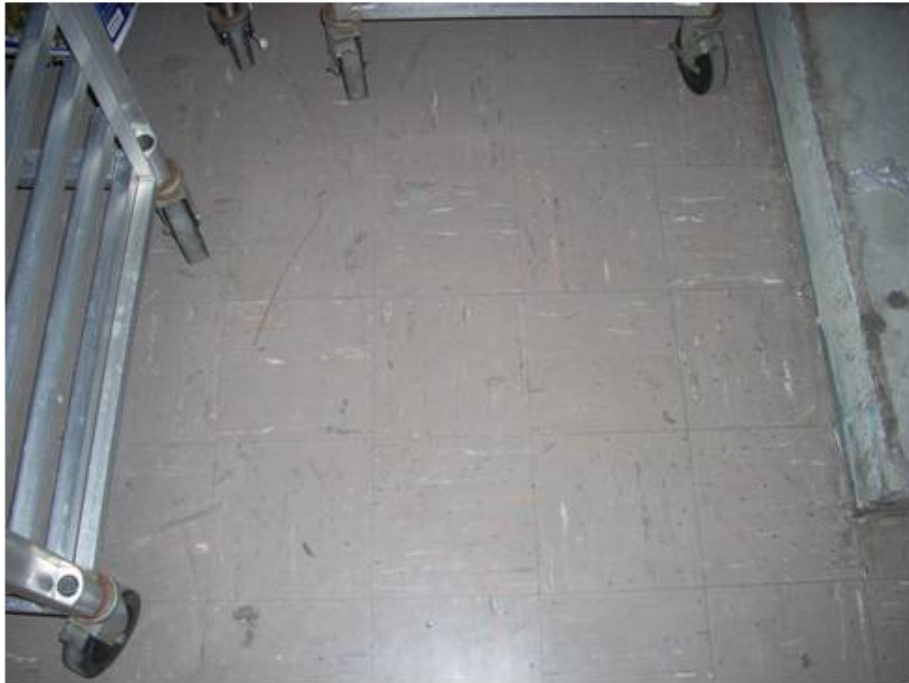
9"x9" Gray Floor Tile, Sample 27A

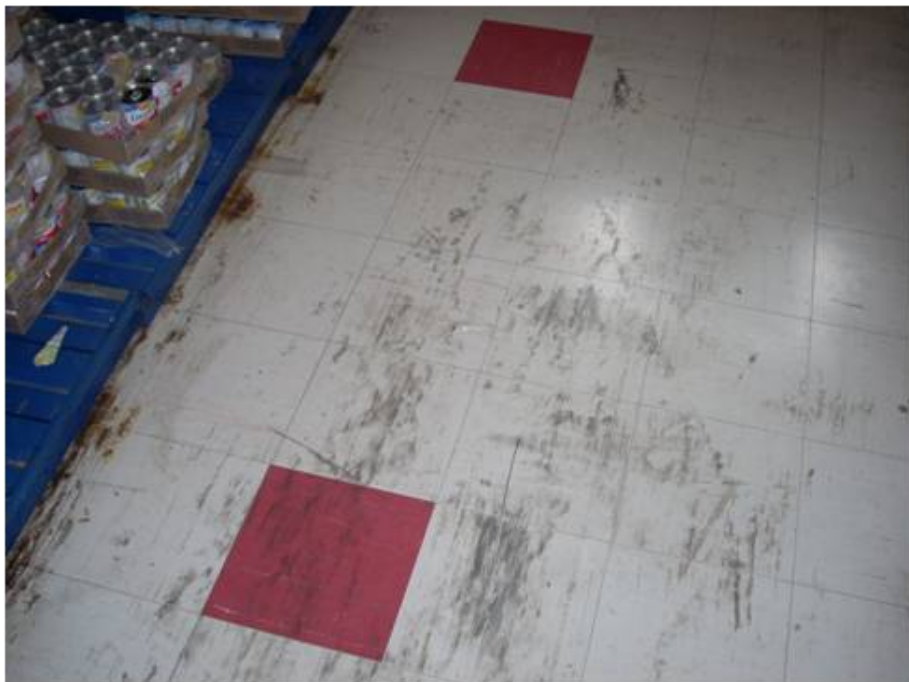
12"x12" Red Floor Tile and Mastic, Samples 35A and 36A  
12"x12" Bright White Floor Tile and Mastic, Samples 37A and 38A

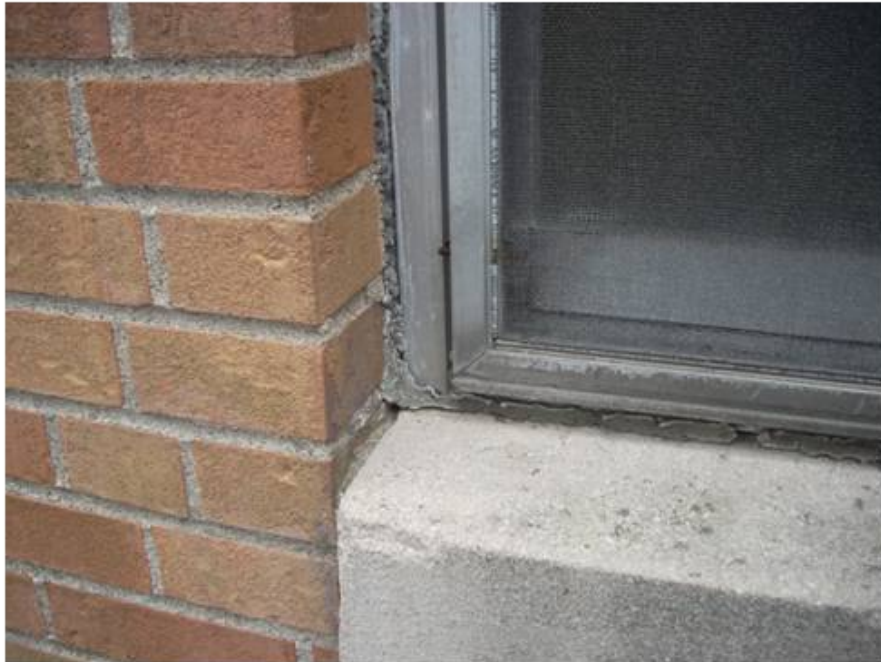
Exterior Window Caulking, Sample 44A

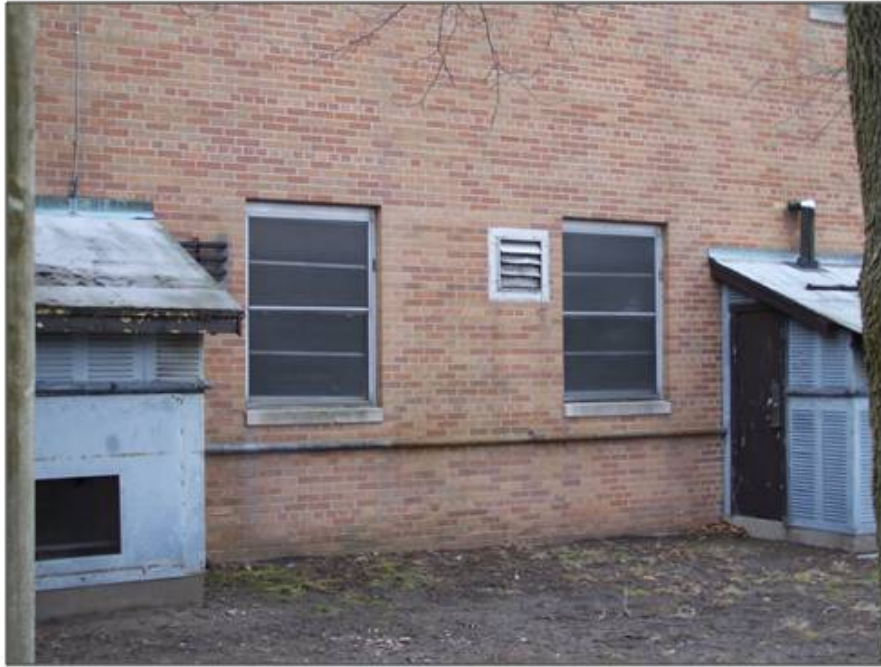
Wood Trim, Reading 596

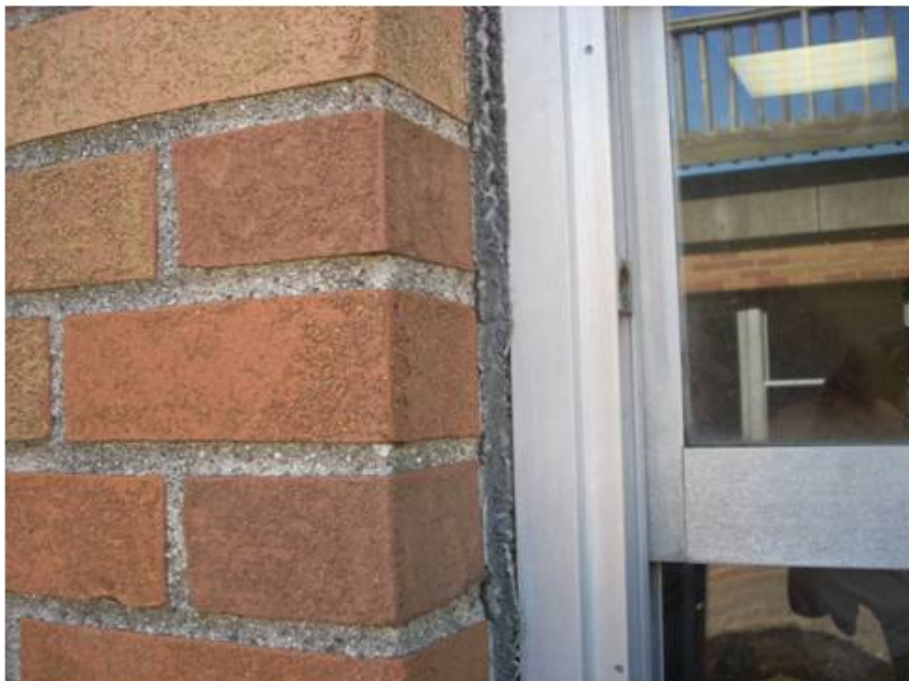
Exterior Window Caulk, Sample 11A

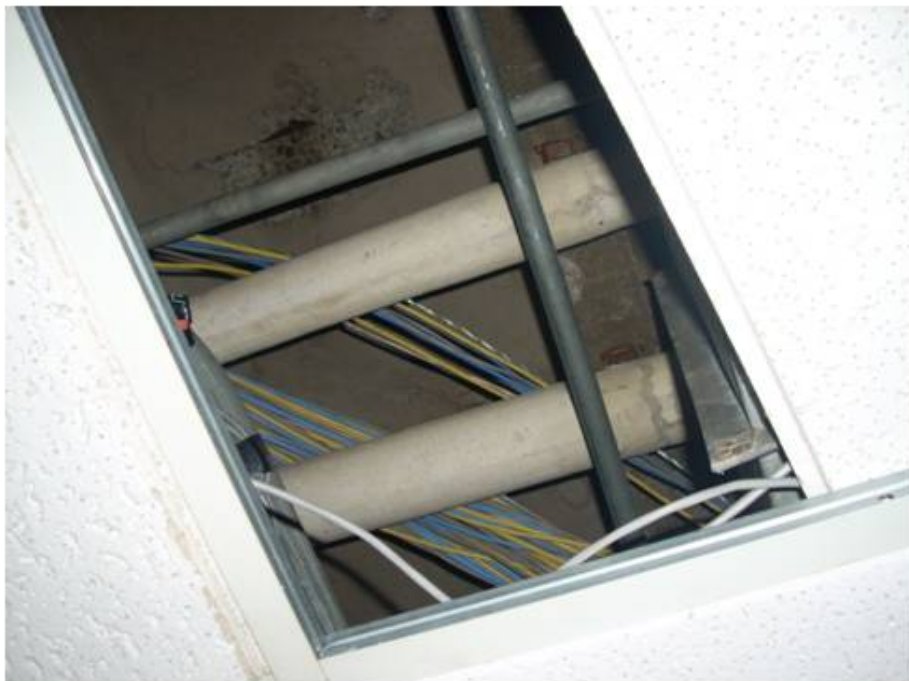
2" Pipe Insulation, Sample 13A

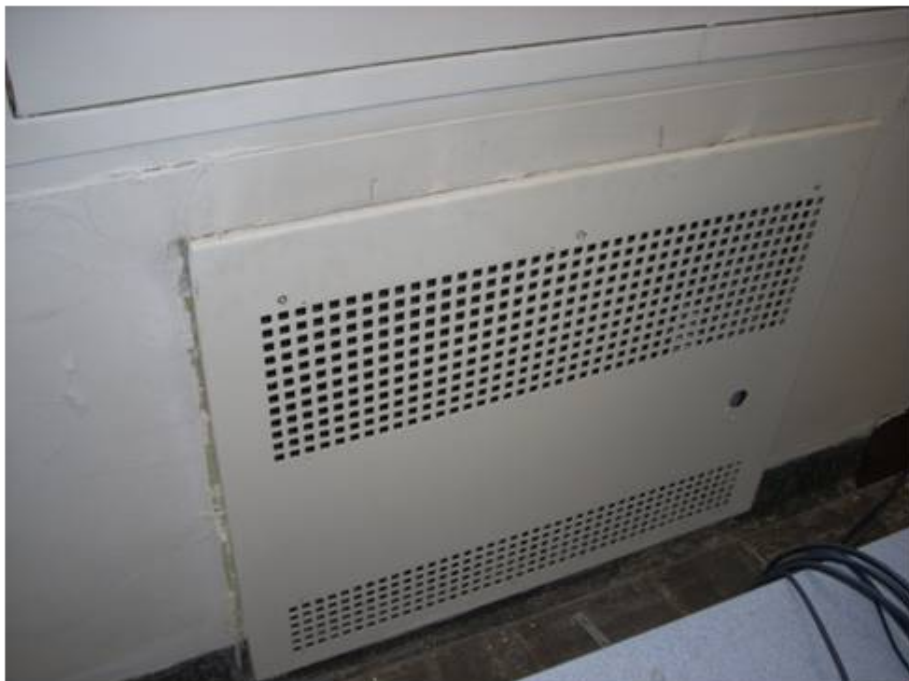
Transite Covering Inside Radiator, Sample 16A

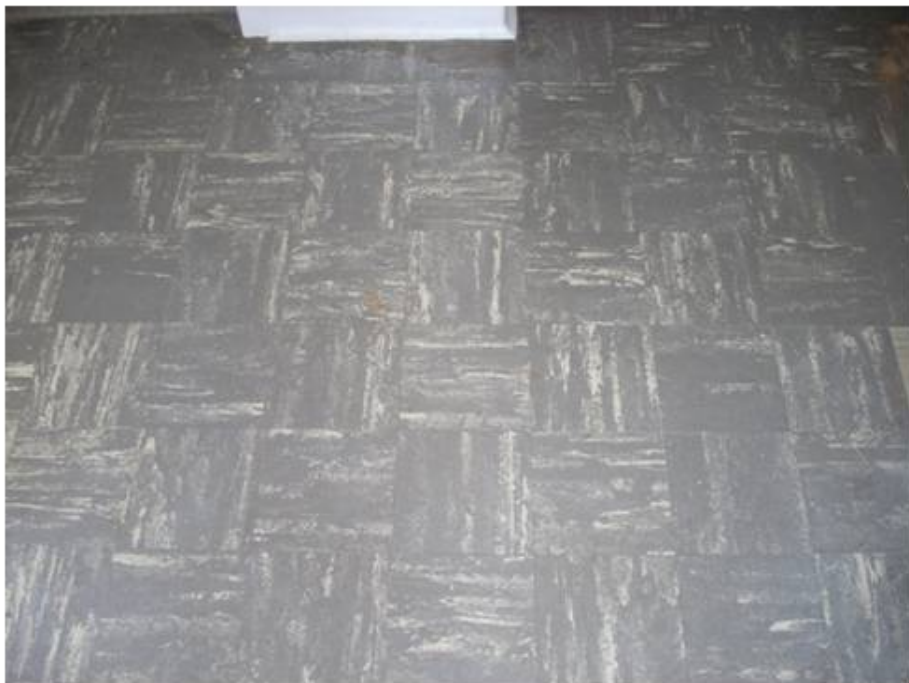
9"x9" Gray Floor Tile, Sample 22A

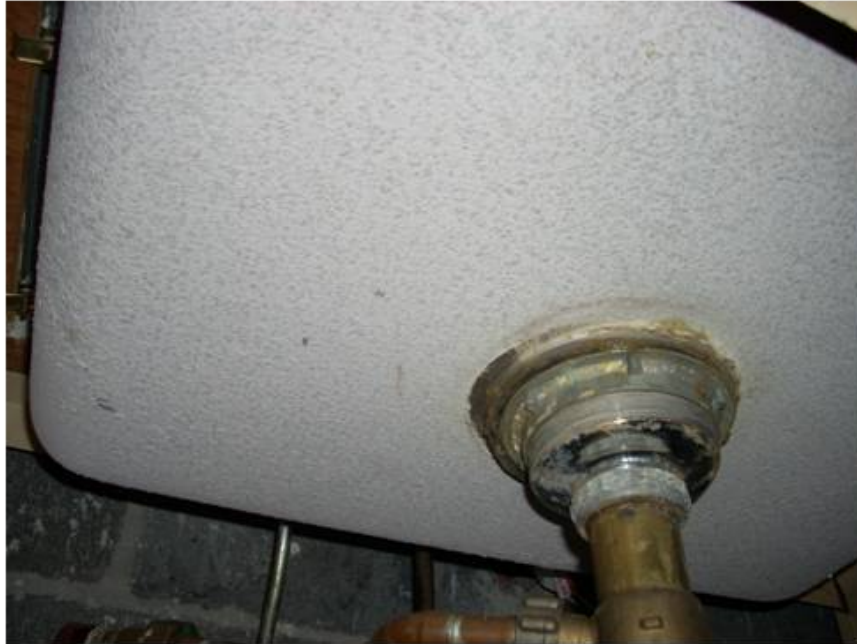
Sink Undercoating, Sample 33

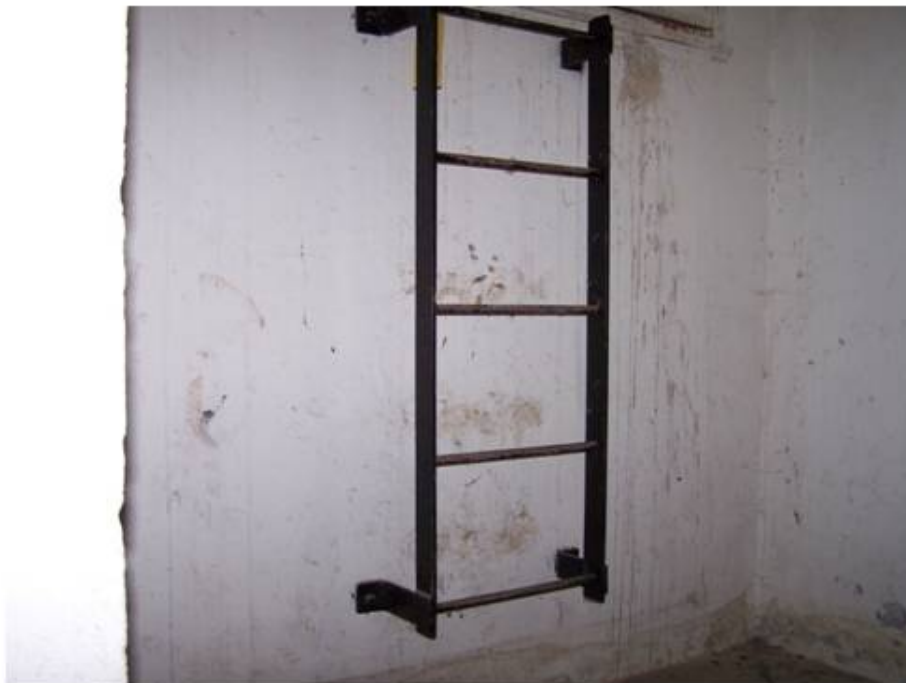
Metal Ladder, Reading 2536

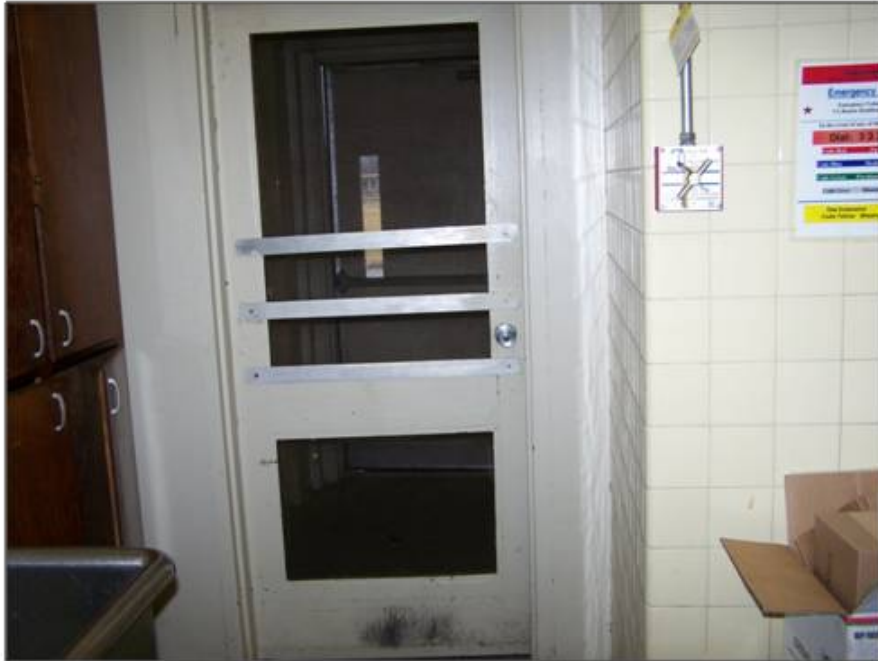
Wood Screen Door, Reading 2561

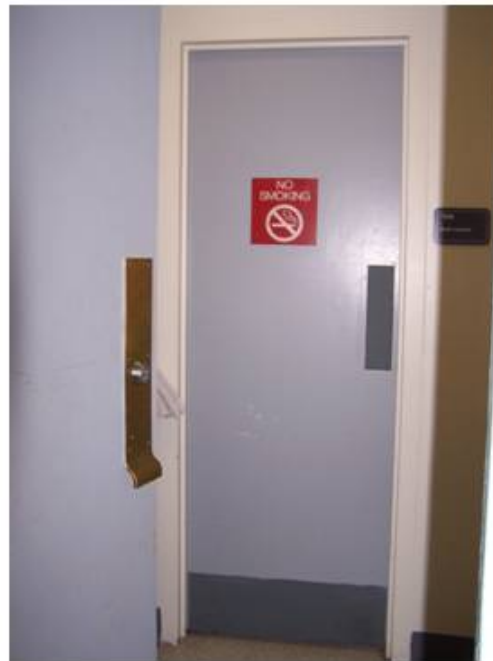
Wood Door, Reading 2567

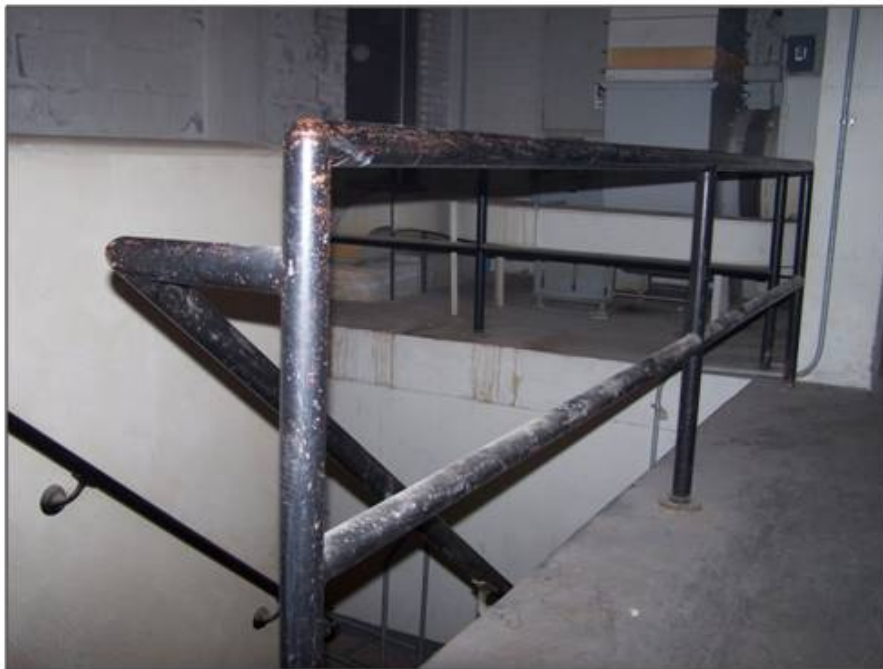
Metal Handrail, Reading 2675

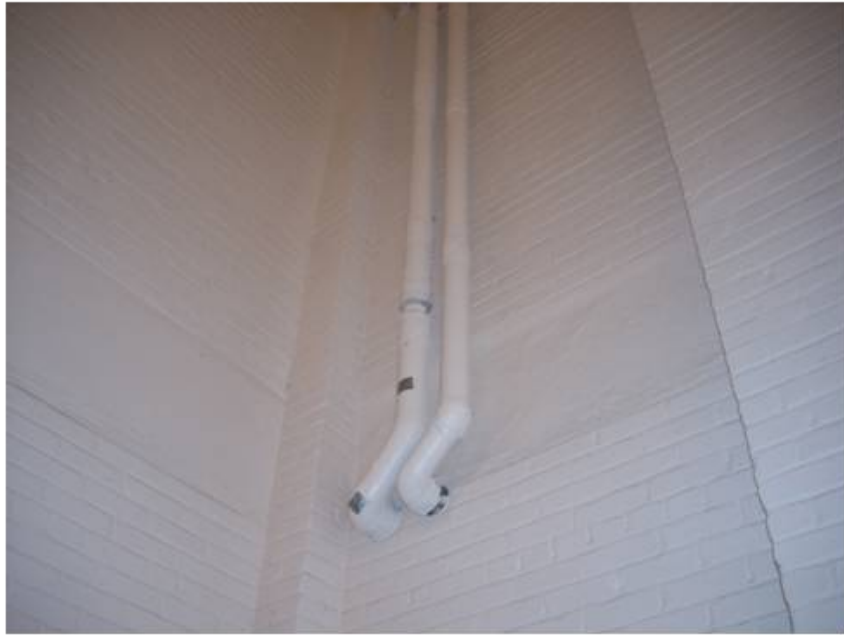
Pipe and Fitting Insulation, Samples 1A and 2A

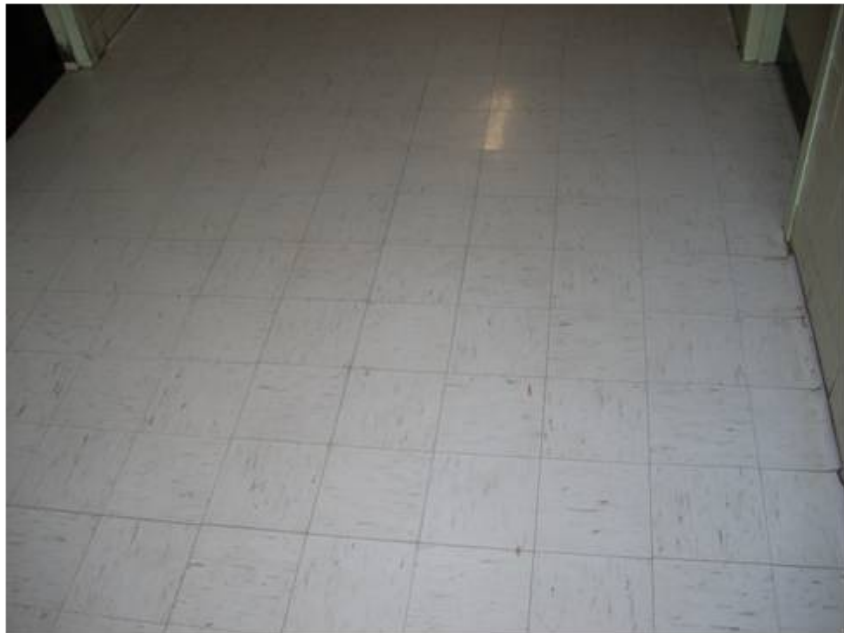
9"x9" White Floor Tile and Mastic, Samples 3A and 4A

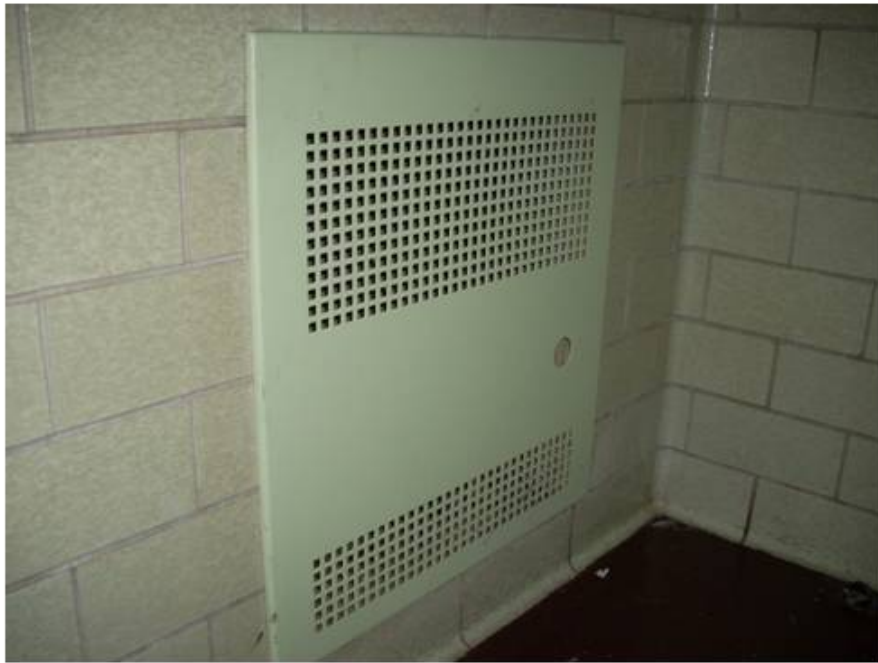
Transite Panel Set into Walls at Radiator

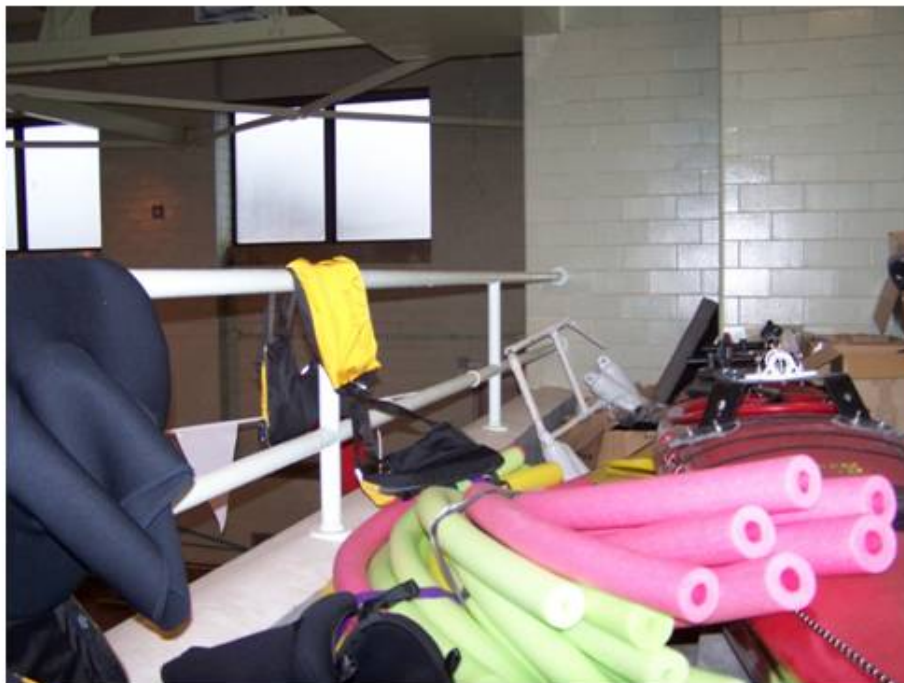
Metal Handrail, Reading 2239

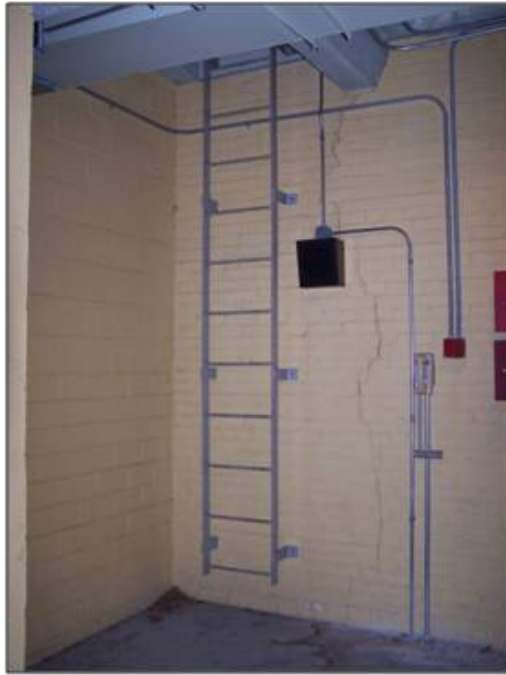
Metal Ladder, Reading 2252

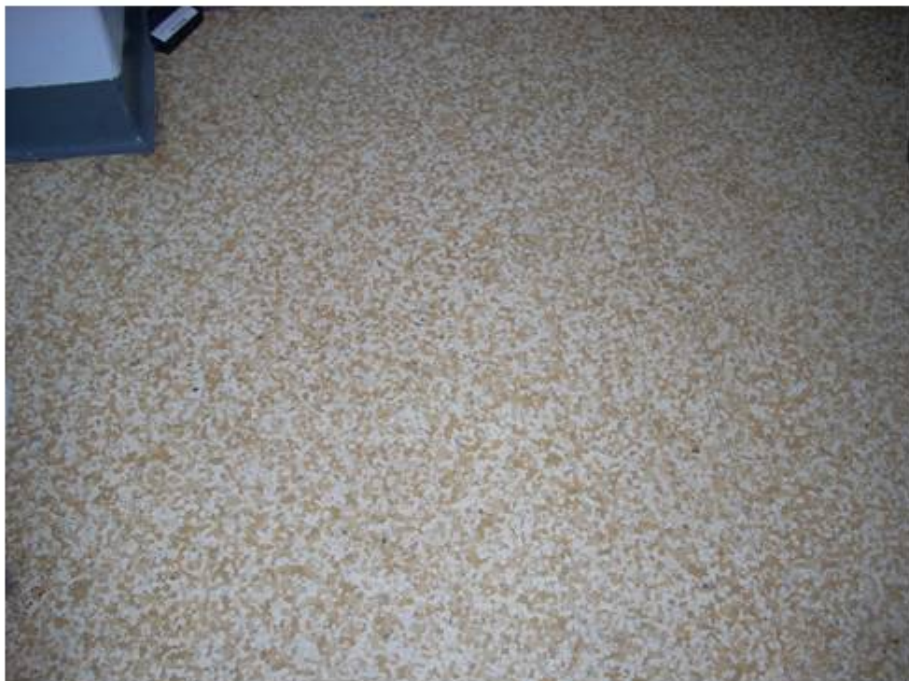
Tan Mosaic Sheet Flooring, Sample 8A

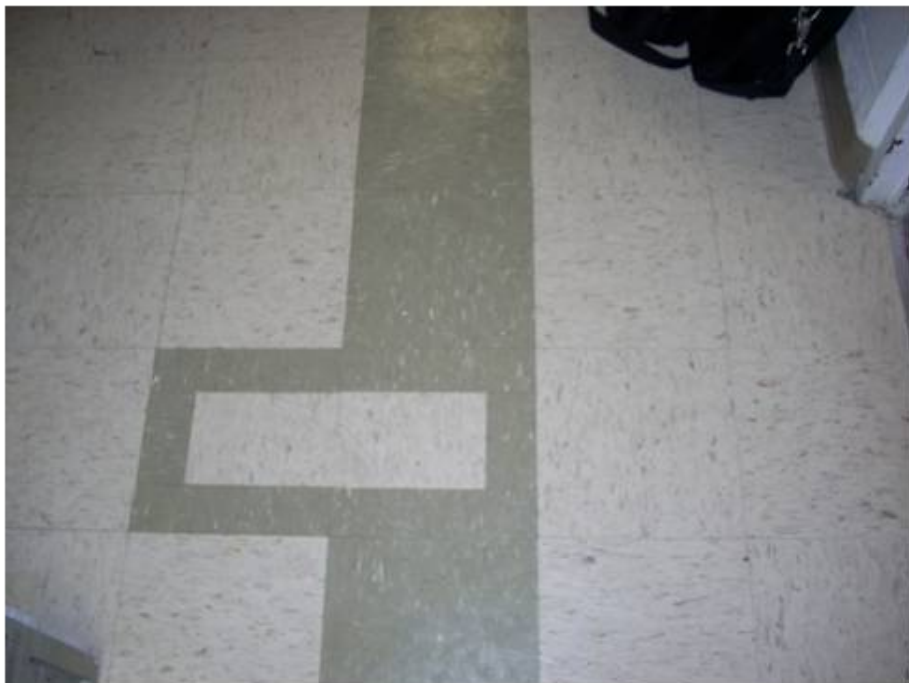
12"x12" Green Floor Tile, Sample 16A

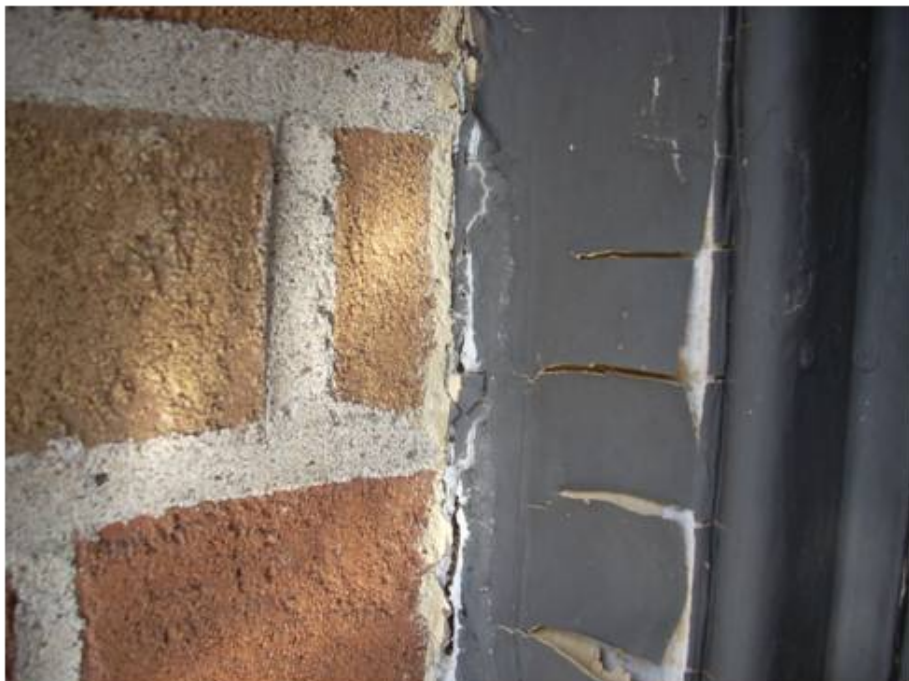
Exterior Door Caulking, Sample 30
