## **VOLUME II ASBESTOS CONTAINING MATERIAL & LEAD CONTAINING PAINT SURVEY REPORTS**

**VISN 1**  
**Brockton VA Medical Center**  
940 Belmont Street  
Brockton, Massachusetts

Project No. 2009023.003

June 21, 2010

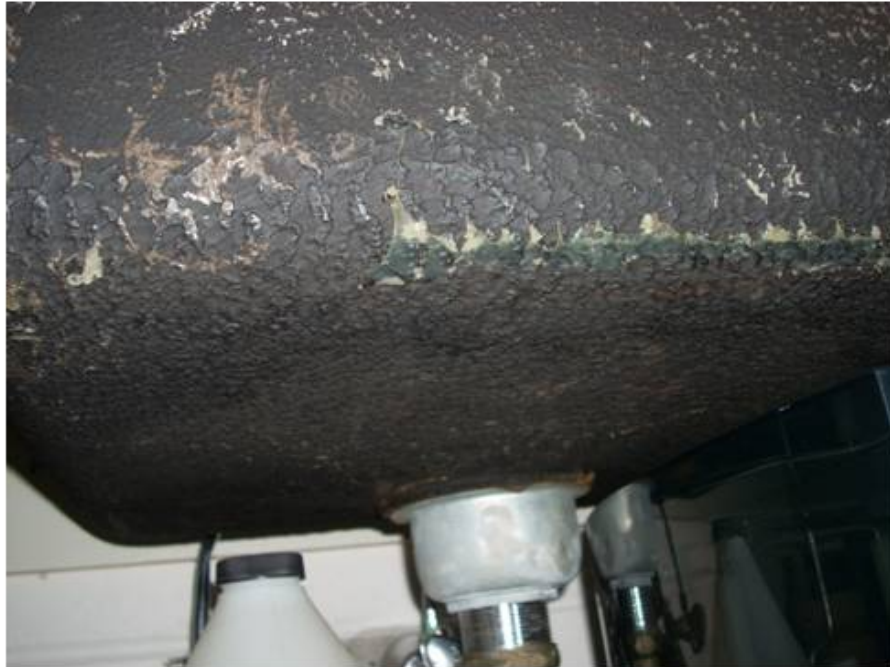
BlackSink Undercoating, Sample 33

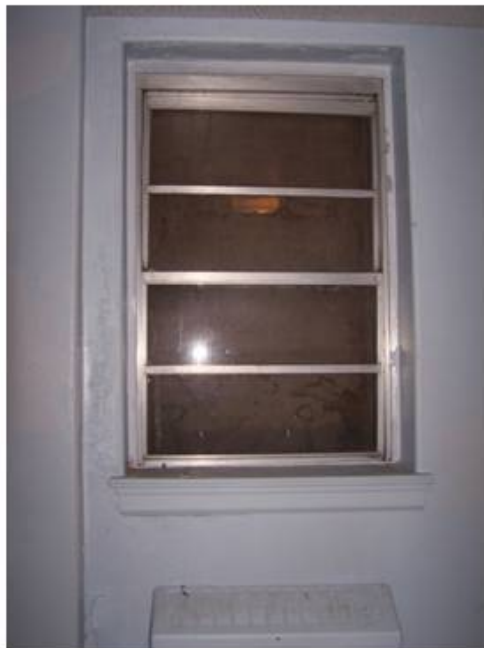
Wood Window Sill, Reading 1669

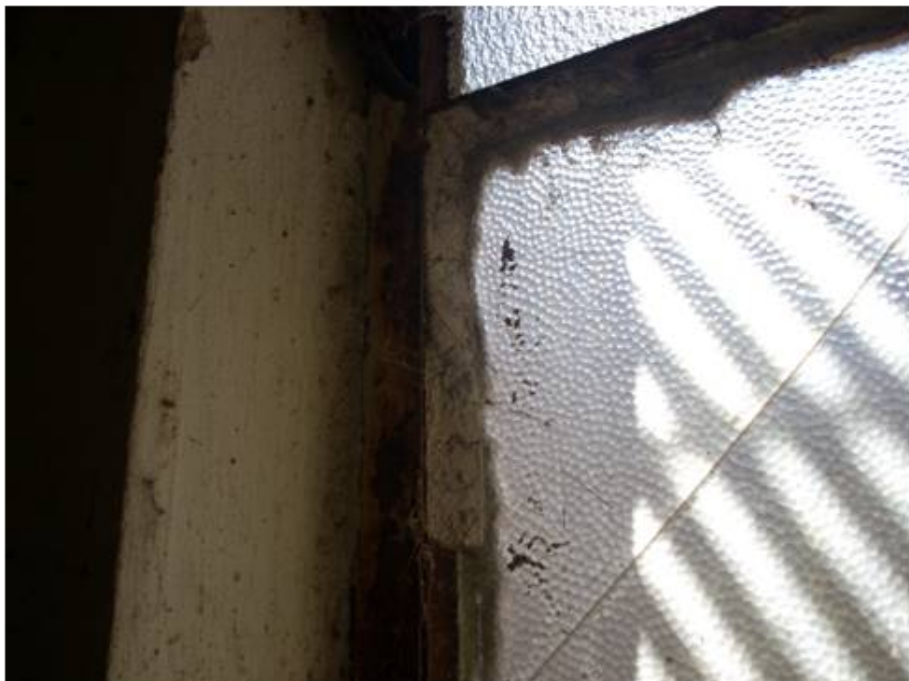
Window Glazing, Sample 2A

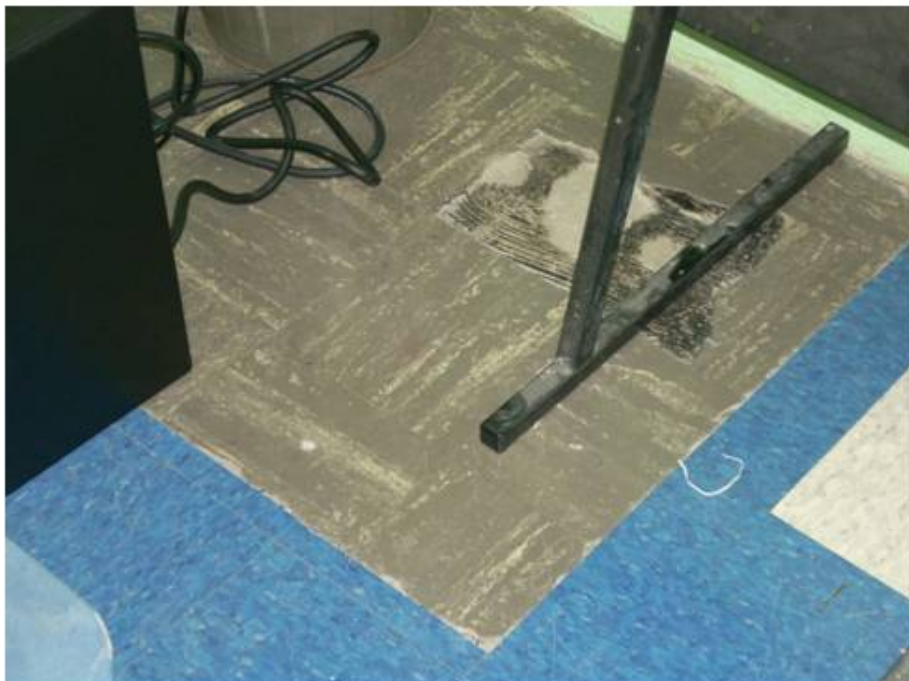
9"x9" Green Floor Tile, Sample 22A

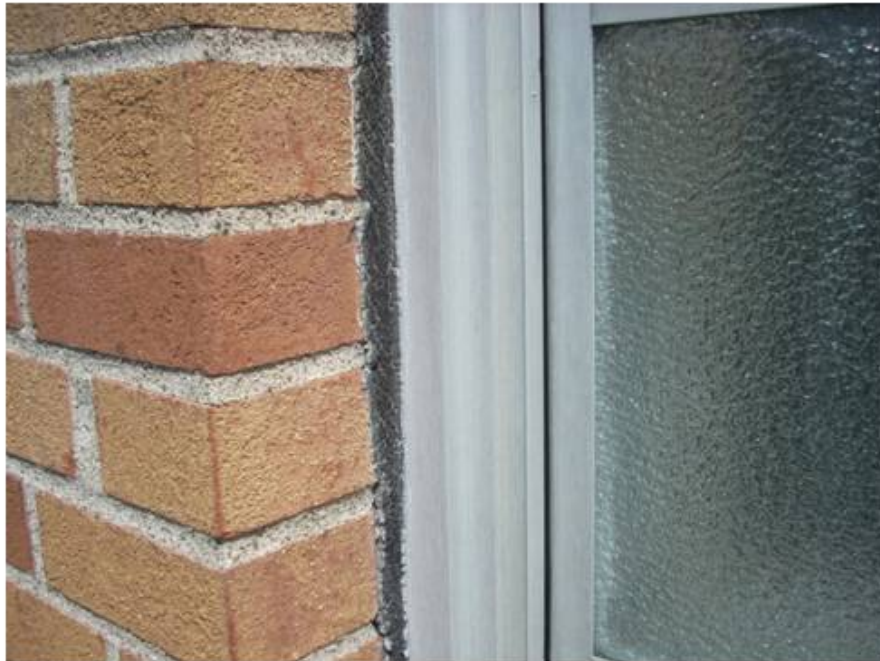
Window Caulking, Sample 36A

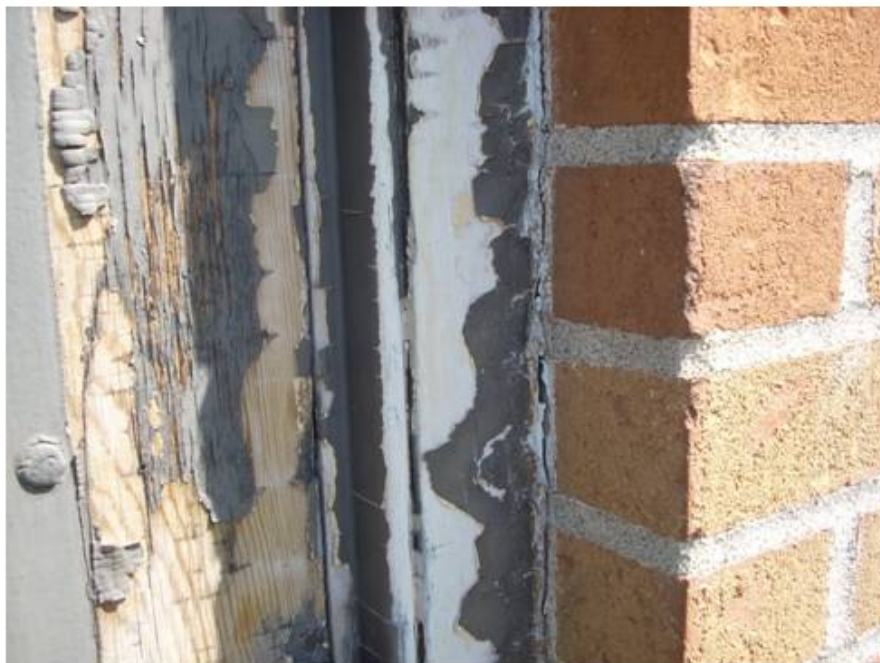
Old Door Caulking, Sample 38A

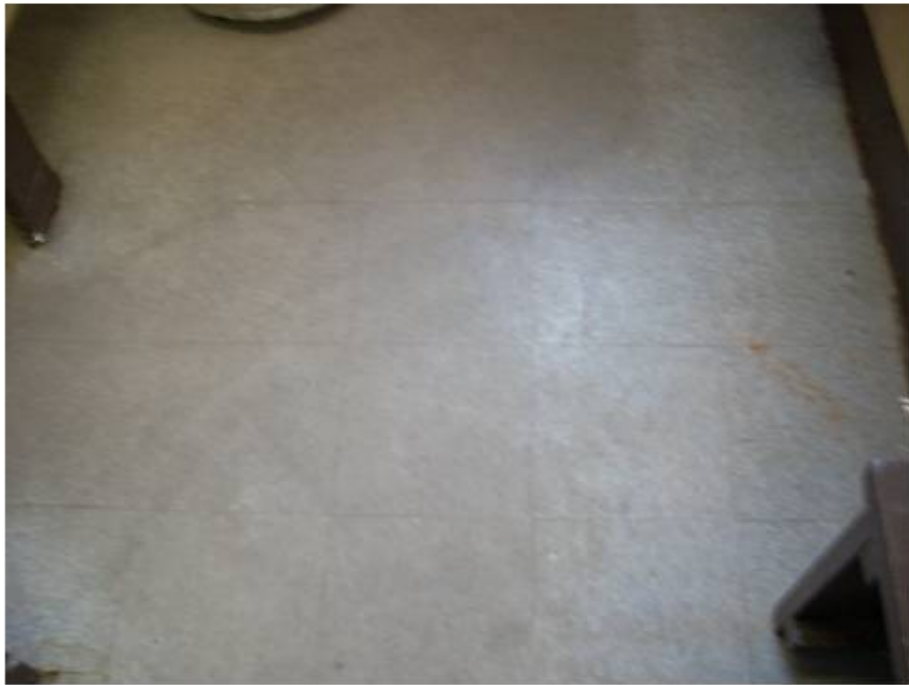
Mastic Associated with 12"x12" Blue Floor Tile, Sample 3C

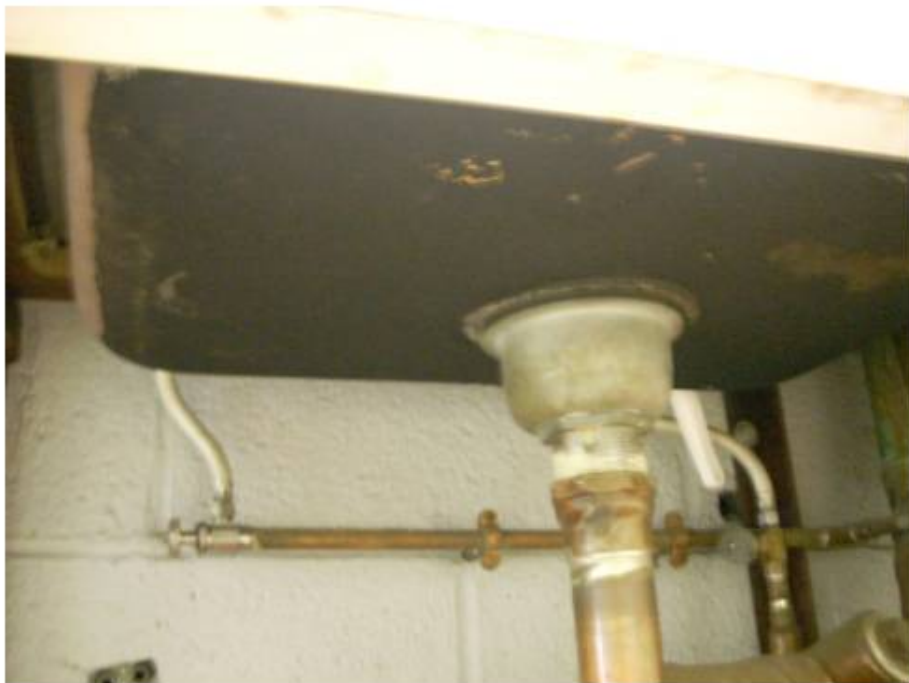
Sink Undercoat, Sample 9A

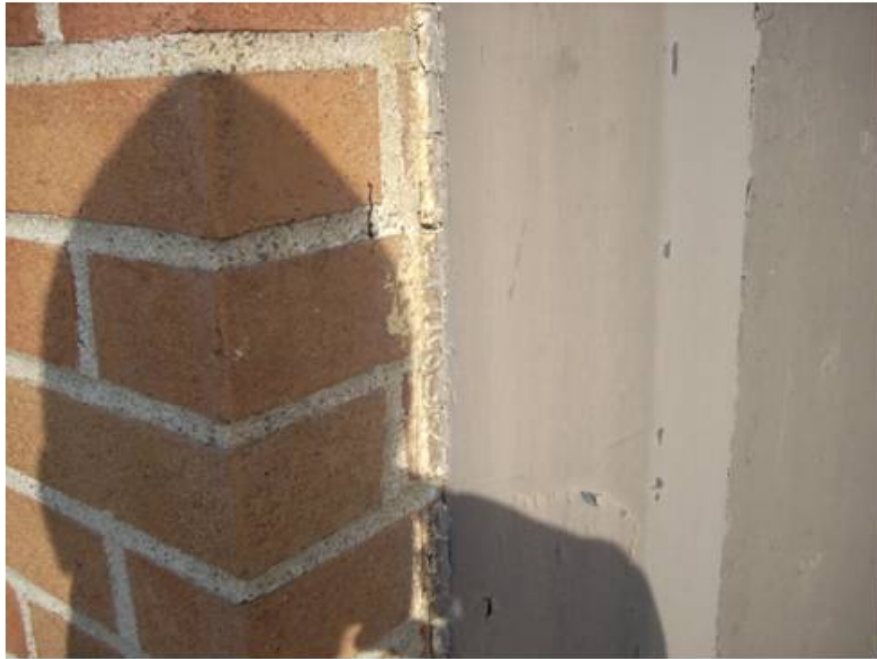
Exterior Door Caulk, Sample 16C

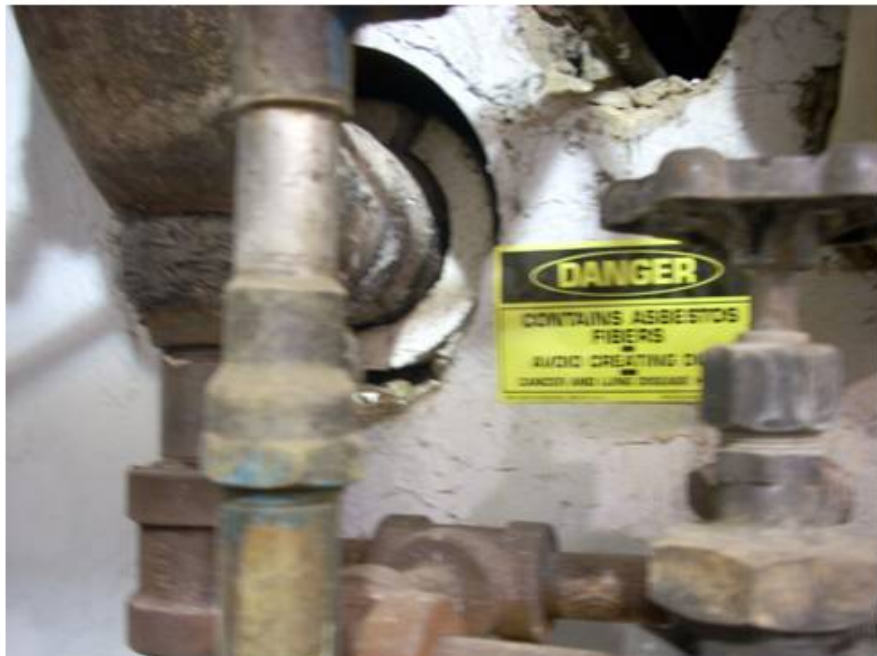
Pipe Insulation Inside Wall Cavity, Sample 20A

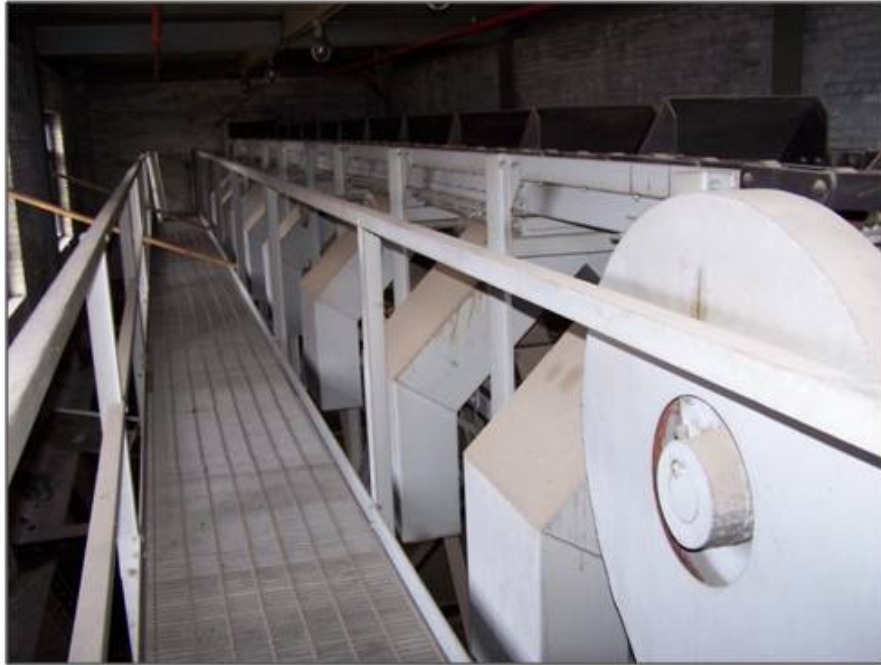
Metal Handrail and Metal Conveyor Belt Structure, Readings 182, 183 and 184

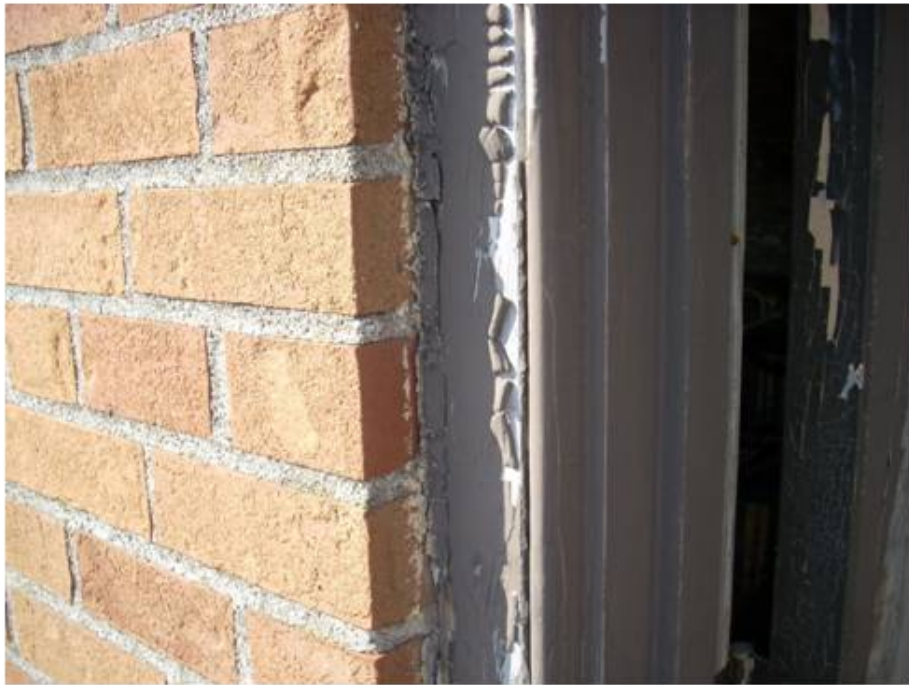
Exterior Door Caulk, Sample 1A

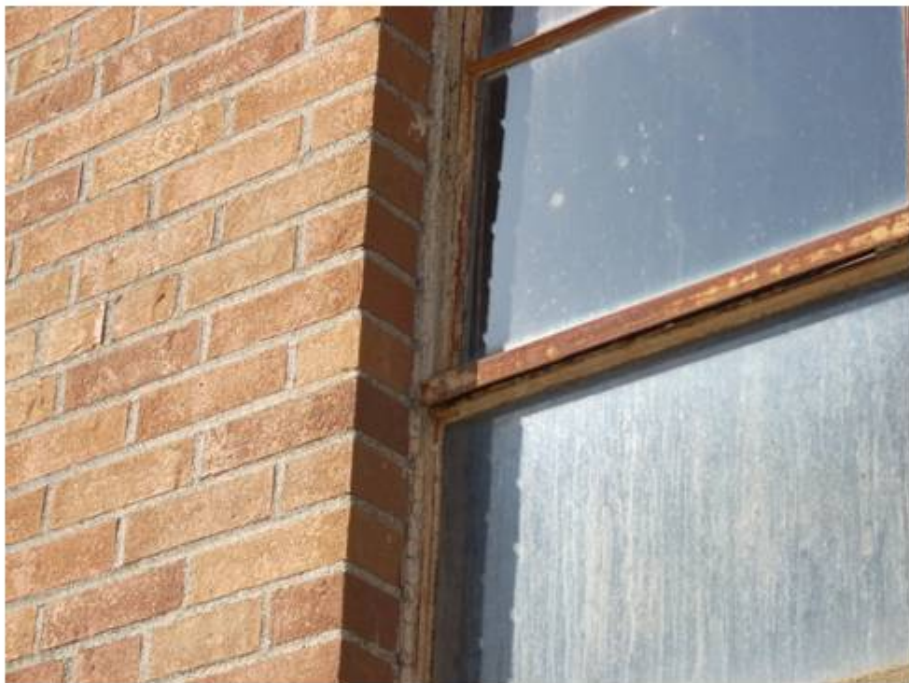
Exterior Window Caulk, Sample 2A

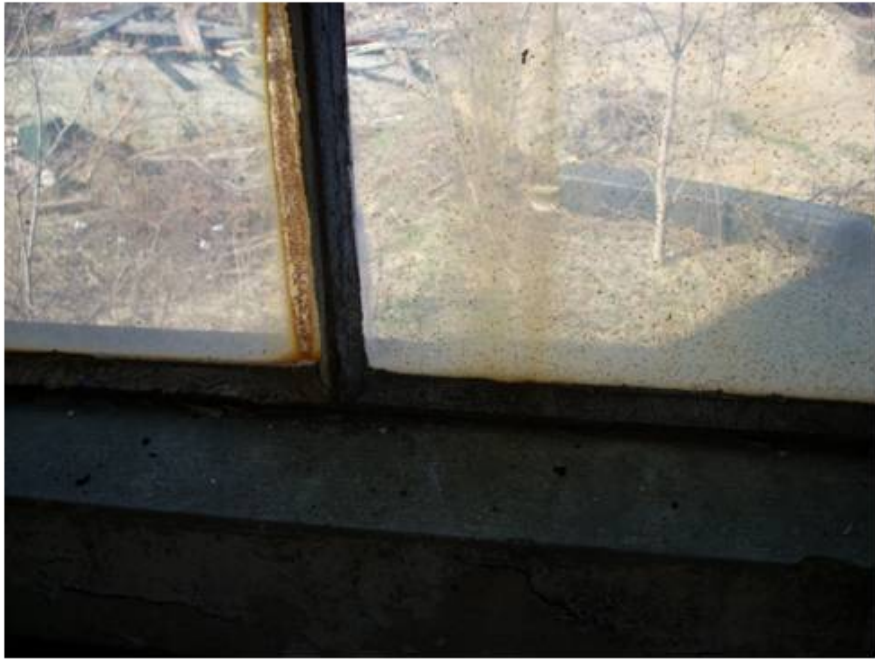
Interior Window Glazing, Sample 3A

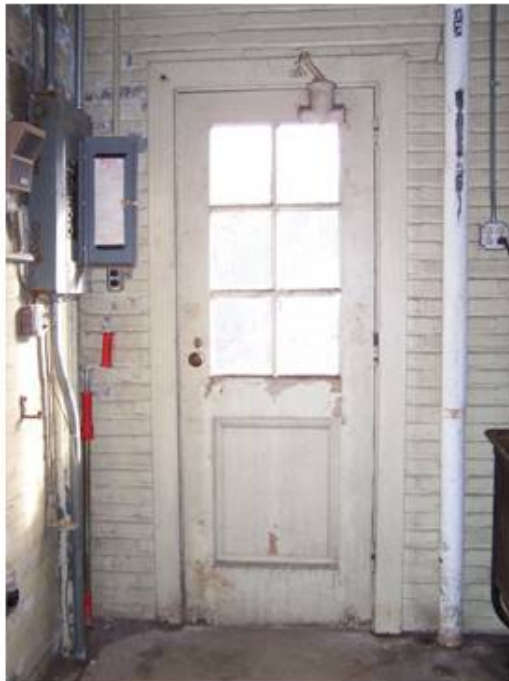
Wood Door, Reading 14

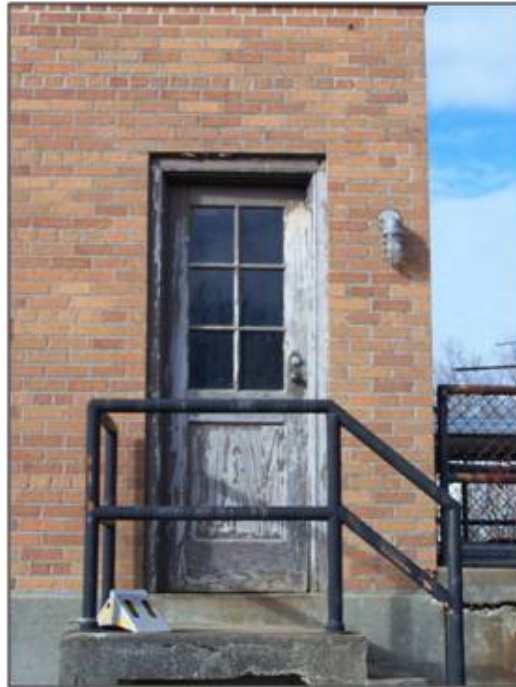
Wood Door Casing, Reading 16

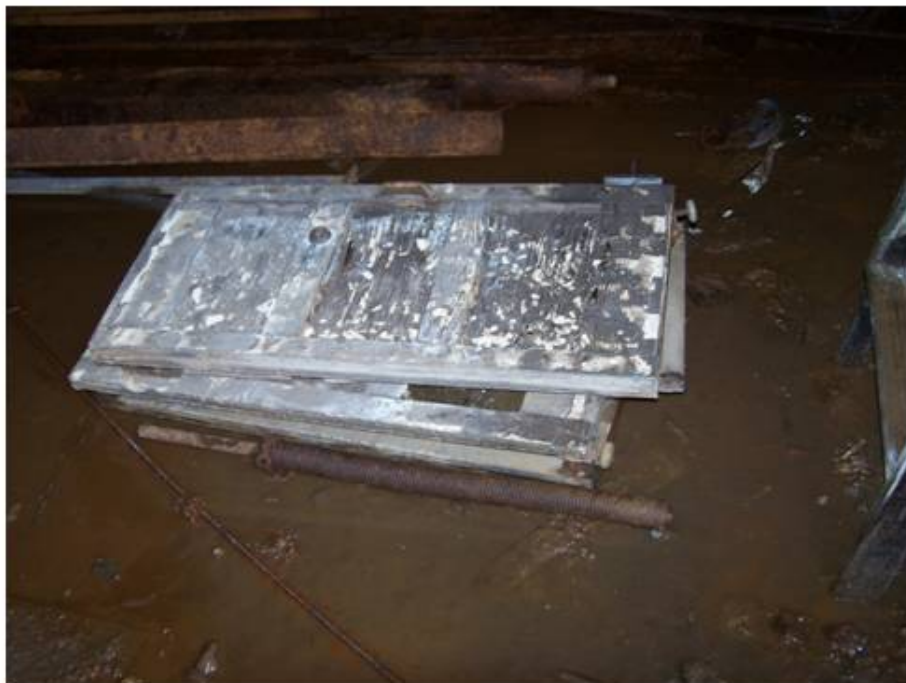
Wood Doors Stacked and Stored, Reading 23

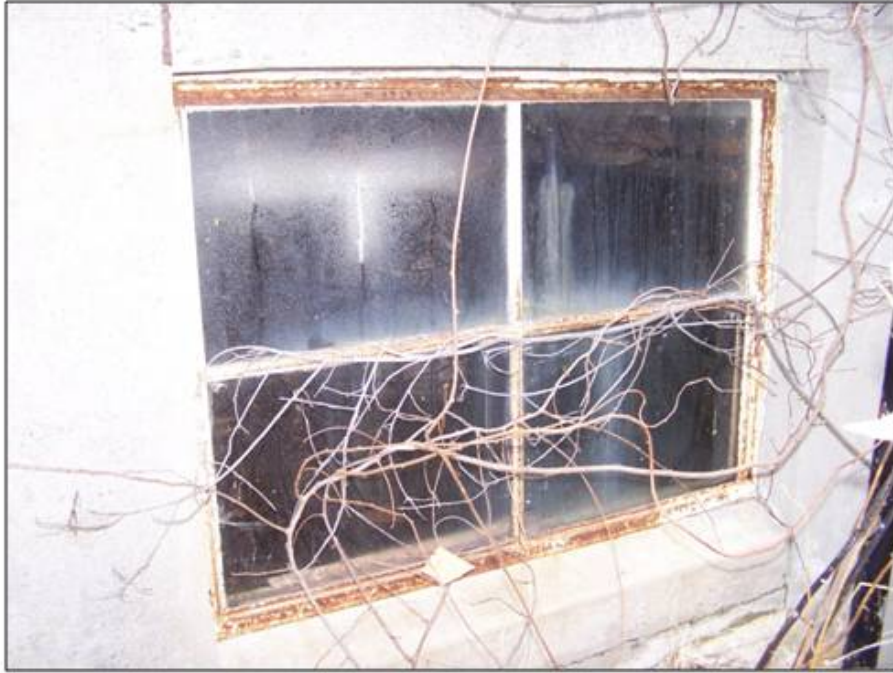
Metal Window Casing, Reading 25

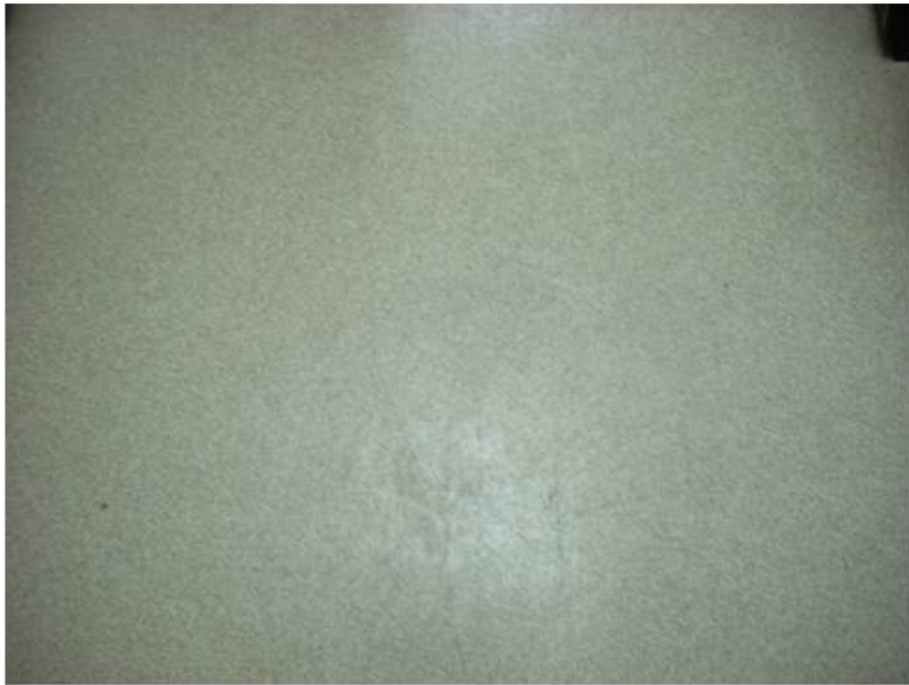
Light Brown Sheet Flooring, Sample 1A

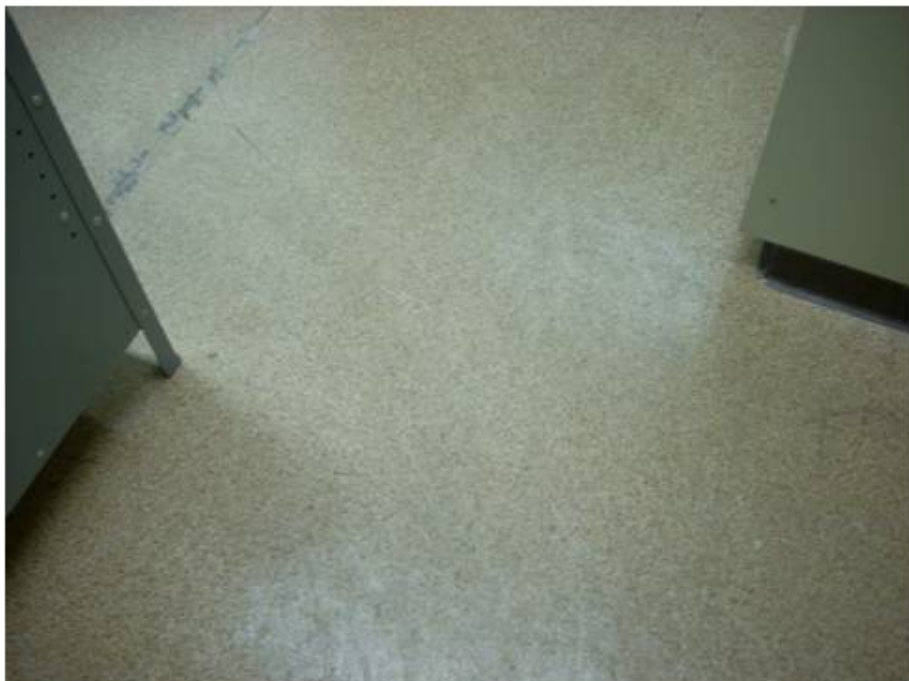
Dark Brown Sheet Flooring, Sample 3A

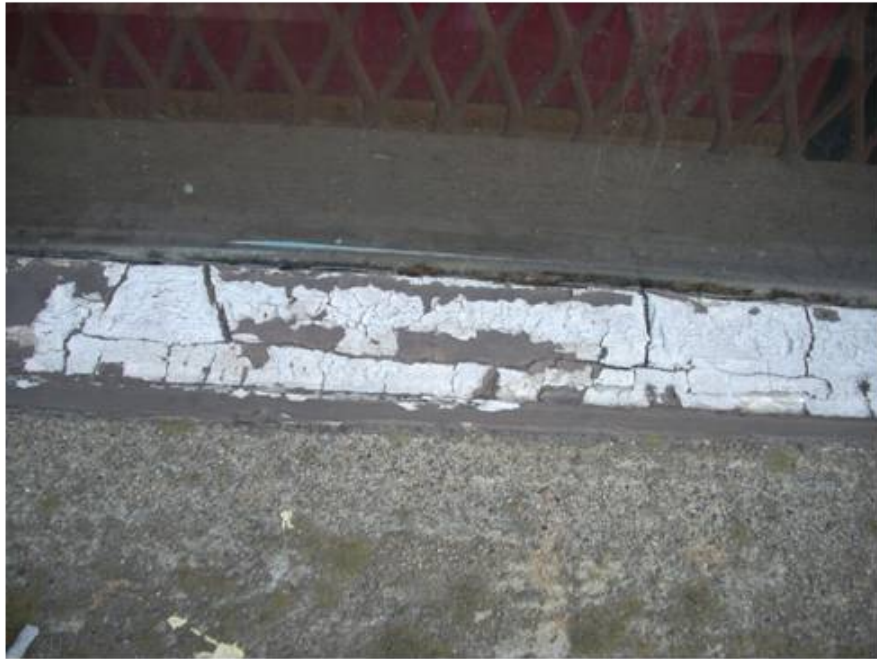
Exterior Window Caulking, Sample 13B

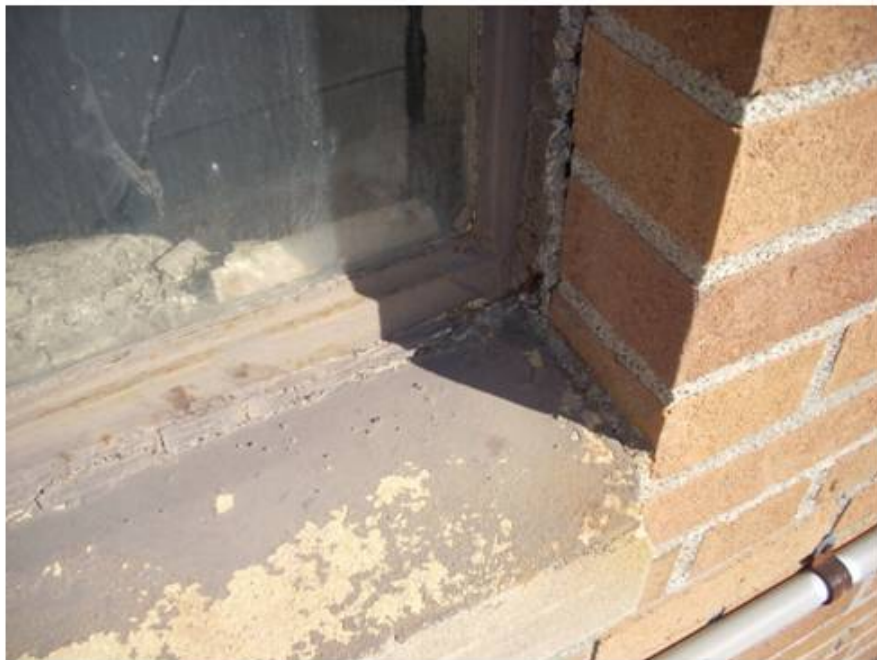
Exterior Window Caulk (Old), Sample 16A

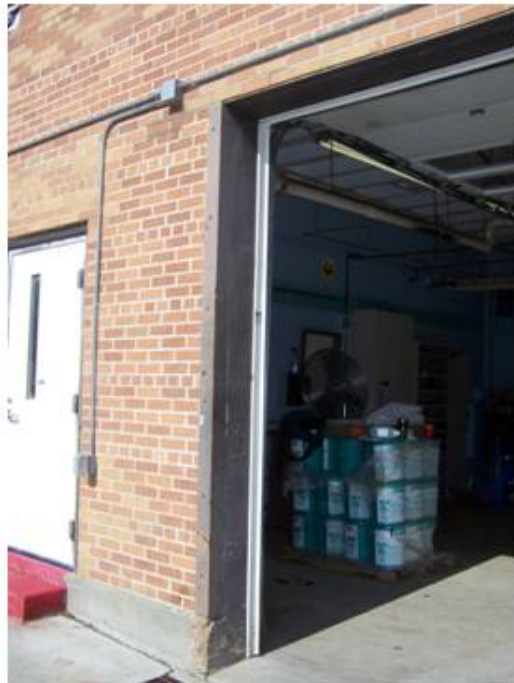
Concrete Door Casing, Reading 73

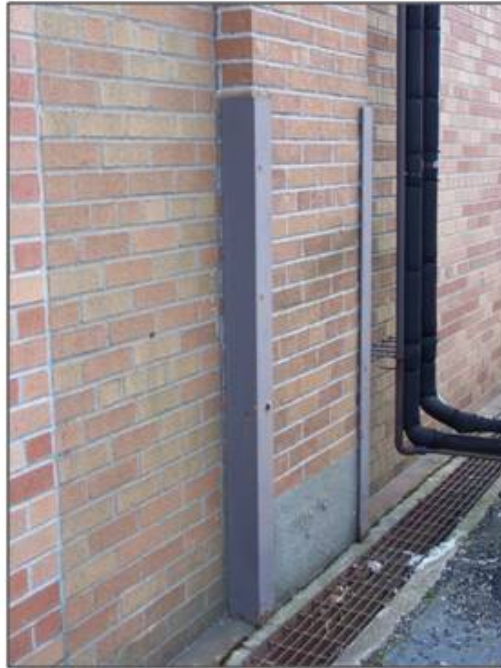
Metal Corner Guard, Reading 141

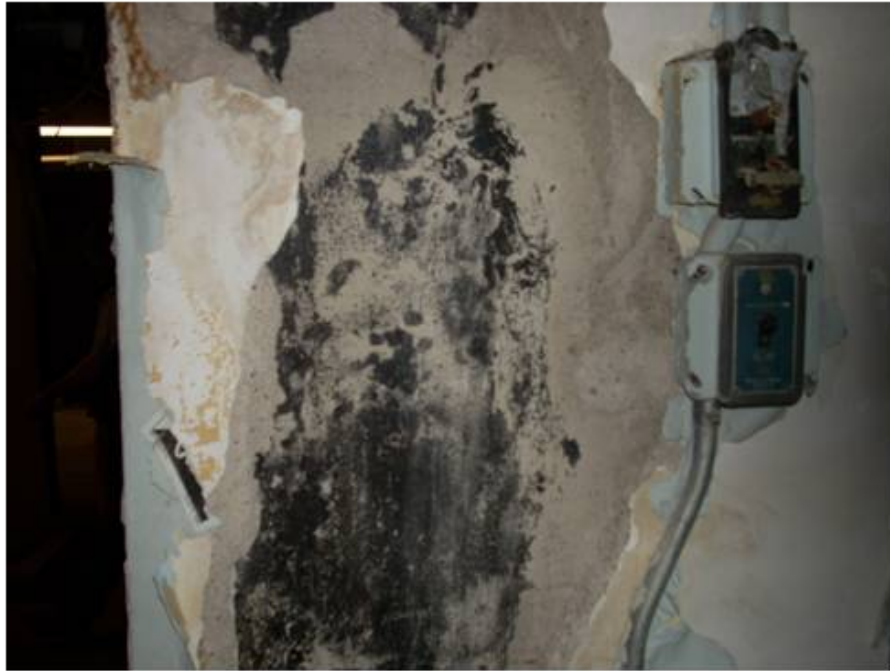
Black Damp Proofing, Sample 15A

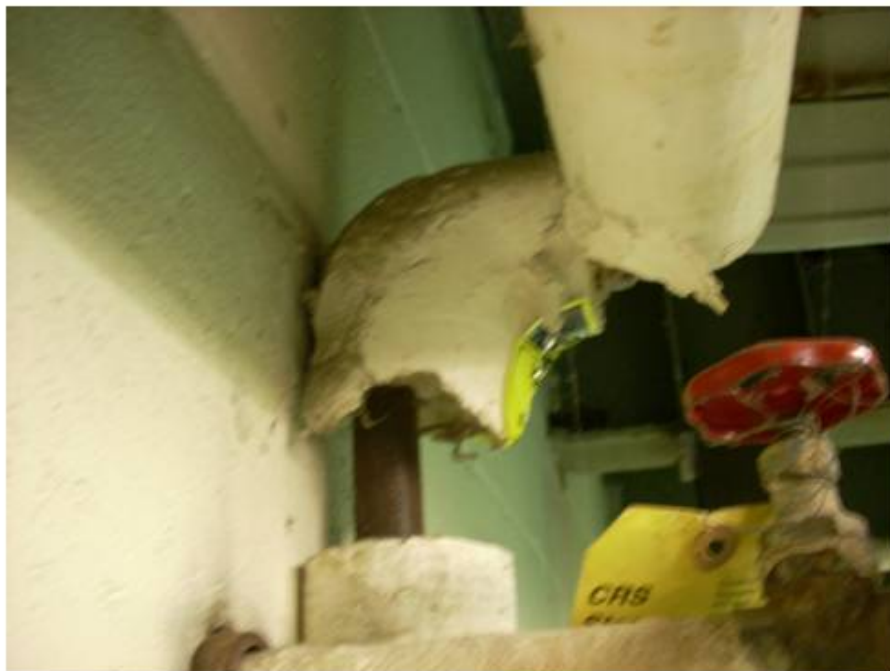
Fitting Insulation, Sample 18A

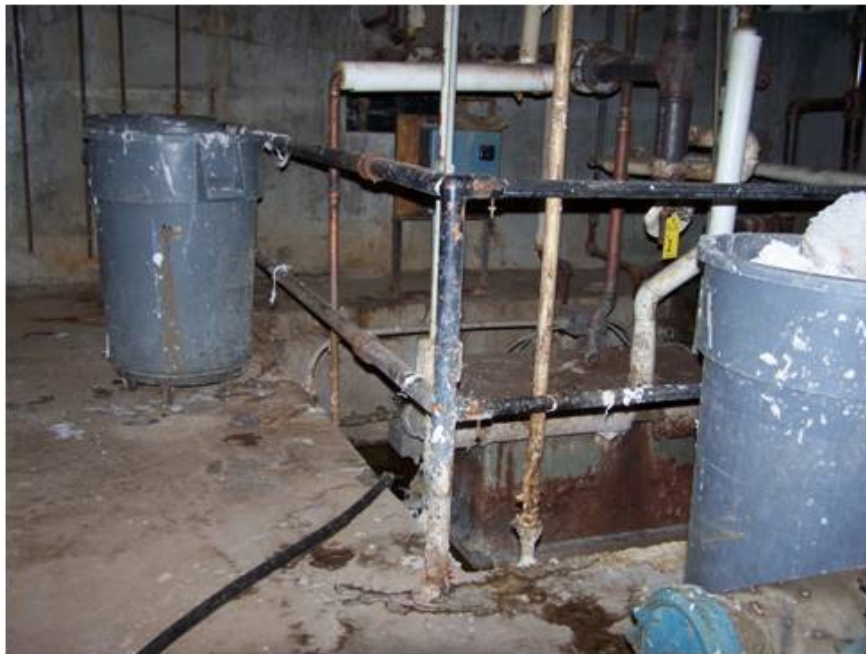
Metal Handrail, Reading 206

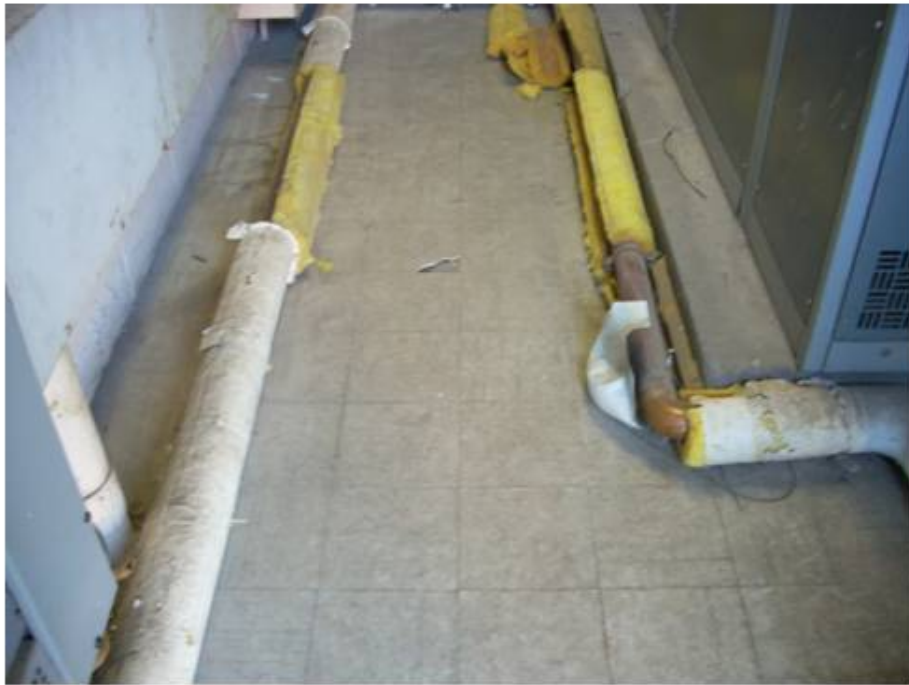
9"x9" Gray Floor Tile and Mastic, Samples 1A and 2A

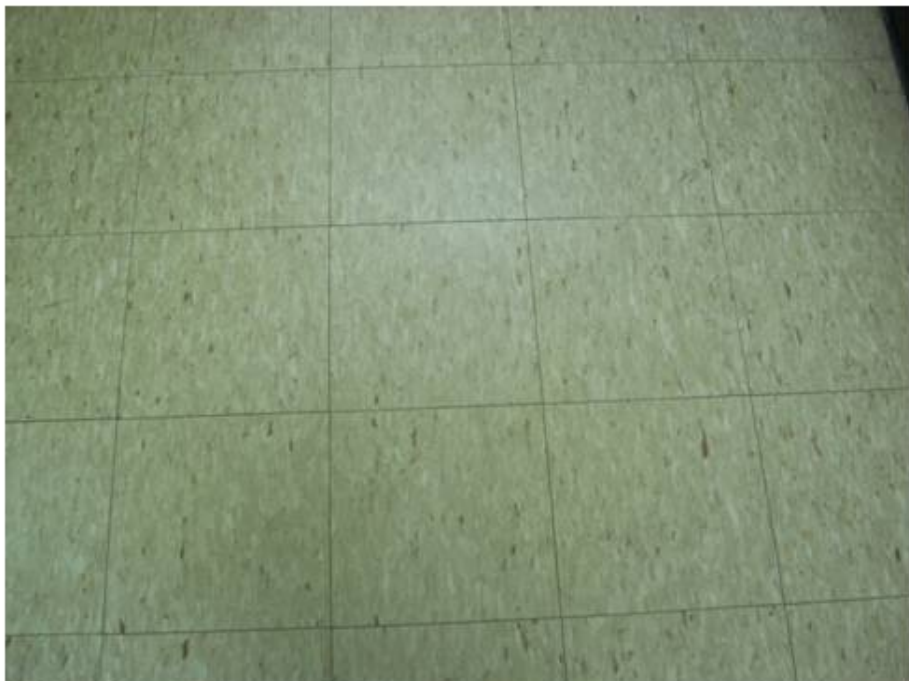
Mastic Associated with 12"x12" Beige Floor Tile, Sample 4A

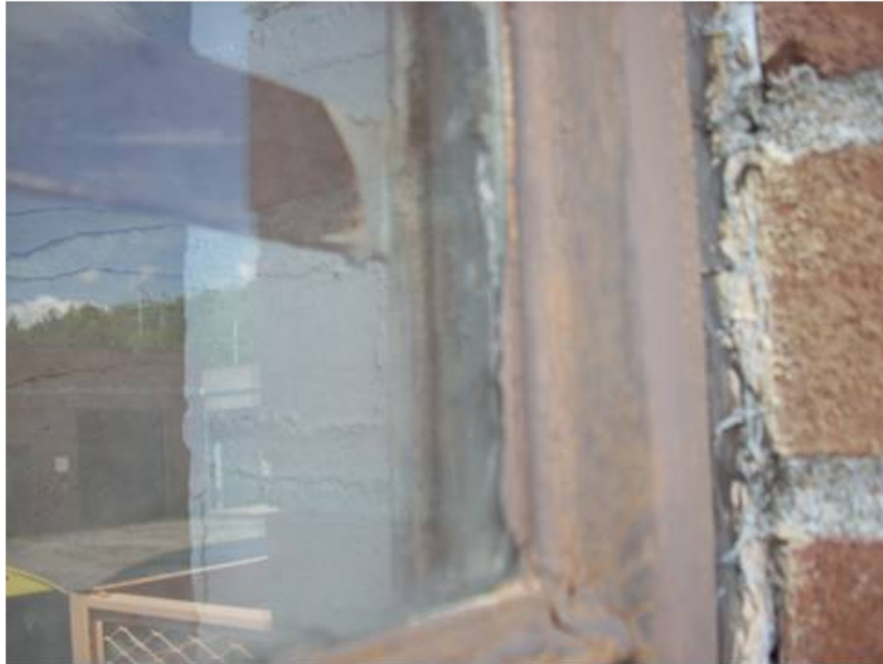
Interior Window Caulk (taken from outside), Sample 14A

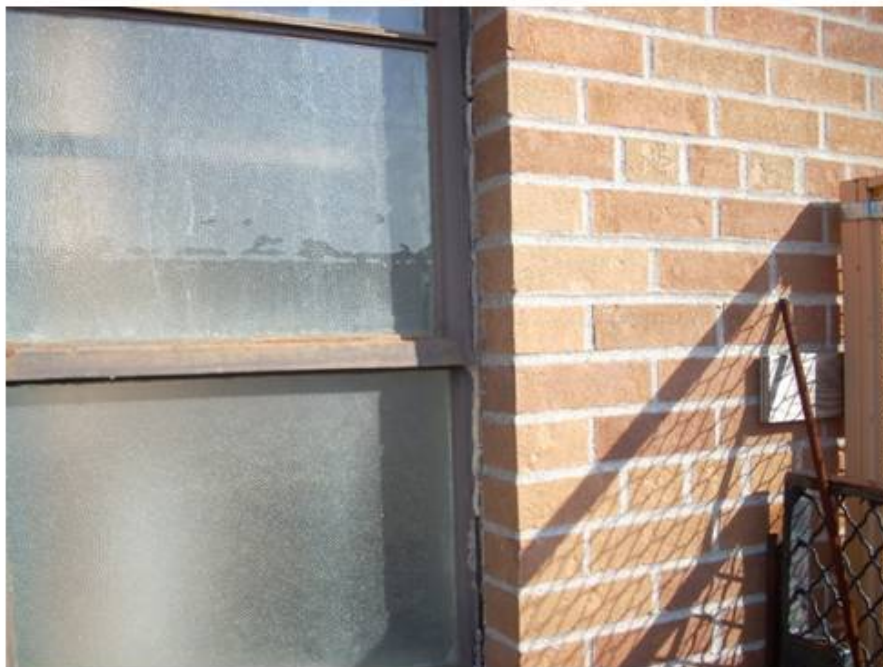
Exterior Window Caulk, Sample 17A

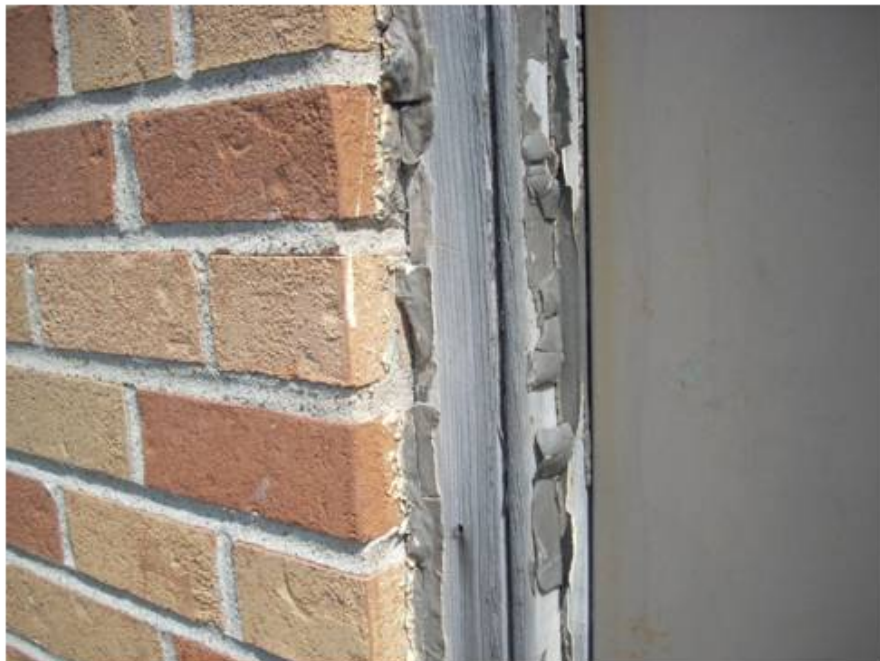
Exterior Door Caulk, Sample 2A

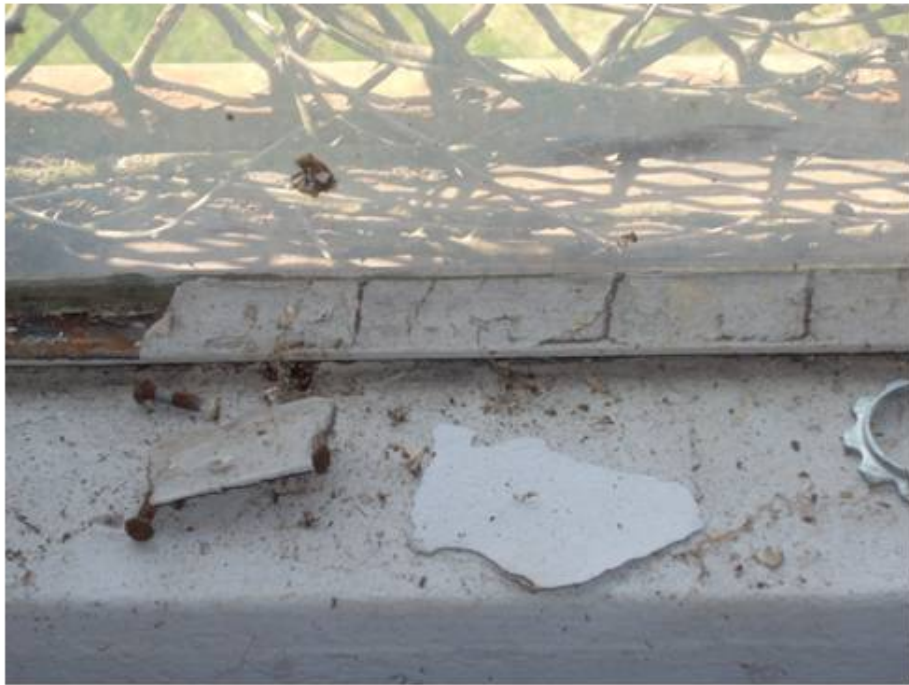
Interior Window Glazing, Sample 1B

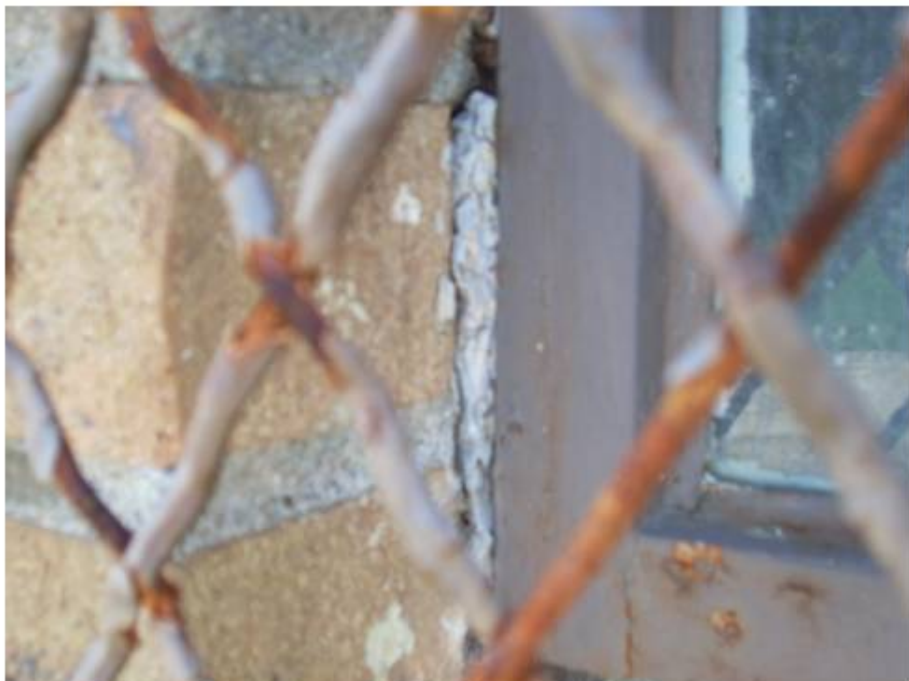
Exterior Window Caulk, Sample 2A

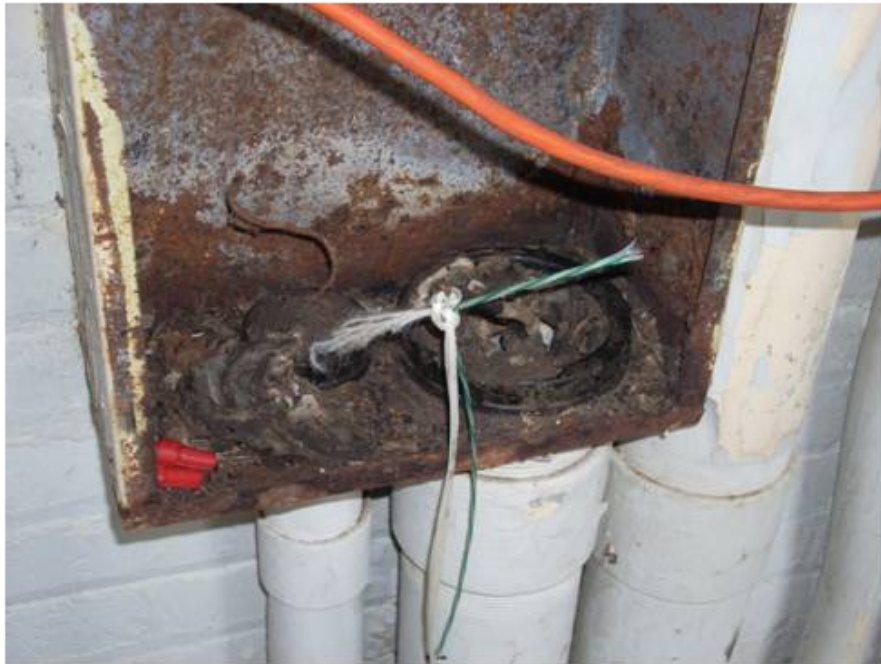
Wire Insulation, Sample 3

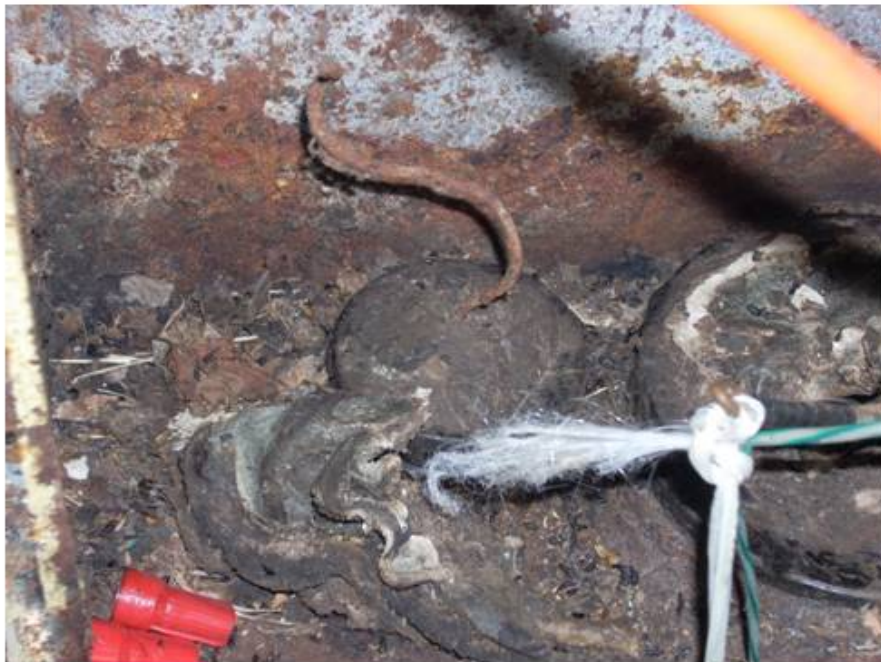
Fire Stop, Sample 4A

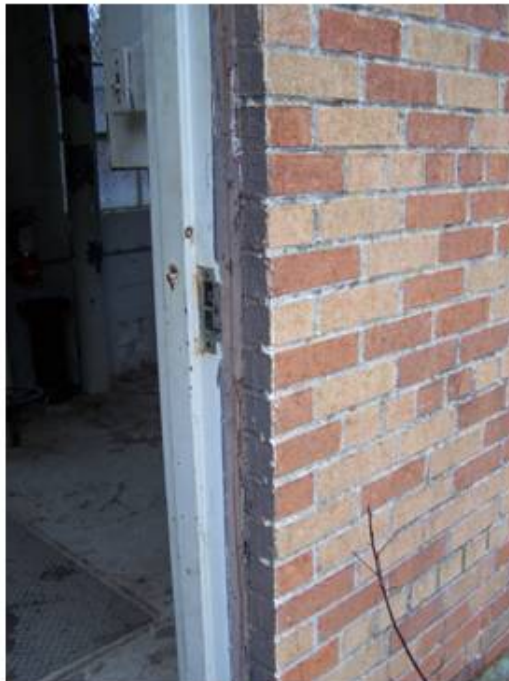
Brick Wall (Exterior), Reading 316

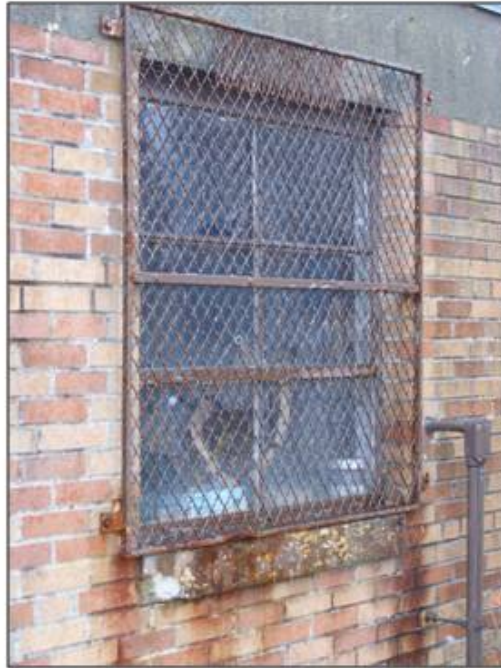
Metal Security Bars on Window, Reading 318

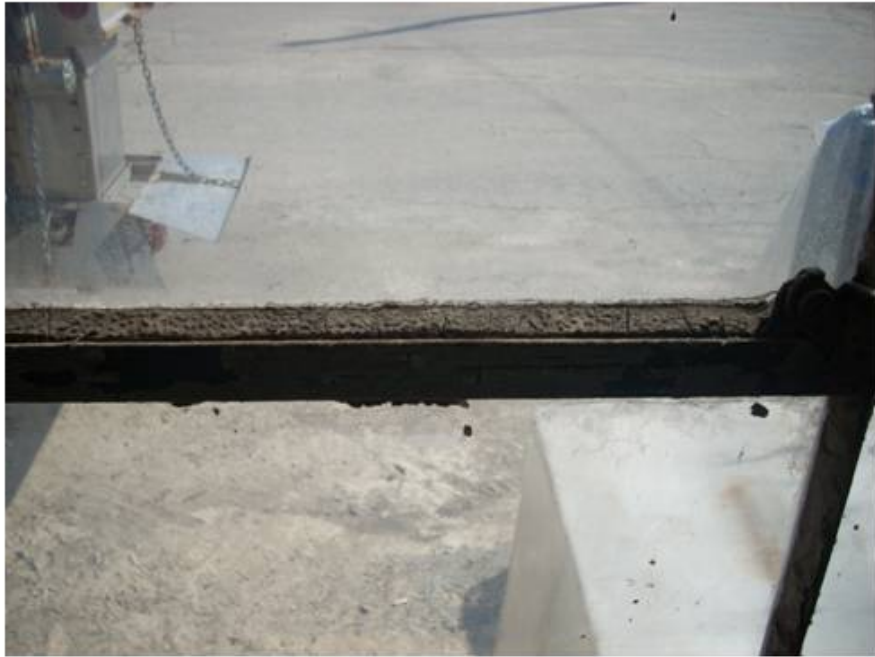
Interior Window Glazing, Sample 1A

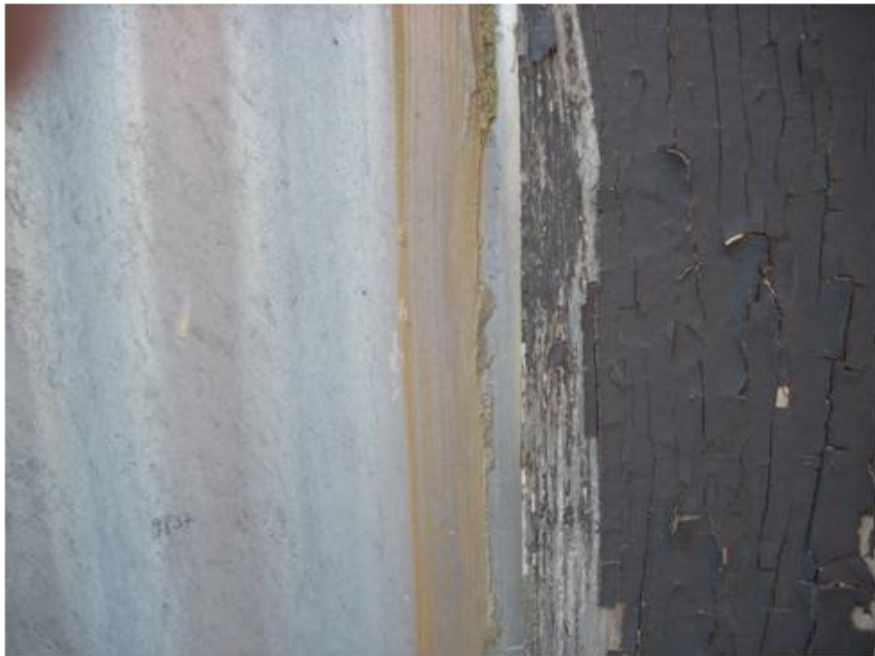
Exterior Building Caulk, Sample 2A

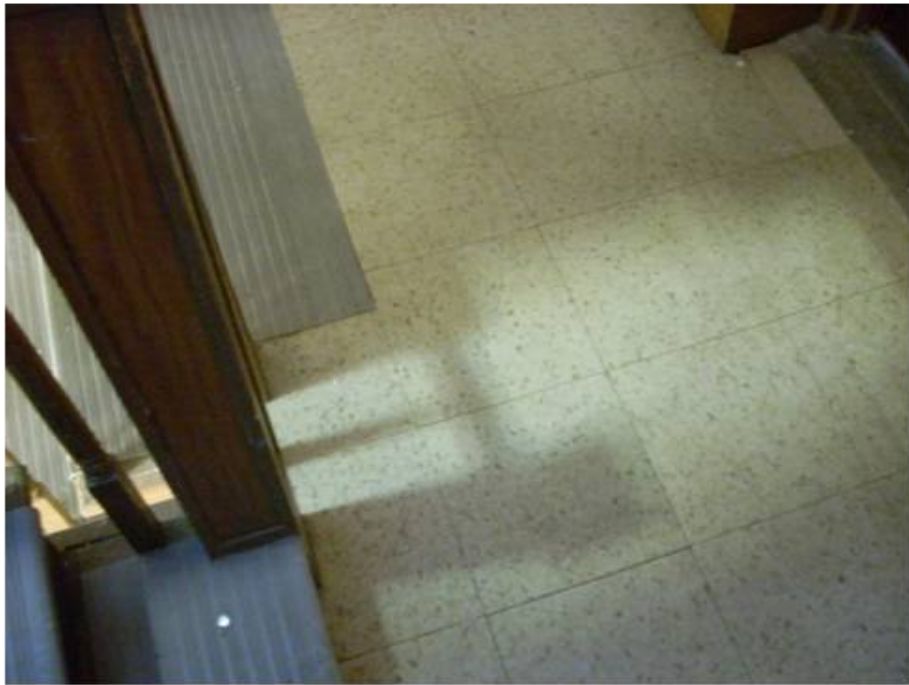
12"x12" Beige Floor Tile and Mastic, Samples 3A and 4C
