## **VOLUME II ASBESTOS CONTAINING MATERIAL & LEAD CONTAINING PAINT SURVEY REPORTS**

**VISN 1**  
**Brockton VA Medical Center**  
940 Belmont Street  
Brockton, Massachusetts

Project No. 2009023.003

June 21, 2010

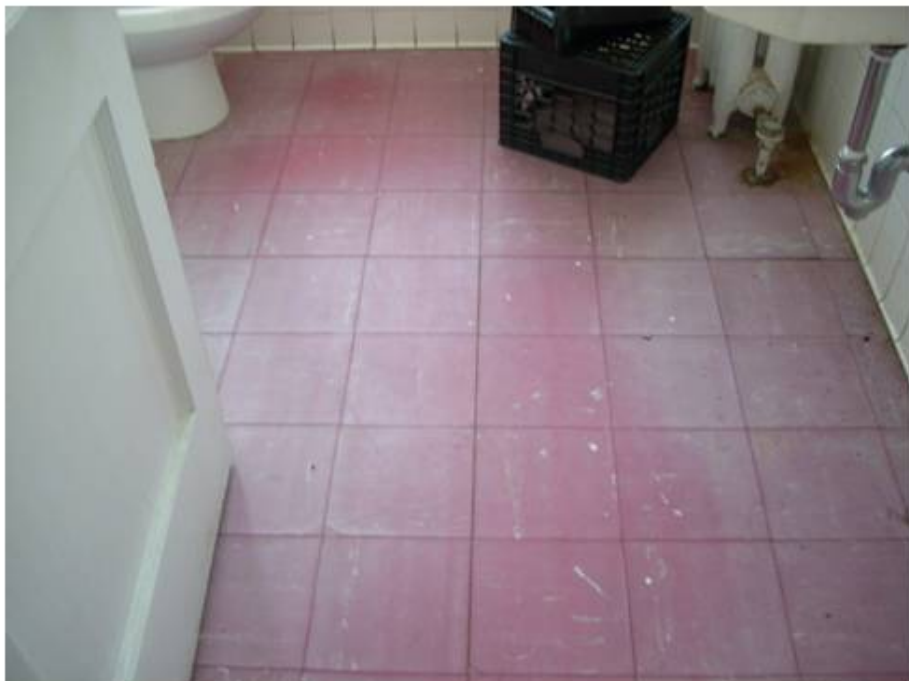
9"x9" Red Floor Tile, Sample 13A

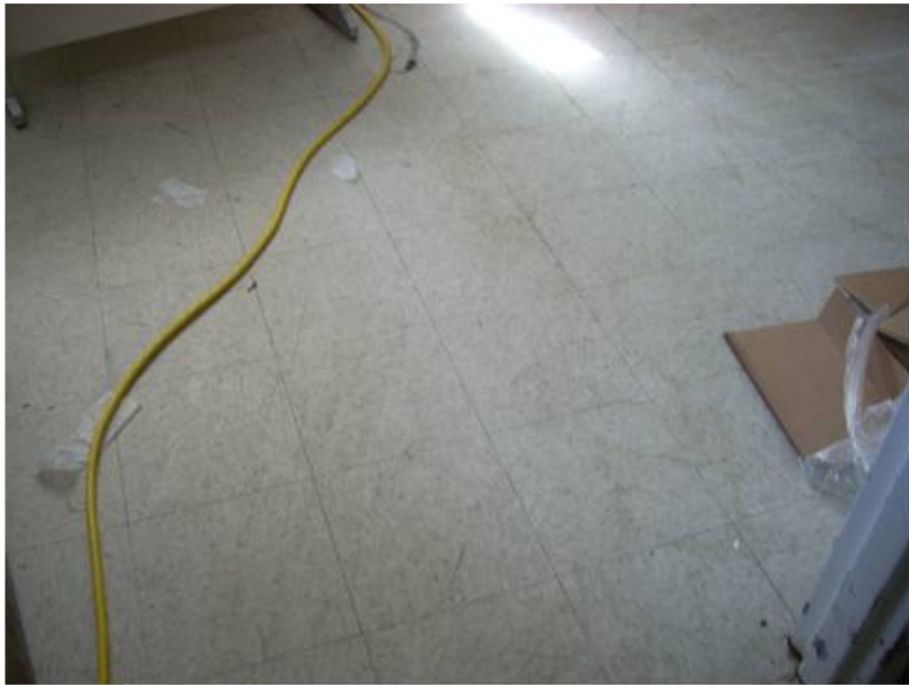
12"x12" Basement Floor Tile and Mastic, Samples 49A and 50A

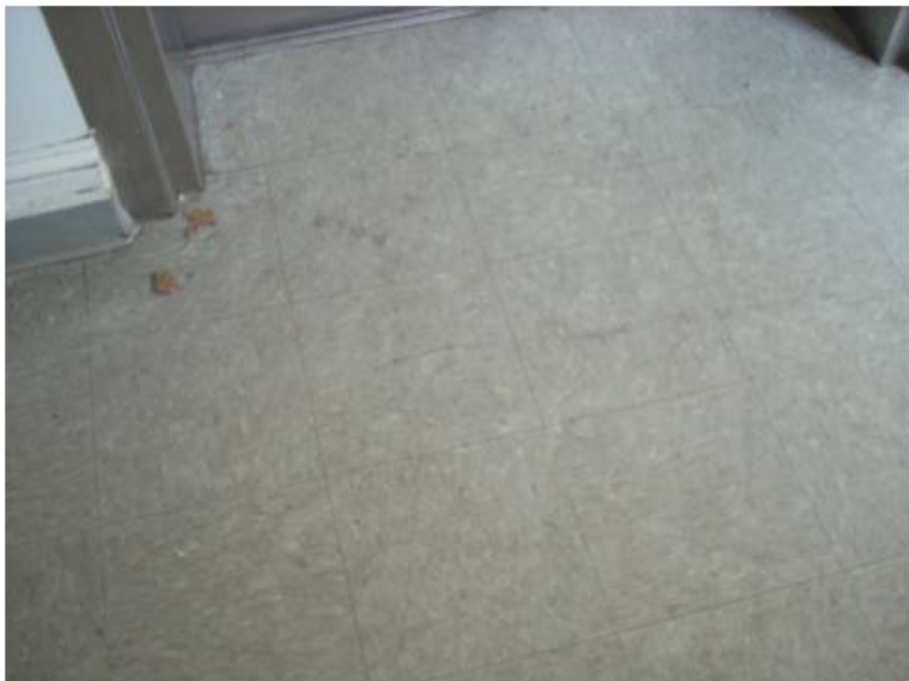
Mastic Associated with 12"x12" Lobby Floor Tile, Sample 52

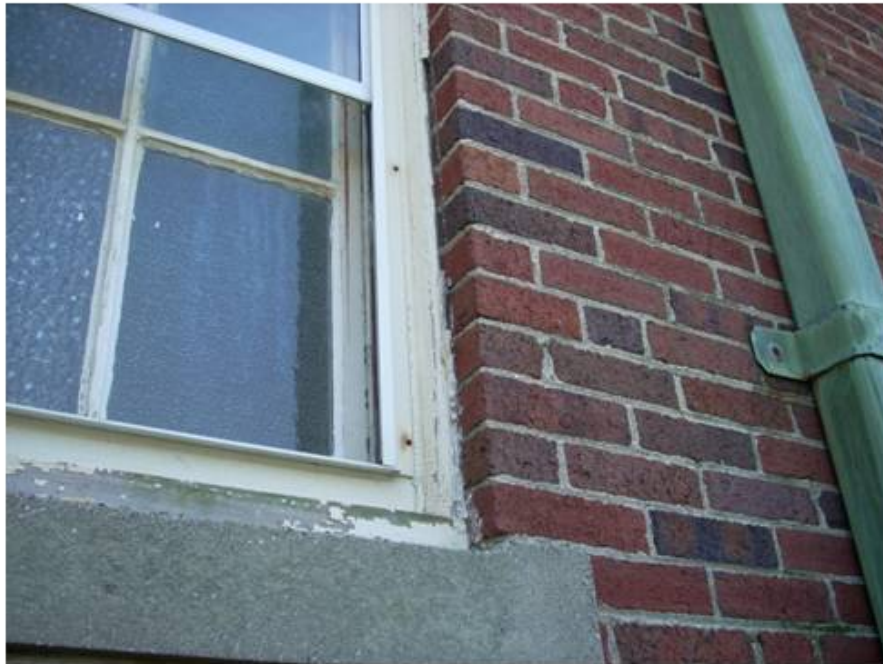
Exterior Window Caulking, Sample 54A

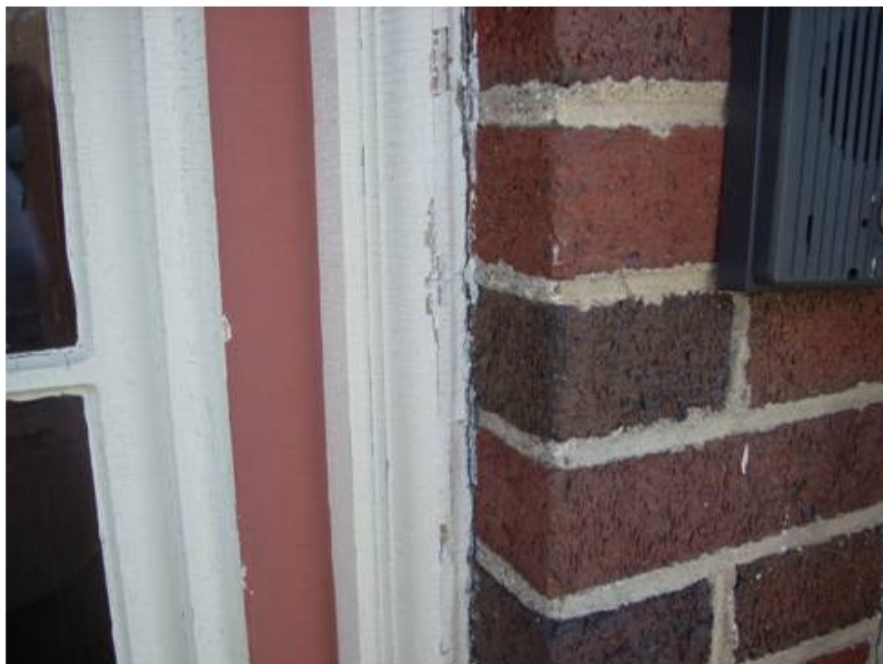
Exterior Door Caulking, Sample 56A

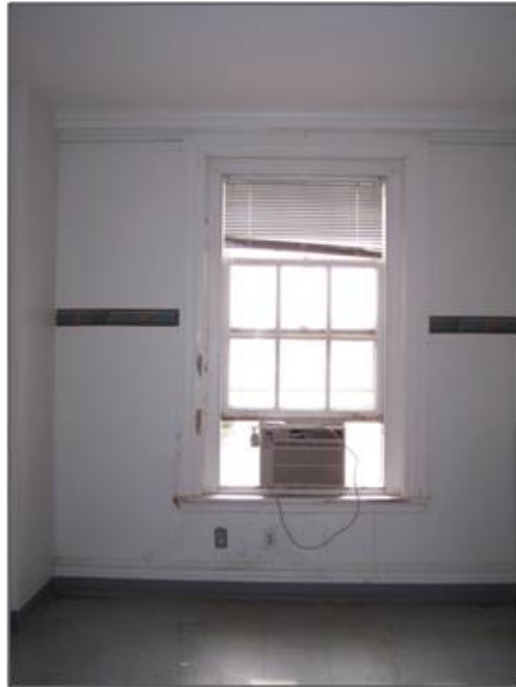
Wood Window Sash, Wood Window Casing and Wood Window Sill, Readings 497, 498 and 499

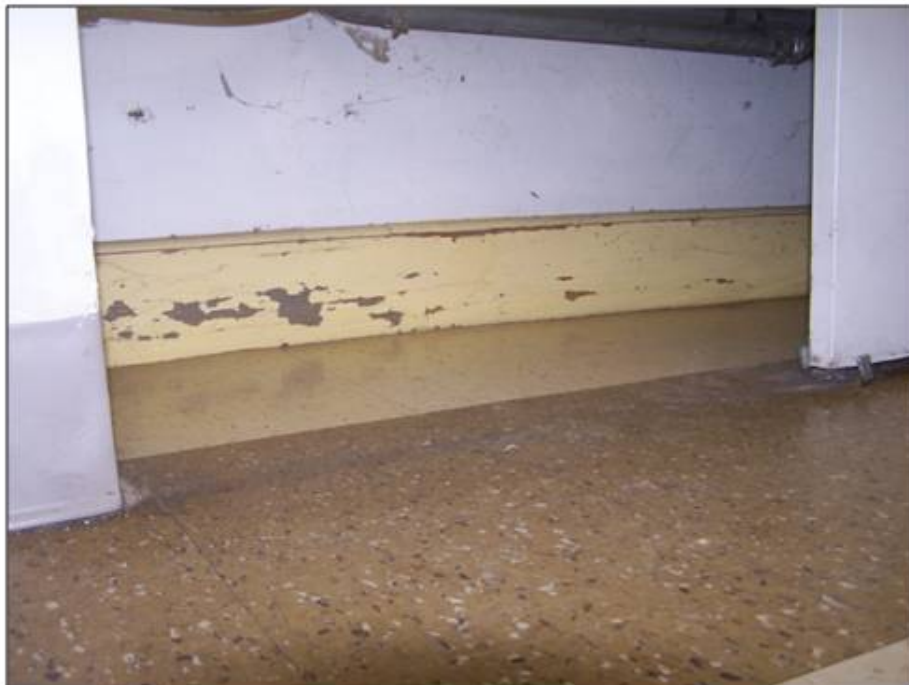
Wood Baseboard, Reading 567

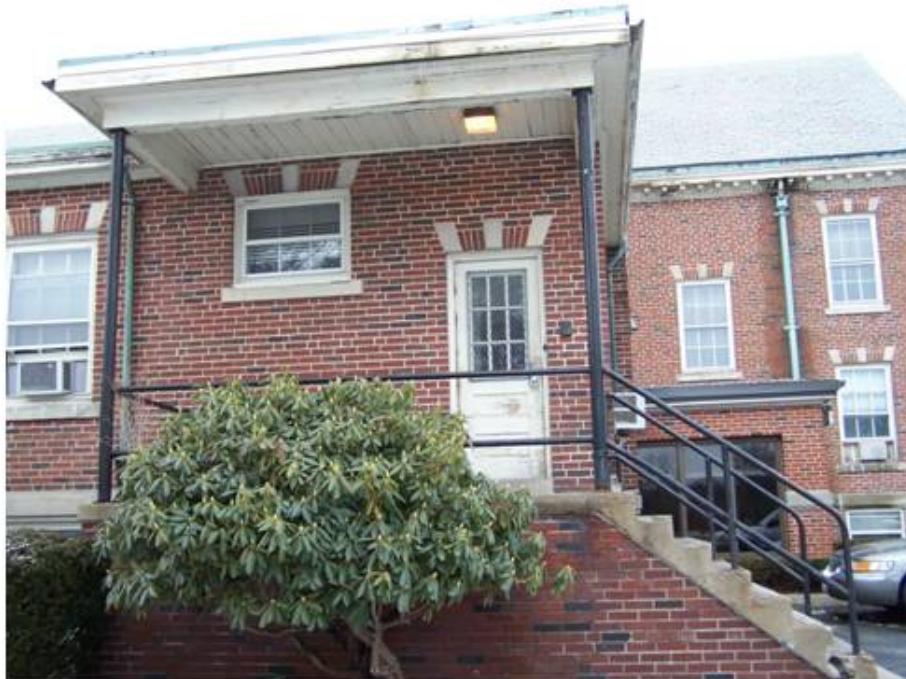
Metal Handrail. Wood Door and Wood Door Casing, Readings 586, 587 and 588

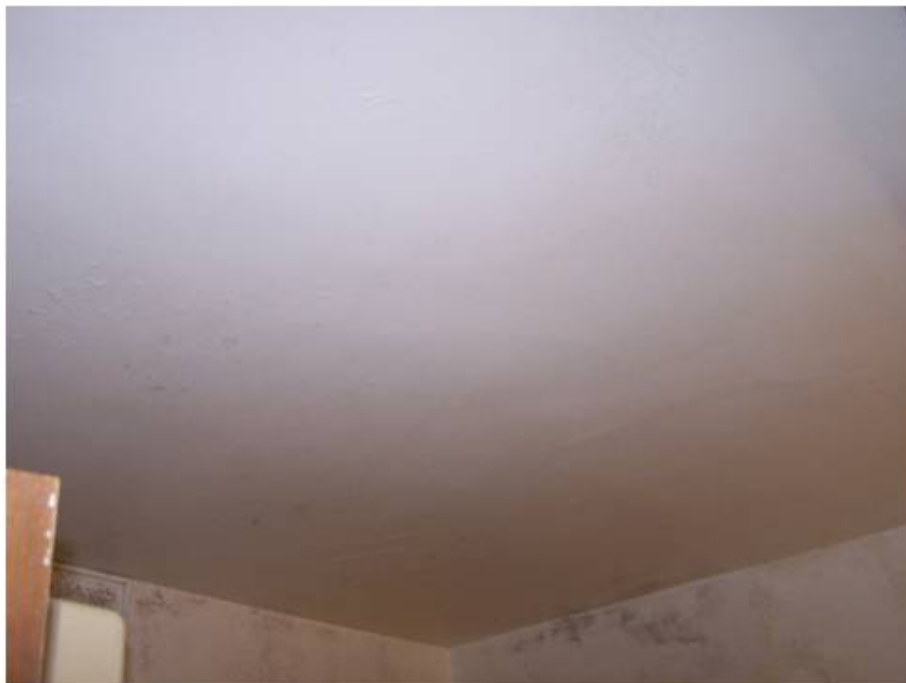
Plaster Ceiling, Reading 1135

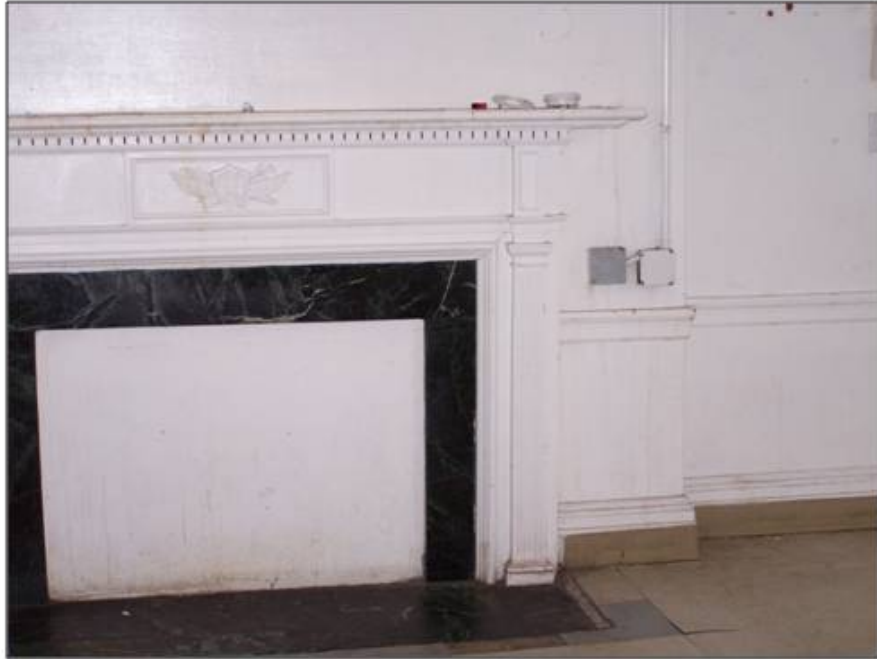
Wood Mantel and Wood Chair Rail, Readings 1610 and 1612

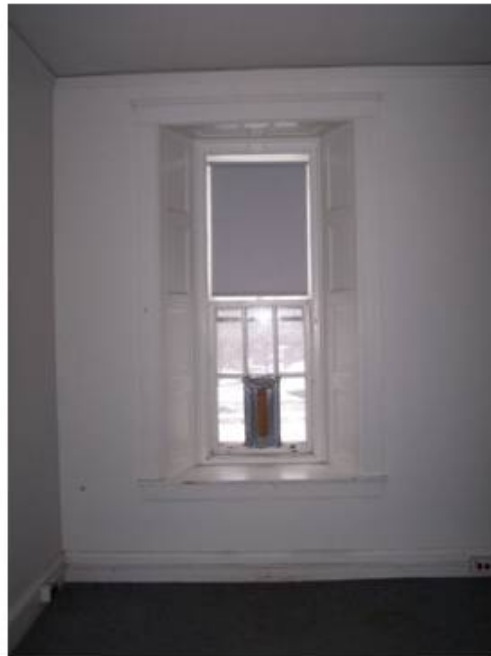
Wood Raised Panels Associated with Windows and Wood Bench Seat in Front of Window, Readings 2702 and 2706

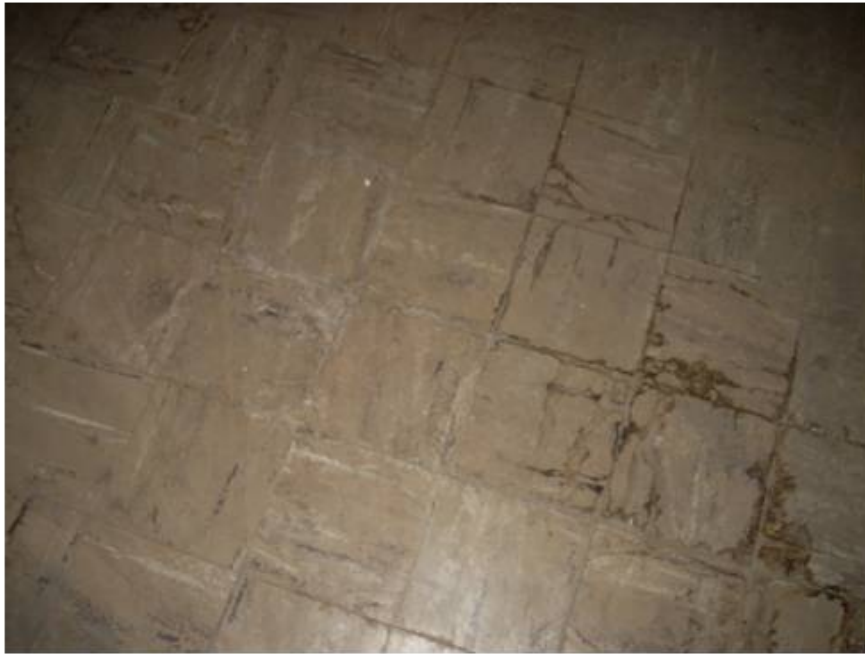
9"x9" Brown Floor Tile, Sample 2A

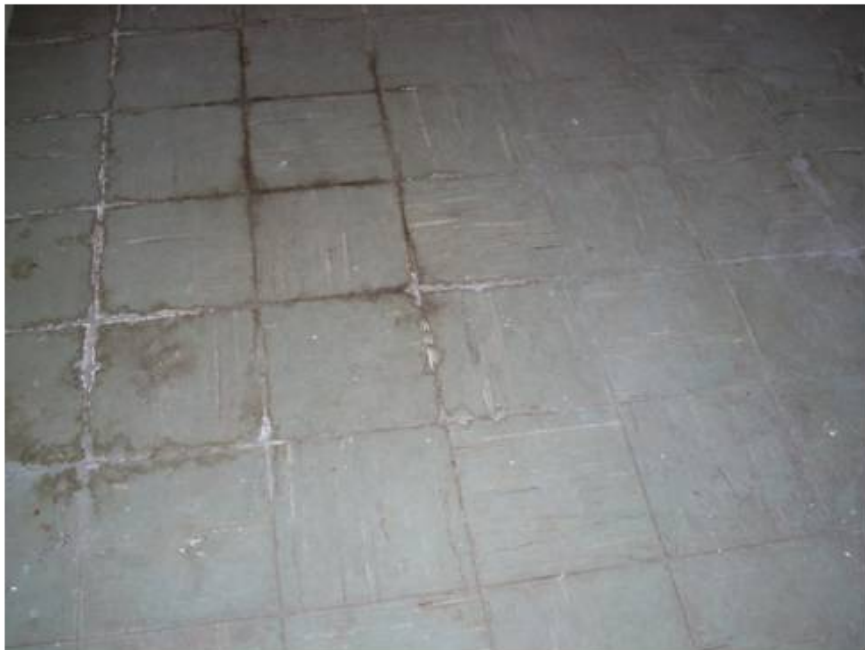
12"x12" Green Floor Tile and Mastic, Samples 4A and 5A

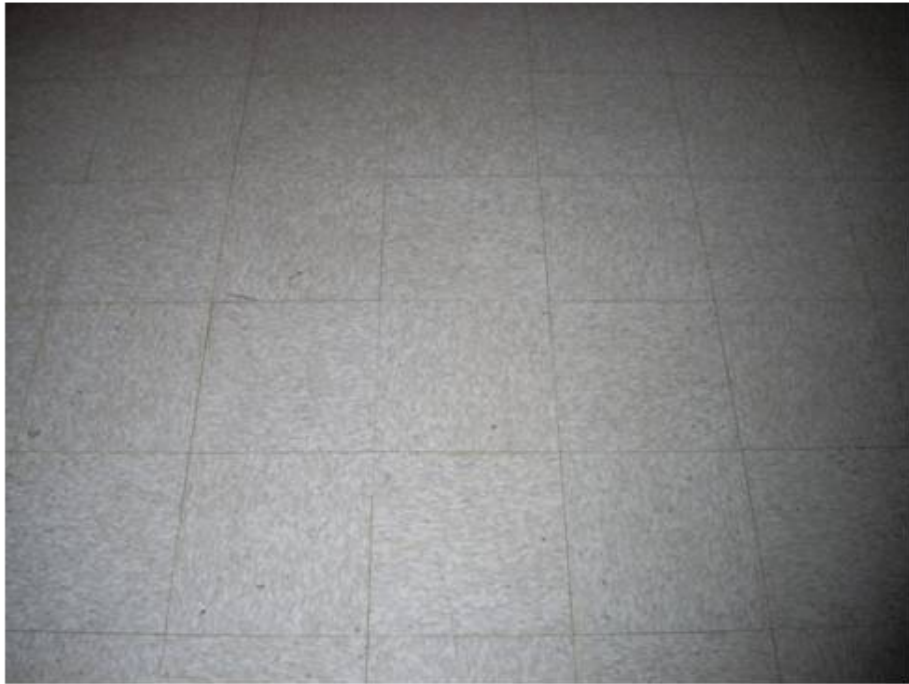
Mastic Associated with 12"x12" Brown Floor Tile Mastic, Sample 10C

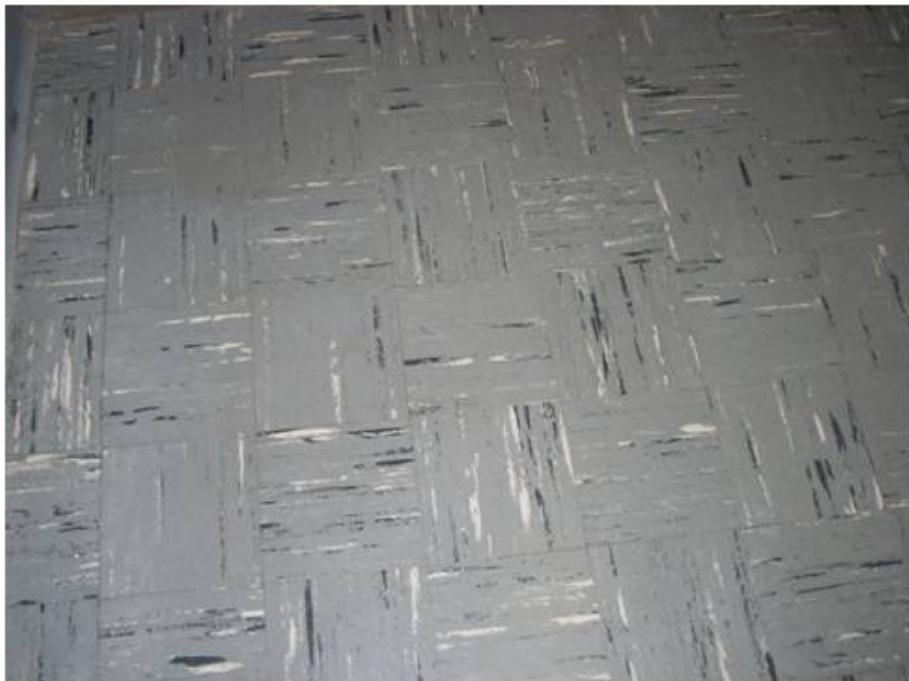
9"x9" Gray Floor Tile, Sample 13A

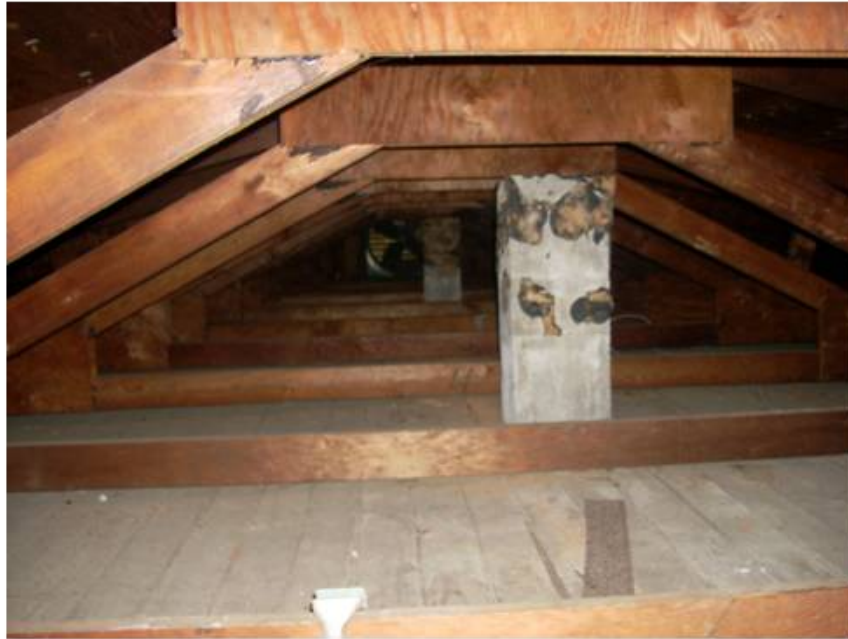
Column Mastic, Sample 21B

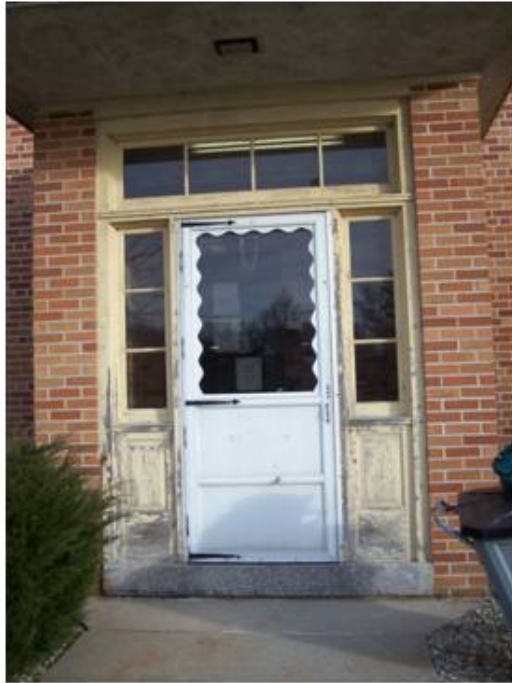
Wood Door Casing, Reading 186

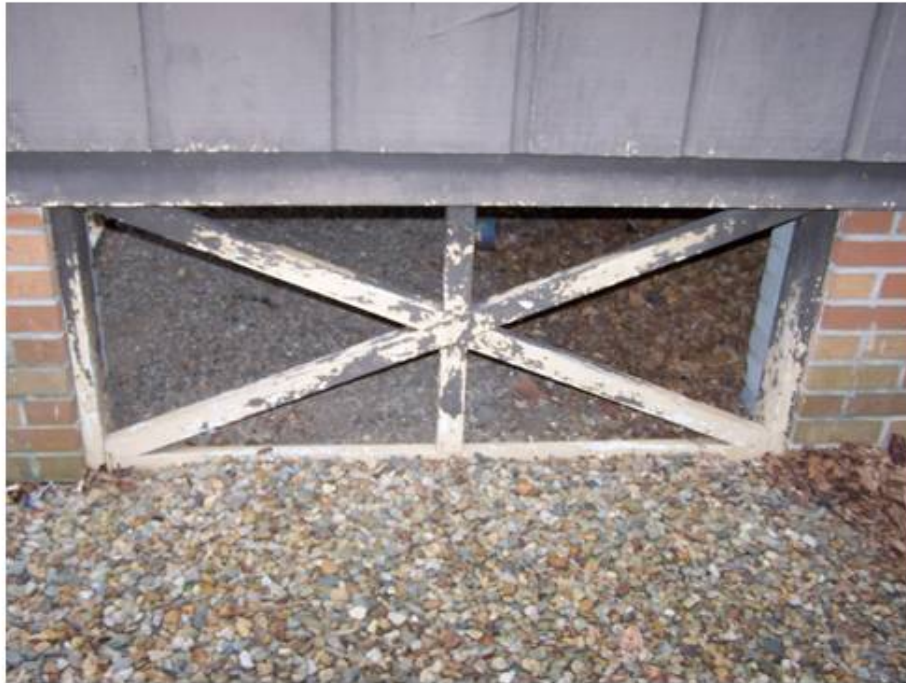
Wood Trim, Reading 190

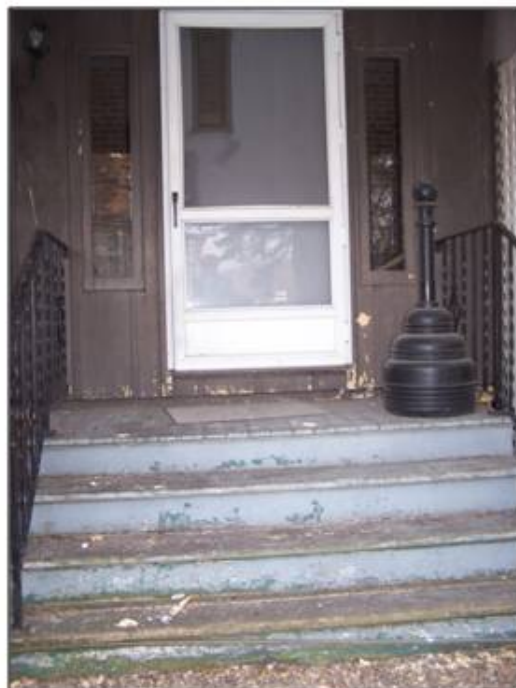
Wood Tread and Wood Riser, Readings 193 and 194

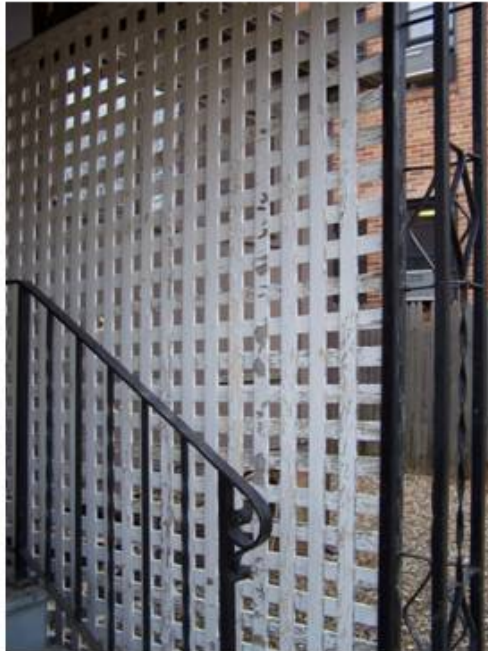
Wood Lattice, Reading 199

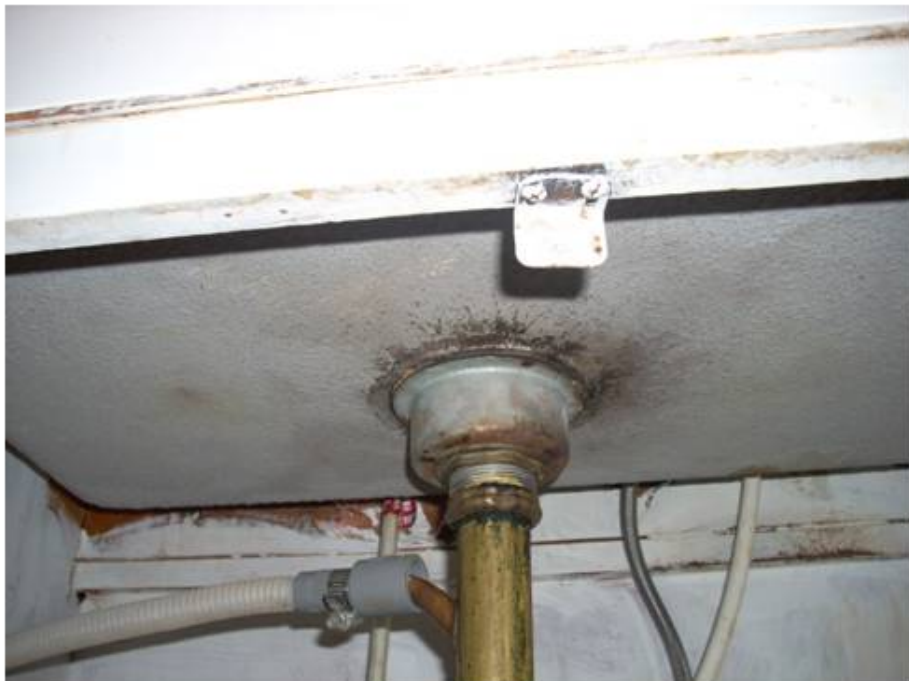
Sink Undercoating, Sample 15A

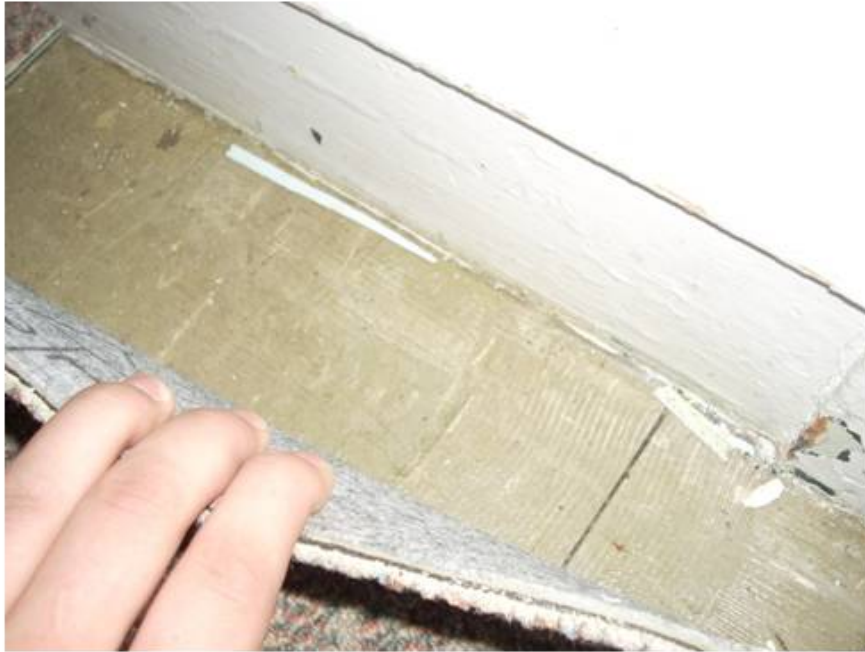
12"x12" Green Floor Tile and Mastic Underneath Carpet, Samples 17A and 18A

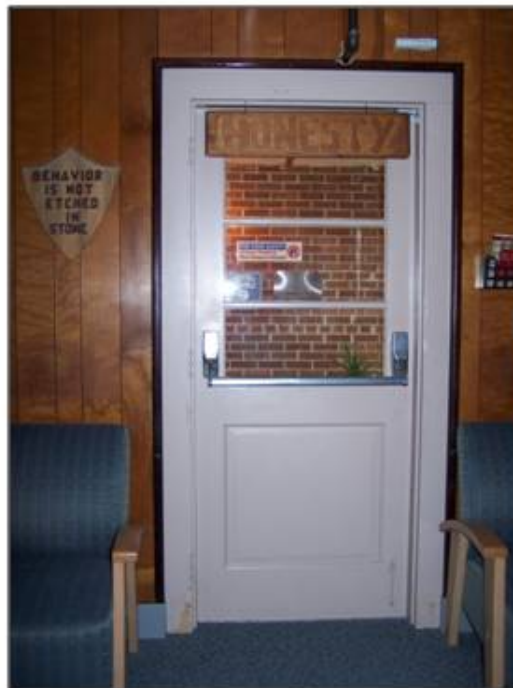
Wood Door and Wood Door Casing, Readings 345 and 346

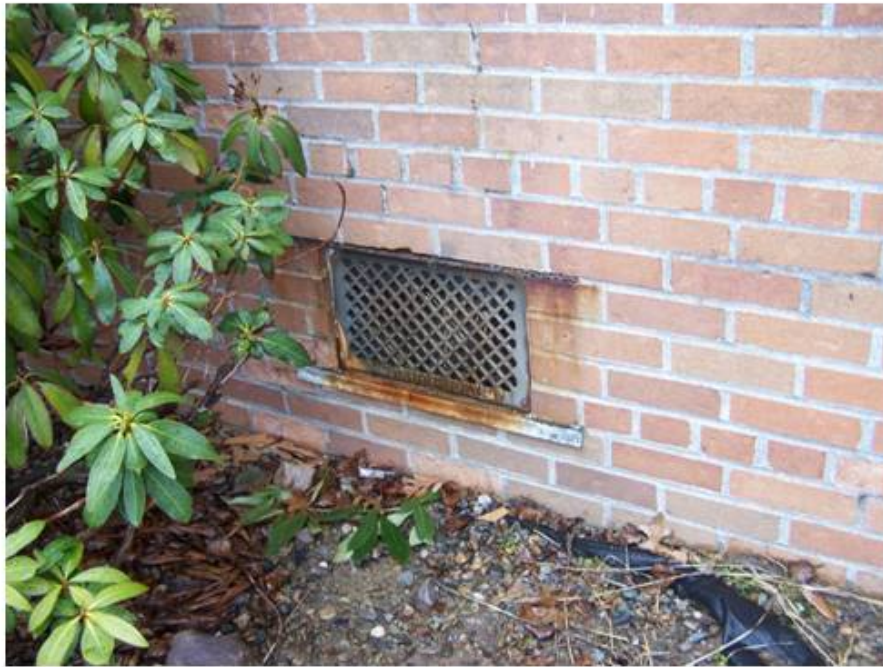
Exterior Metal Vent, Reading 384

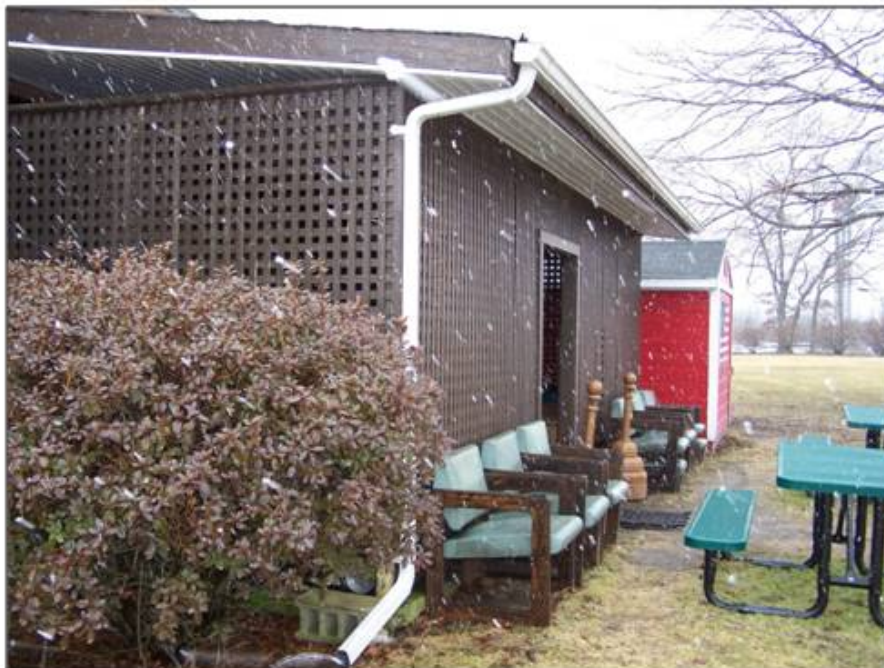
Wood Lattice Work, Reading 385

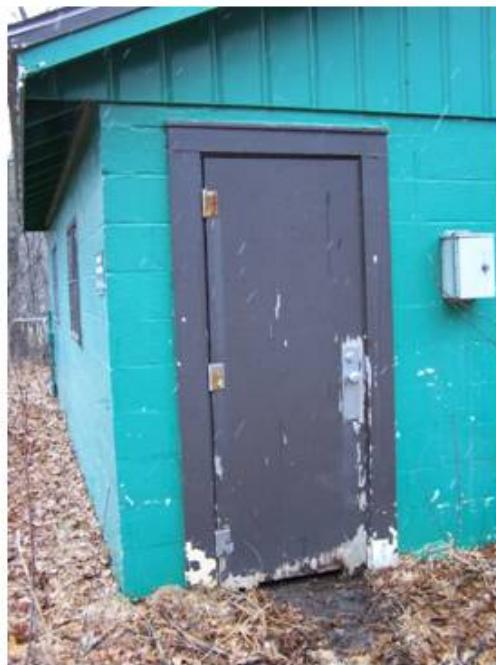
Wood Door Casing, Reading 327

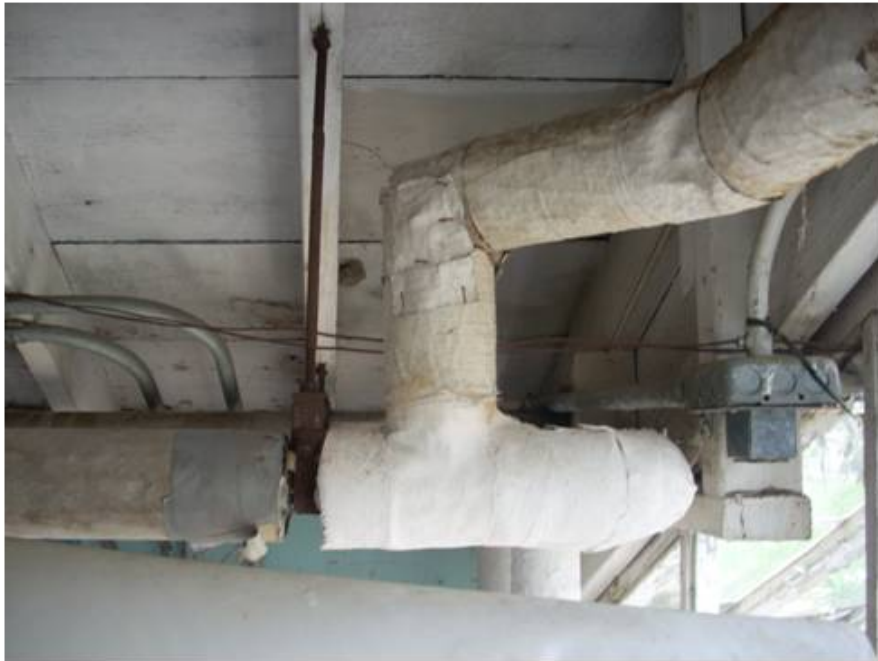
Pipe Insulation, Sample 1A  
Elbow Insulation, Sample 2A

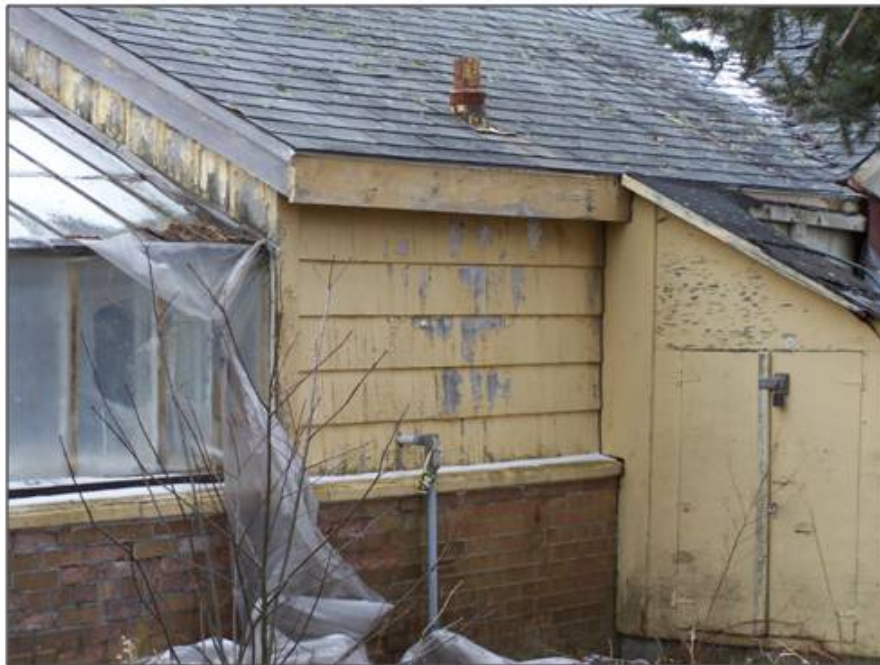
Wood Window Casing and Exterior Wood Wall, Readings 604 and 606

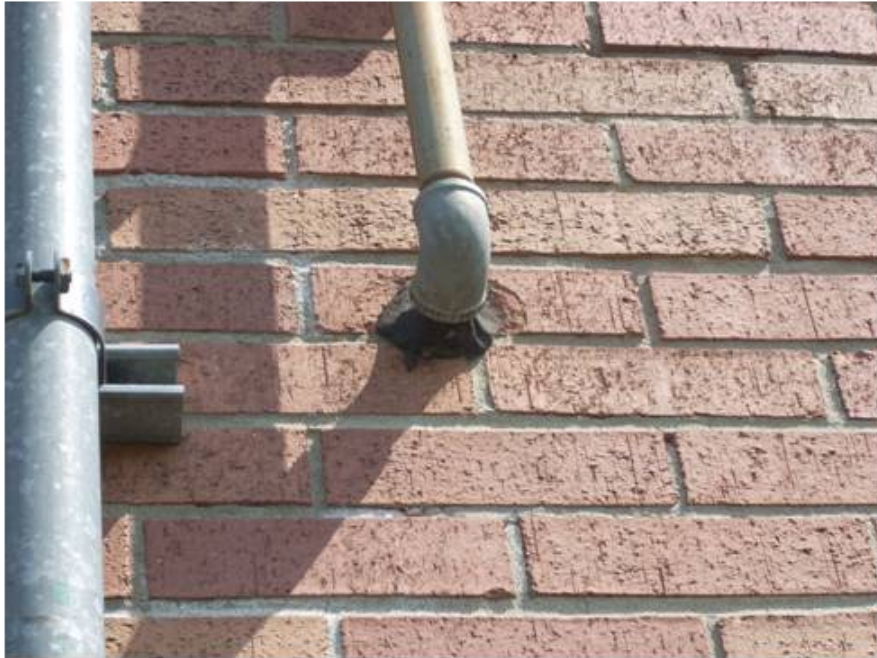
Black Penetration Caulking, Sample 4

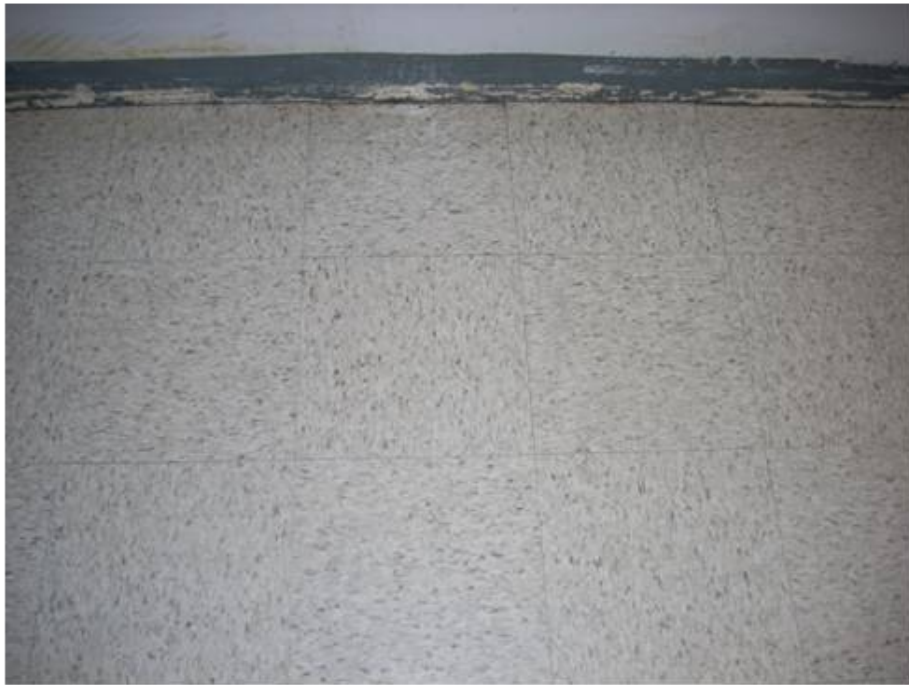
Mastic Associated with 12"x12" Shelter White Floor Tile, Sample 2A

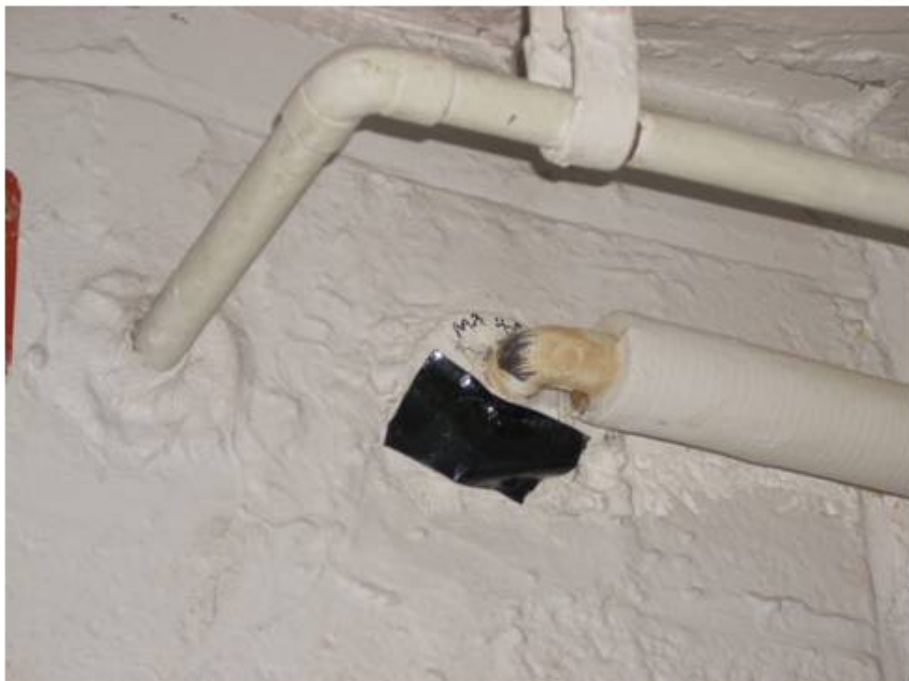
Pipe Insulation, Sample 4

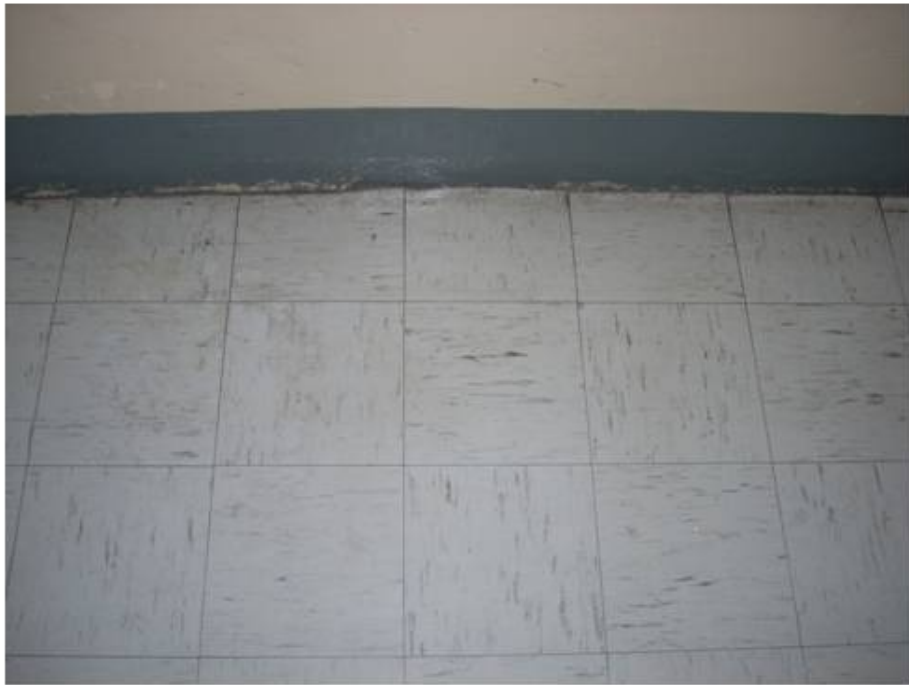
9"x9" White Floor Tile and Mastic, Sample 5A, 6A

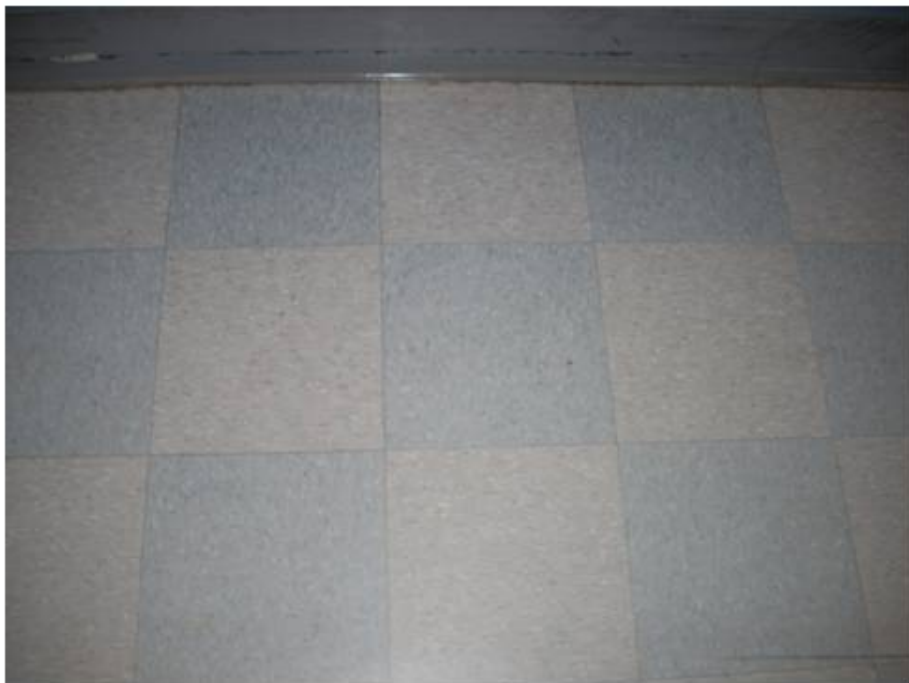
Mastic Associated with 12"x12" Blue/Gray Floor Tile, Sample 11B

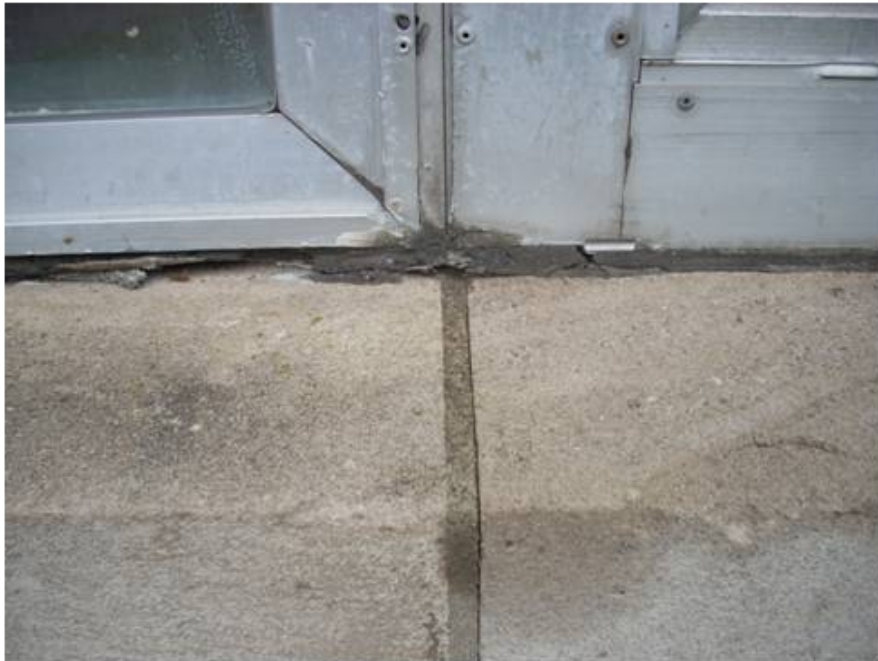
Window Caulking, Sample 15A
